COAL MINE SAFETY AND HEALTH
REPORT OF INVESTIGATION

Fatal Powered Haulage Accident
June 23, 2014

Spring Creek Mine
Spring Creek Coal Company
Decker, Big Horn County, Montana
ID No. 24-01457

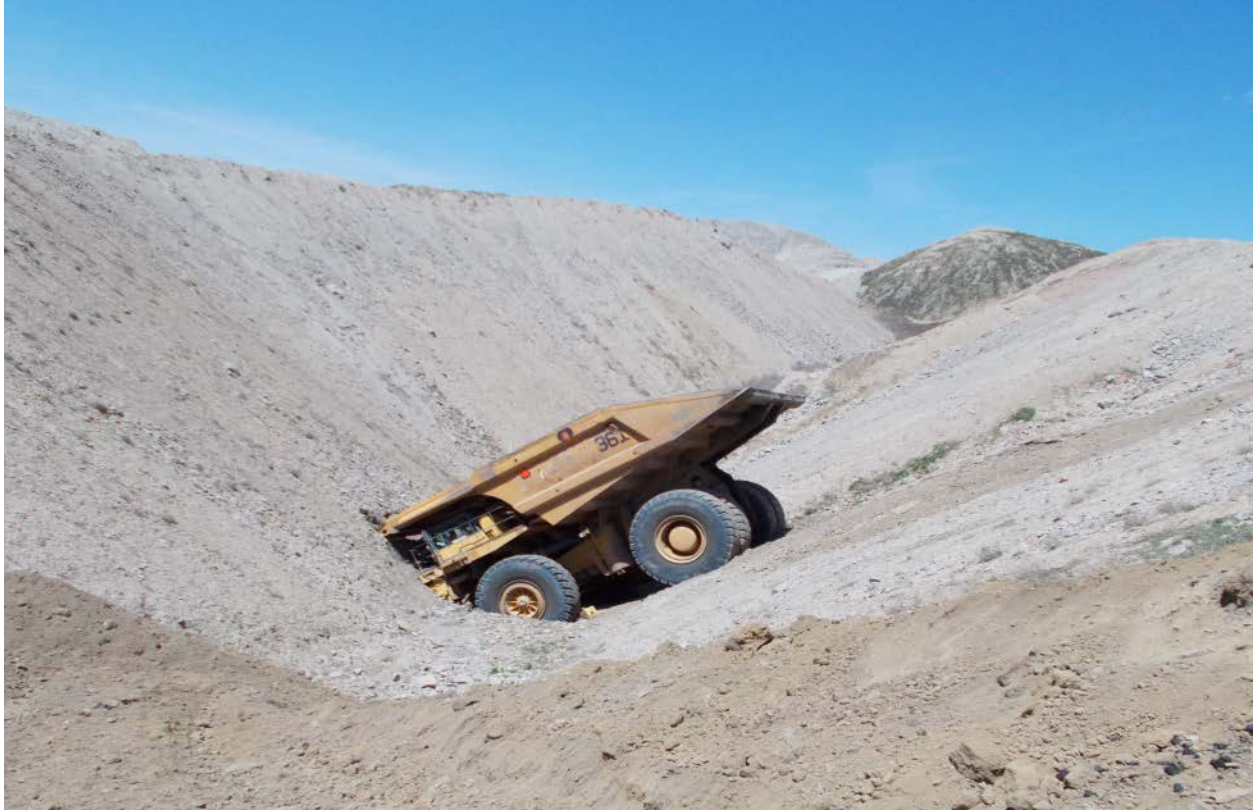
PHOTOGRAPH OF ACCIDENT SCENE

HAUL TRUCK IN THE SPOIL "V"

The fatal accident occurred when the haul truck, operated by the victim, traveled through a berm, descended approximately 75 feet, and stopped abruptly against the opposite embankment in the bottom of a spoil "V." The cause of the truck traveling through the berm was not determined. The victim was not wearing his seat belt when the accident occurred which resulted in him receiving fatal injuries.

Corrective Action: The mine operator modified its new miner and contractor training plans to emphasize the importance of the use of seat belts. The plan further emphasized the potential disciplinary actions for not wearing a seat belt.
