REPORT OF INVESTIGATION

Fatal Powered Haulage Accident  
September 16, 2014

West Ridge Mine  
West Ridge Resources Inc.  
East Carbon, Carbon County, Utah  
ID No. 42-02233

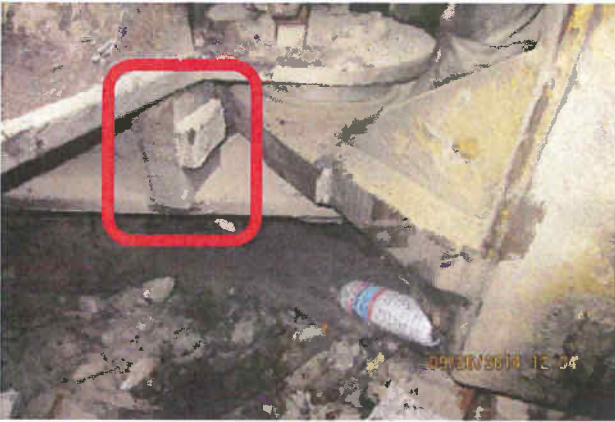
At some point in time, after original manufacturing and prior to West Ridge’s purchase, metal blocks were added to the original steering stops at the articulation frame that increased the closure distance between frames, so that a miner could potentially not be crushed if his body was in the articulation area. The off side steering stop plate was measured at 4 ¼ inch long by 2 ¼ inches wide and estimated to be ½ inch thick. When examined, the operator’s side forward steering stop was missing. This allowed the closure, frame to frame, at the pinch point where the victim became entrapped. These steering stops were not original to the machine when manufactured (see Appendix C).

Steering stop on No. 5 Wagner ST-2DS

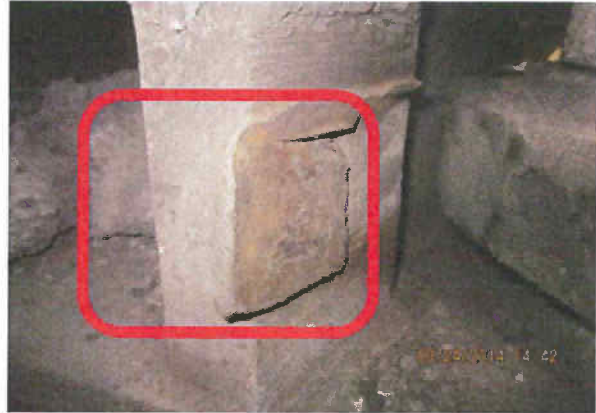
- (9) The operator's side forward steering stop was missing.

Missing steering stop, Wagner 24-43

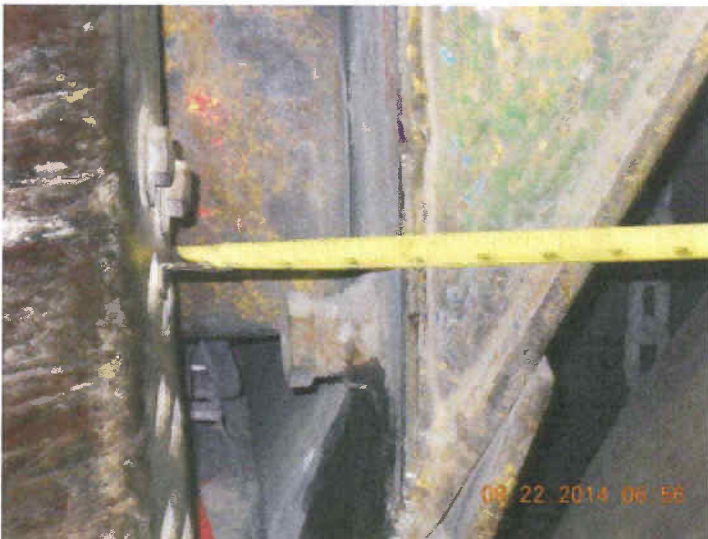
Once repaired for testing, the machine was able to articulate fully to the left as it did in the accident. To articulate, the machine had to overcome the fact that the park brake was set, friction from contact with the mine floor, and turn up hill against the 13 percent grade. The Wagner was articulated to the left multiple times to show the position and closure necessary to simulate the condition that occurred during the accident. It took an average of 28 seconds to close to the steering stops. The gap between the operator’s compartment frame to the water tank frame, when fully articulated to the left to the steering stops, measured 3 ½ inches (see Appendix C).

Wagner frame to frame closure as measured at 3 1/2 inches.
