REPORT OF INVESTIGATION

Surface Coal Mine
Fatal Powered Haulage Accident

October 18, 2014

North Antelope Rochelle Mine
Peabody Powder River Mining LLC
Wright, Campbell County, Wyoming
ID No. 48-01353

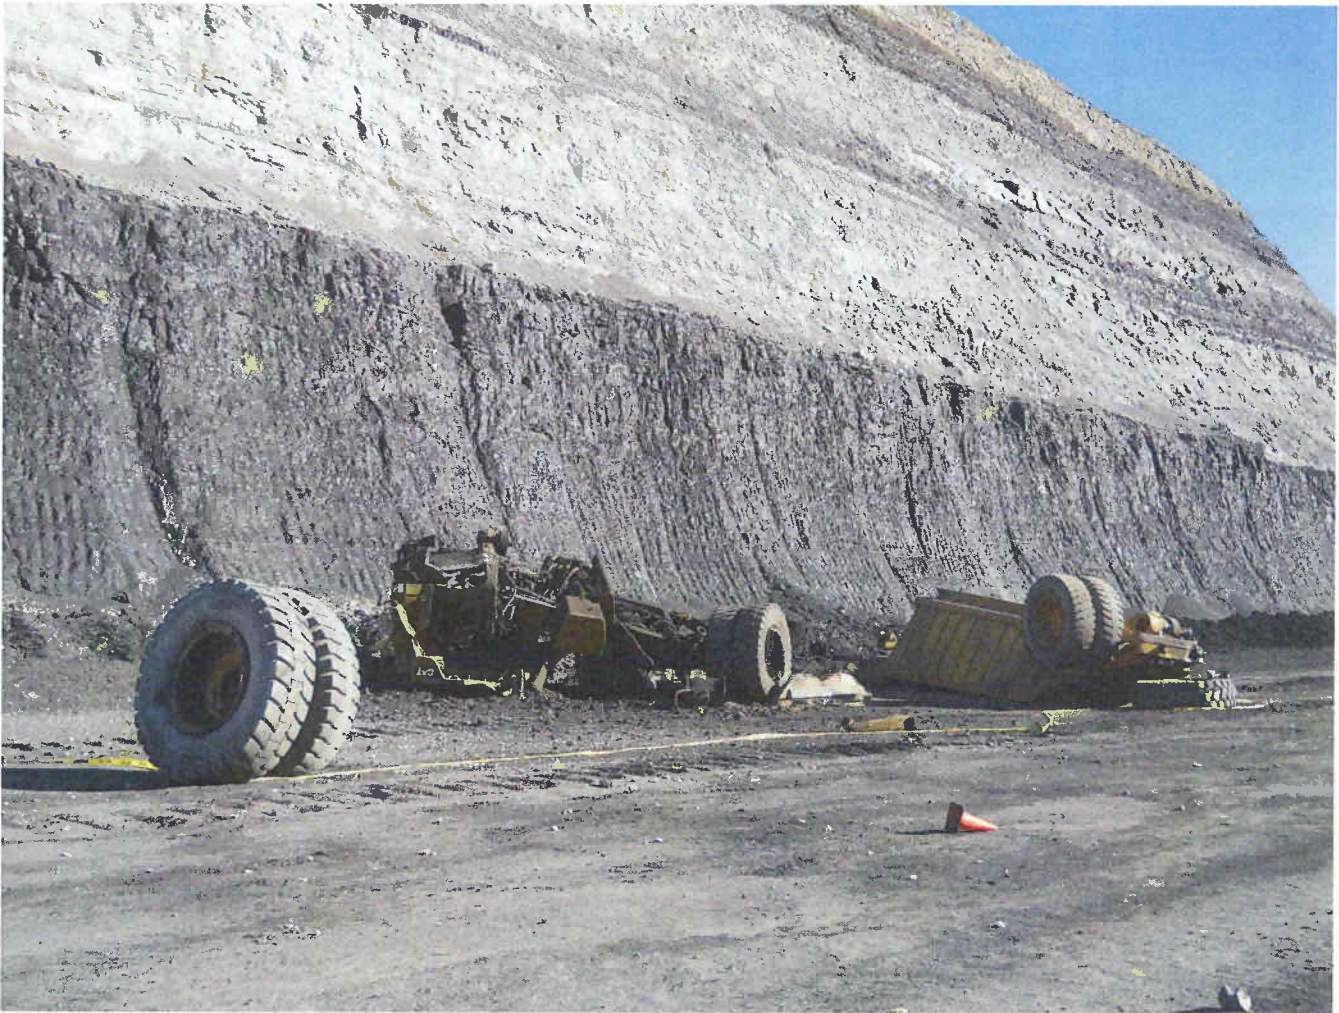
PHOTO SHOWING ACCIDENT SCENE

At approximately 10:05 p.m. on October 18, 2014, Darwin Lee Reimer (victim) age 51, received fatal injuries when the Caterpillar 777B haul truck he was operating went over a 238 foot highwall. The haul truck traveled 2,296 feet over the top soil limit area, through the old top soil berm section (previously stripped), through the cast berm, and through the drill pattern section; before it went over the highwall and crashed on the pit bottom.

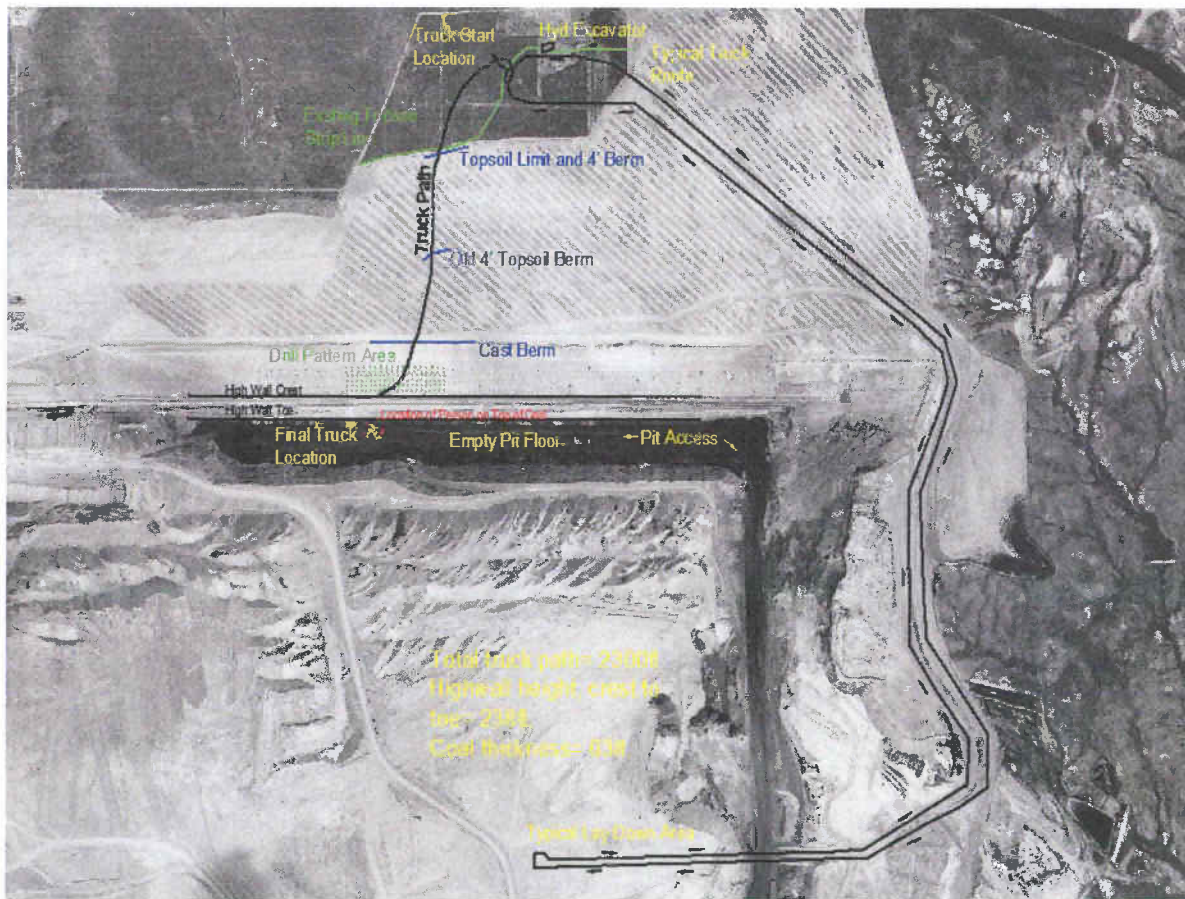
APPENDIX A – Caterpillar 777B Haul Truck's Path of Travel

The haul truck then traveled 2,296 feet through a top soil limit area, through a drainage ditch and over a 4 foot high berm. The truck continued traveling south across the old top soil berm section, and went over a 3 foot high berm in the process. The truck continued traveling south through the cast berm section and it broke through the cast berm which measured approximately 6 to 9 feet high and 32 feet wide. The truck continued traveling in a southerly direction through the drill pattern section (cast section). The truck traveled through the shot pattern, running over drill material 3 to 5 feet in height and over six loaded shot holes. The truck then traveled over the north highwall of the East Elk Pit. The left front side of the truck's operator compartment struck the top bench of the highwall before falling to the pit bottom. The victim was ejected at some point. This portion of the event lasted approximately 4 minutes according to testimony. See Appendix A for the haul truck's path of travel.

The truck exited the staging area by taking a sharp left hand turn and traveled to the top soil limit area. It went over the 3 foot cut where the excavator had removed the top soil. Then the truck traveled north before making a turn to the west, and continued on a wide looping turn, eventually turning back to the south toward the staging area. Next, the truck traveled 786 feet across the topsoil limit section, before it went over a ditch (clearing a 5 foot wide section of the ditch) and traveled through a 4 foot berm. The truck continued traveling south 669 feet across the old topsoil berm section and went over a 3 foot high berm. Afterwards, the truck continued traveling south 280 feet through the cast berm section. It then turned slightly to the west where it went through the cast berm, which is approximately 6 to 9 feet high and 32 feet wide. The axle height of a Caterpillar 777B haul truck is 4 feet and 1 inch. Next, the truck continued in a slight southwesterly direction of travel through the drill pattern section for 382 feet. The truck continued on this route for 179 feet through the shot pattern, running over drill material 3-5 feet in height. Lastly, the truck ran over six loaded shot holes before going over the north highwall of the East Elk Pit.
