COAL MINE SAFETY AND HEALTH
REPORT OF INVESTIGATION

Fatal Fall of Roof Accident
November 10, 2014

Red Bone Mining Company
Crawdad No. 1 Mine
Maidsville, Monongalia County, WV
I.D. No. 46-05589

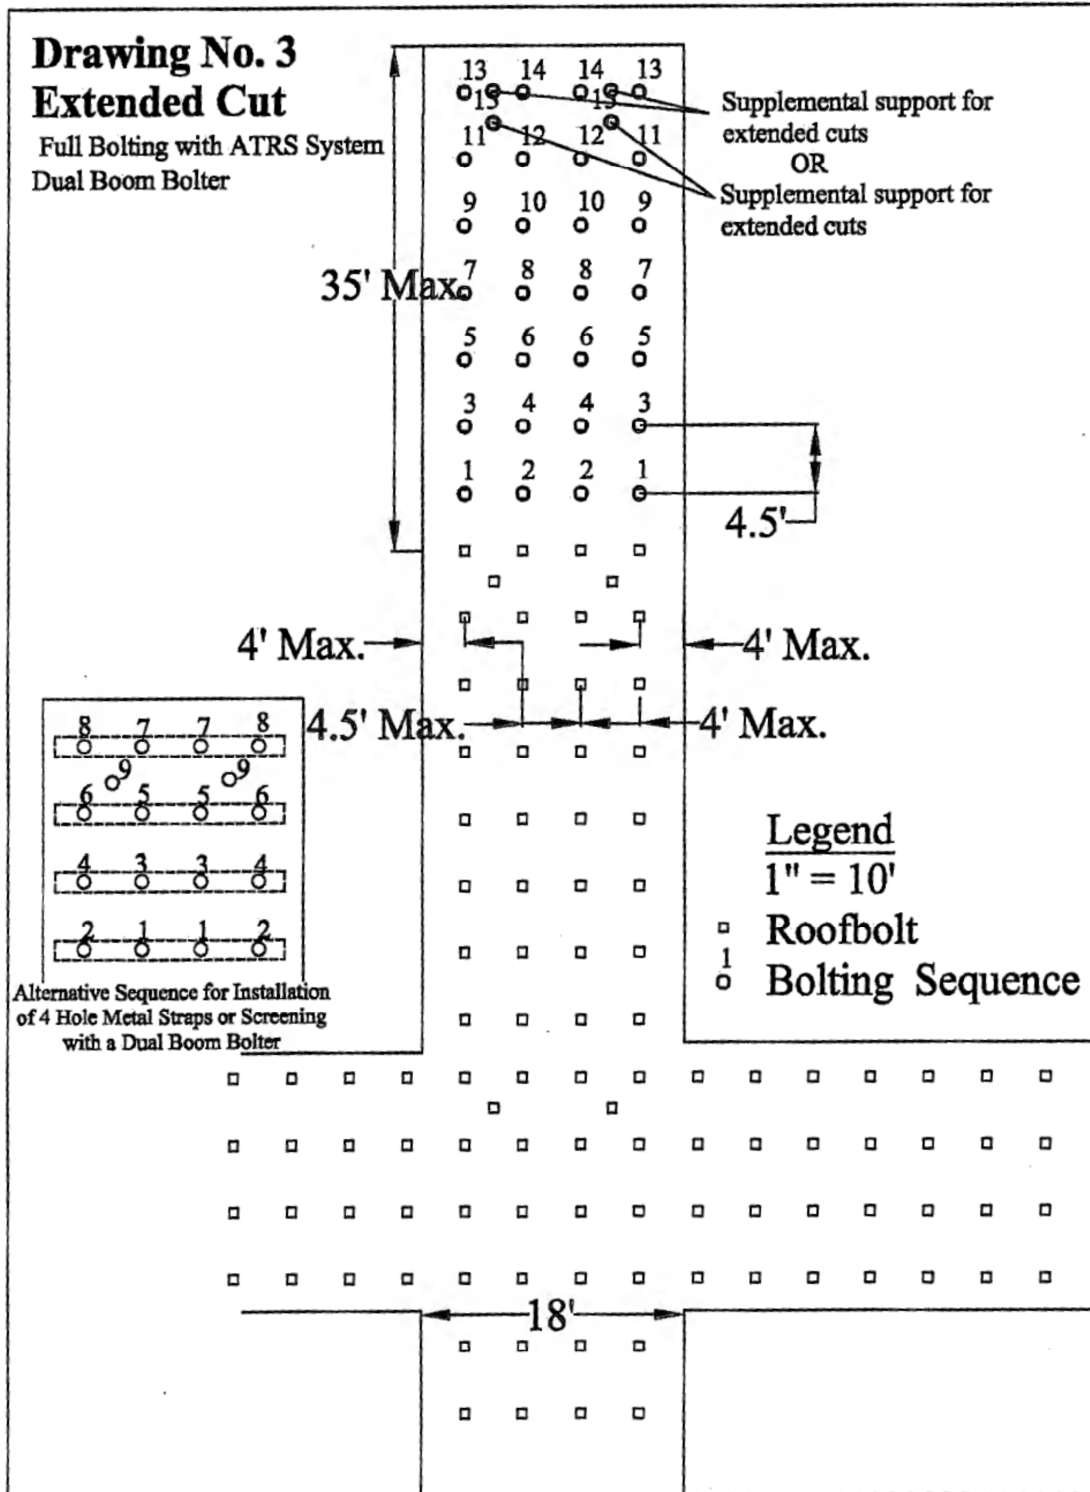
Crawdad No. 1 Mine – Roof Control Plan

Another section of the roof control plan for the "Pittsburgh break" zone requires 2 cable bolts to be installed every other row.
