**REPORT OF INVESTIGATION
(Underground Coal Mine)**

**Fatal Machinery Accident
December 16, 2014**

**Highland 9 Mine
Highland Mining Company LLC
Waverly, Union County, Kentucky
ID No. 15-02709**

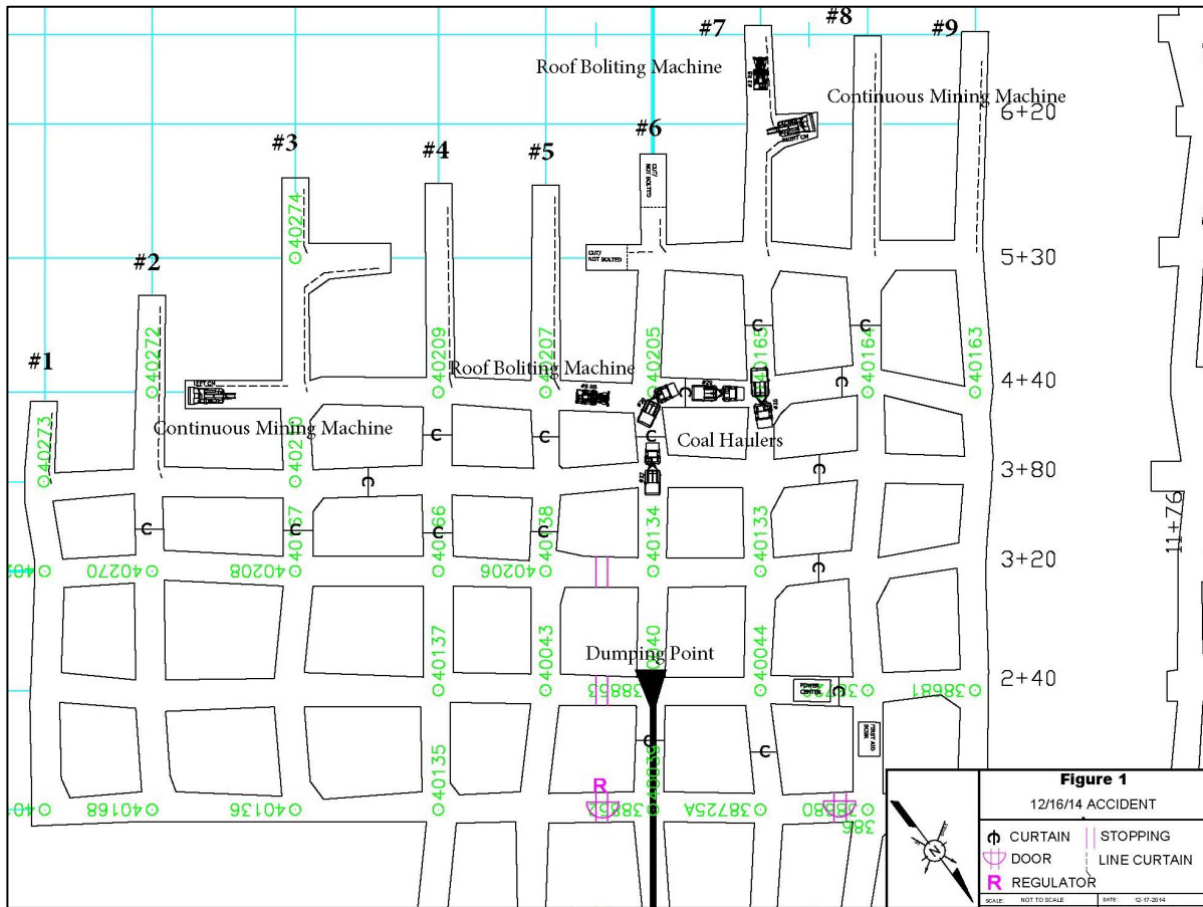
Figure 1

On the coal producing units that utilize battery-powered coal haulers, a unique system of haulage is used to facilitate loading and minimize routes of travel. The coal hauler operator's seat is on the battery end of the coal hauler. Typically, the coal hauler will travel in the direction of the battery end. Each coal hauler runs in a circular route that begins at the dumping point and continues to the continuous mining machine where it is loaded with coal and then returns to the dumping point. The coal is unloaded at the dumping point, and then carried by belt conveyor to the surface. In this circular route of travel, the coal hauler operator must change the direction of travel prior to receiving or dumping a load of coal. This puts the machine loading end either at the continuous mining machine to load coal or at the dumping point to unload coal. To accomplish this task, the coal hauler operator travels through a crosscut, battery end first into the connected entry, turns and then proceeds to the continuous mining machine. Once loaded, the operator will tram the coal hauler to the dumping point, battery end first, into a crosscut and back into the entry with the loading/dumping end toward the dumping point (see Appendix C, Figure 1).

Overview of Equipment on the Section

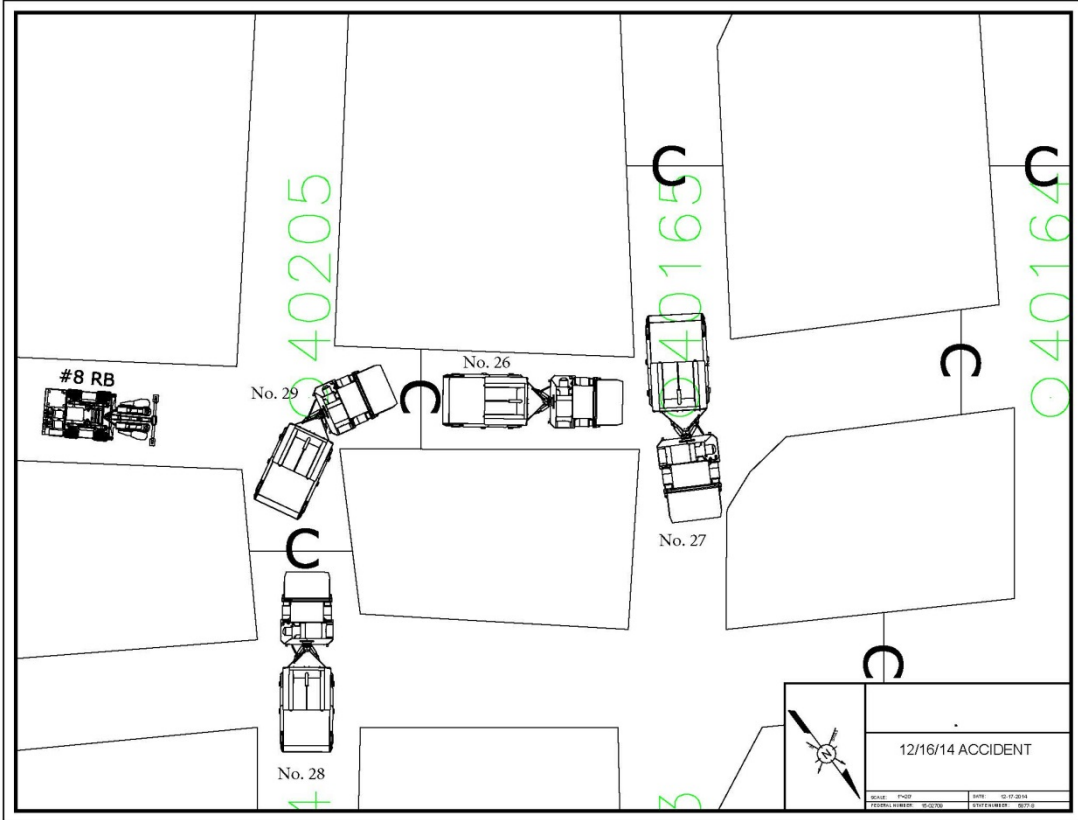
Figure 2

The right side No. 2 continuous mining machine then began mining in the No. 7 right entry at approximately 10:35 a.m. Each coal hauler received a load of coal, except the No. 26 coal hauler operated by Wesley Coots. Coots was parked in the crosscut, between the No. 6 and No. 7 entries at crosscut 4+40, waiting for the No. 27 coal hauler, operated by Patrick Baker, to travel outby before he could pull into the No. 7 entry and proceed to the continuous mining machine (See Appendix C Figure 2).

Location of Equipment Prior to Accident

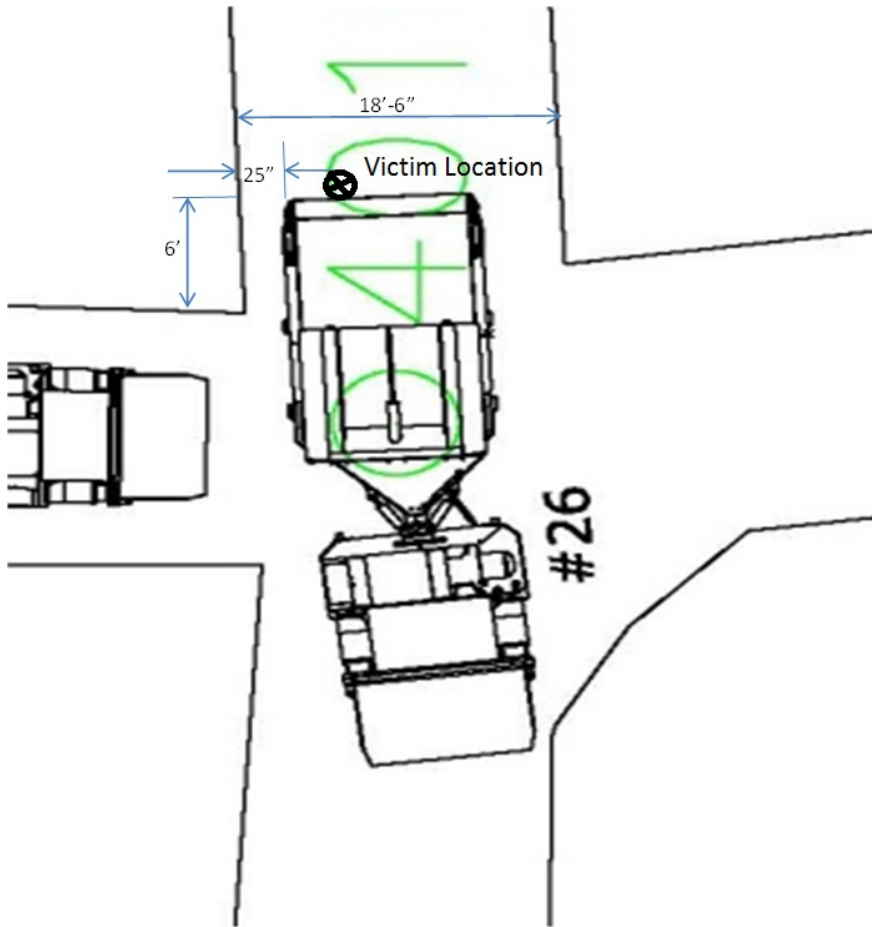
Figure 3

The accident occurred on the right side of the No. 6 unit (MMU 067-0) in the No. 7 entry, approximately 6 feet inby the inby left corner of crosscut 4+40 (see Appendix C, Figure 3). The mine floor in the area of the accident scene had irregularities. This was created when the continuous mining machine cut into the mine floor when developing the right crosscut. Although the coal height was 5½ feet, the actual mining height fluctuated up to 84 inches because of loose roof, soft mine floor, and cutting by the continuous mining machine operator. The uneven floor began in the No. 7 entry intersection at crosscut 4+40 and extended into the right crosscut toward the No. 8 entry. This uneven floor presented itself as a very large pot hole with sloping side walls. The hole was sloped from the left to right side in the No. 7 entry, and extended into the right crosscut. At the location of the accident, the No. 7 entry measured 18' 6" wide and 7' in height.

Location of Equipment after the Accident

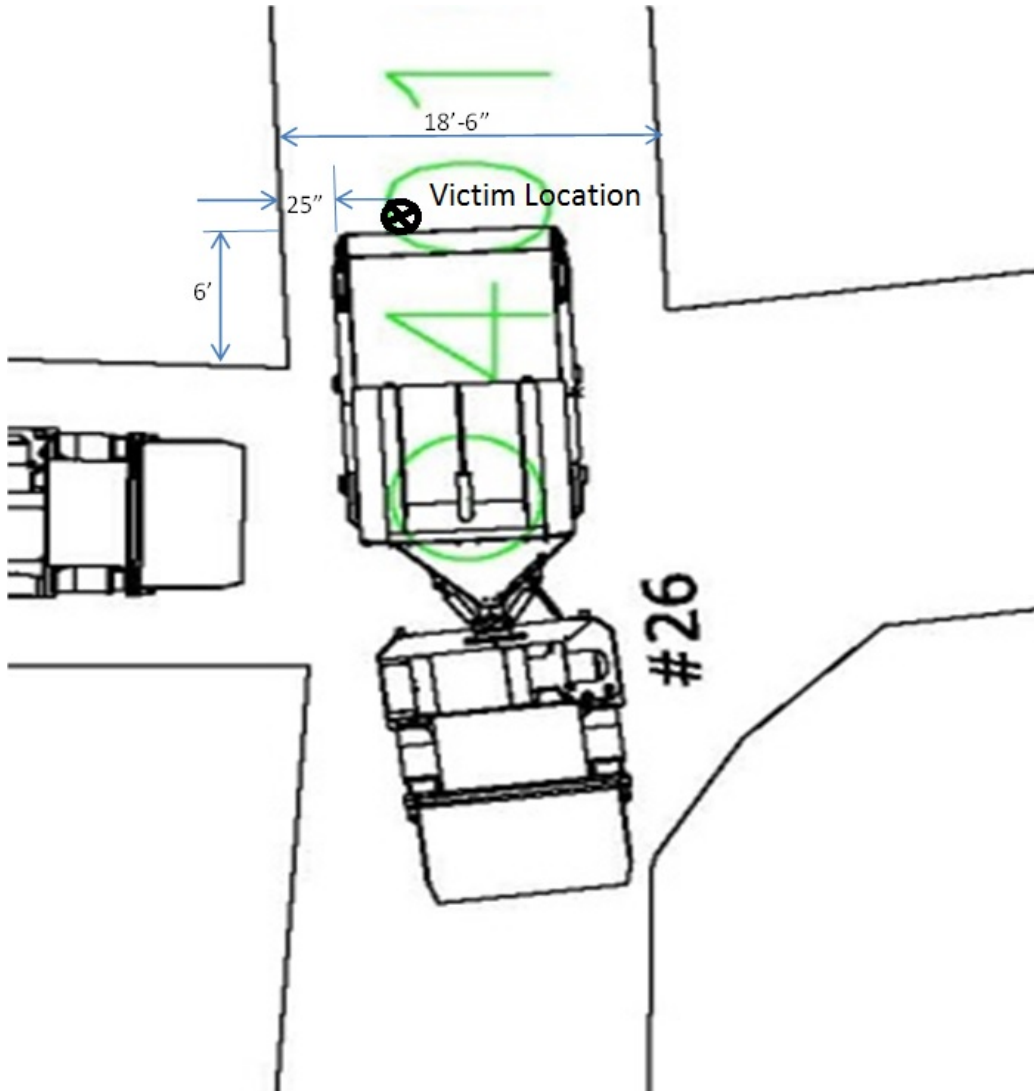
Figure 4

When investigators arrived at the accident scene, the No. 26 coal hauler was located in the intersection of the No. 7 entry at crosscut 4+40. The loading end of the coal hauler was located twenty five inches from the left inby rib (see Appendix C, Figure 4). The battery end of the coal hauler was angled toward the right outby rib corner into the hole cut in the mine floor. The right corner of the coal hauler machine batteries were located thirteen inches from the rib corner.

The coal haulers were traveling through the hole cut into the mine floor in the No. 7 entry intersection. This caused the machine to tilt to the right on the operator's side, raising the left corner of the bed as the coal hauler traveled through the intersection (see Appendix D). The elevated position of the bed contributed to the hazard and limited visibility for the coal hauler operator. After it was determined that the coal haulers had difficulty passing through the area, further grading was performed in the area of the intersection to reduce the slope of the grade. No other corrections had been made to reduce the hazard of reduced visibility in the intersection.

No. 26 Coal Hauler Location in Intersection with Measurements

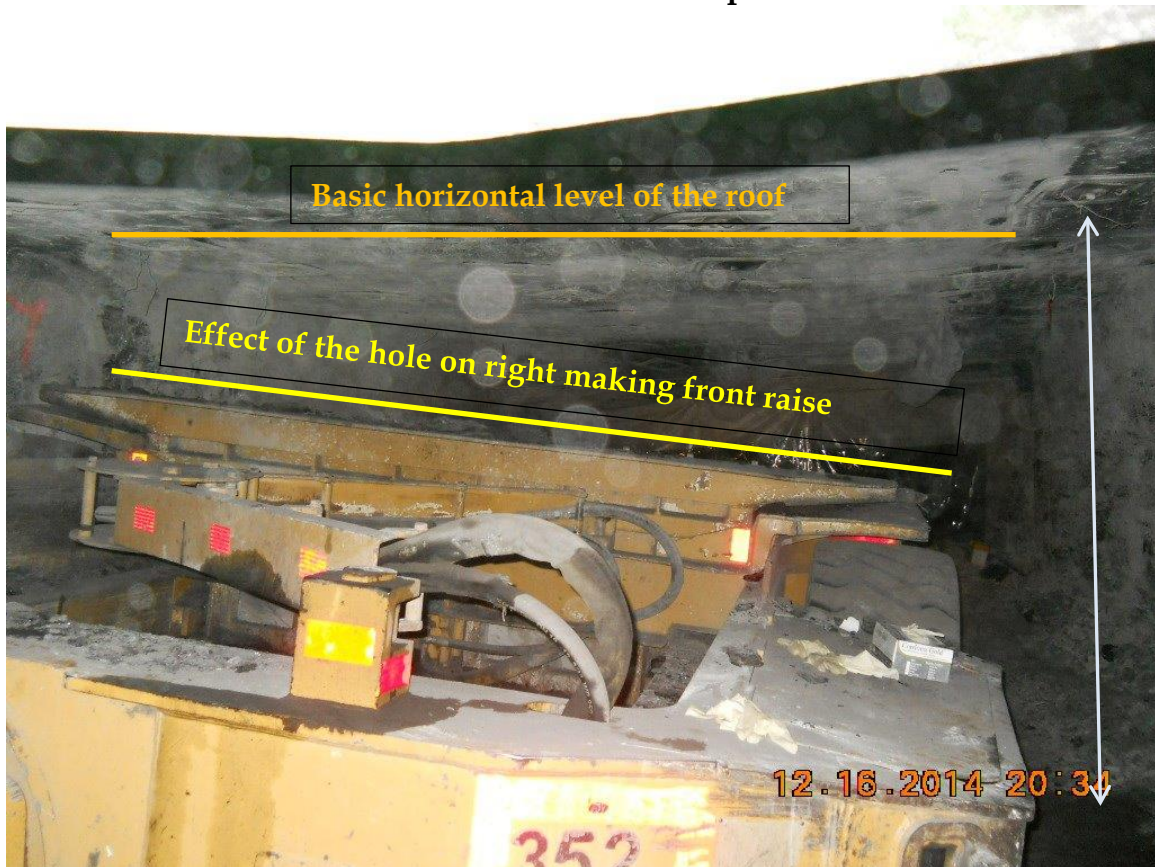
Picture of No. 26 Coal Hauler

View of the area from above the operator's deck
