UNITED STATES  
DEPARTMENT OF LABOR  
MINE SAFETY AND HEALTH ADMINISTRATION

REPORT OF INVESTIGATION

Fatal Rib Burst Accident  
May 12, 2014

Brody Mining, LLC  
Brody Mine No.1  
Wharton, Boone County, WV  
I.D. No. 46-09086

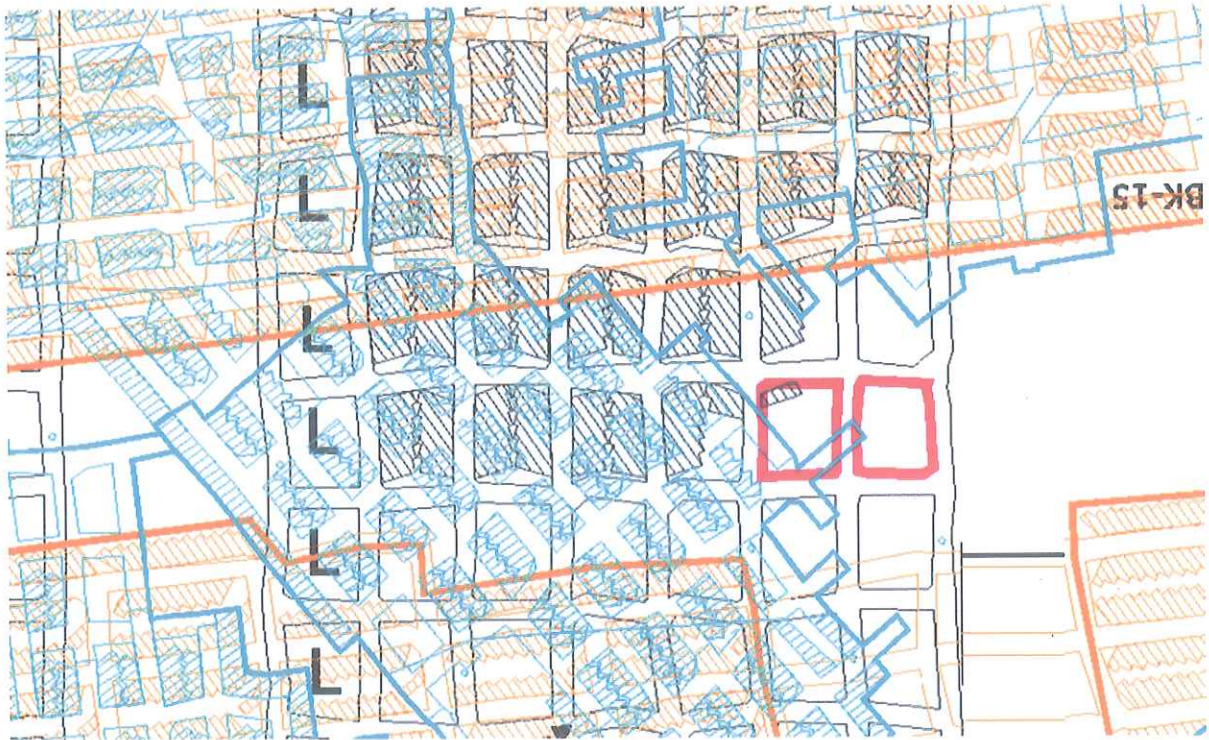
**Figure 1**

directly above the burst site. The abandoned mine workings in the Powellton and No. 2 Gas seams overlap each other such that the burst site is surrounded on three sides by overlying gob areas (see Figure 1). This configuration probably concentrated unusually high loads on the coal pillars that burst.

Figure 1. Location of 4 South Mains panel in the Eagle Seam (black) and the two pillars that burst on 5/12/14 (red), relative to the overlying workings in the Powellton Seam (brown) and the No. 2 Gas Seam (blue).

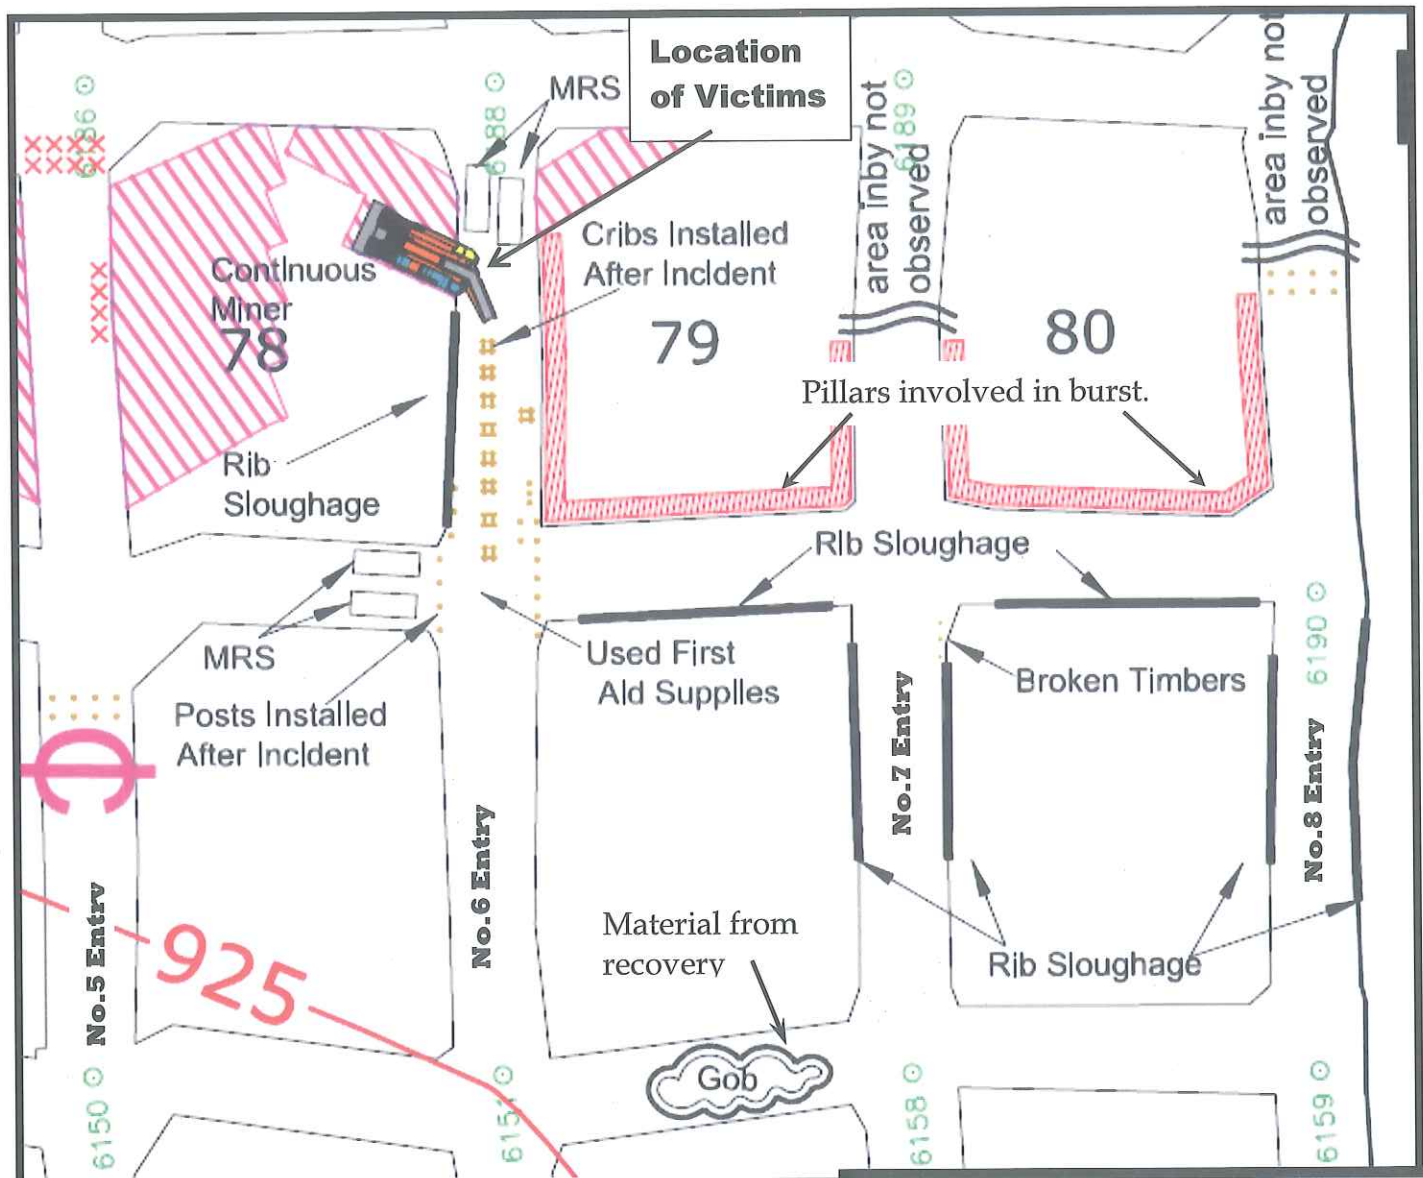
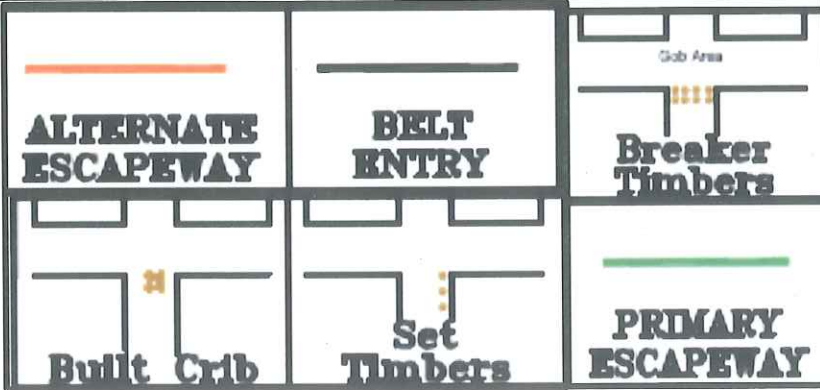
APPENDIX C  
 Sketch of the Fatal Accident Scene

The accident primarily affected the No. 79 coal pillar between the Nos. 6 and 7 entries, located between crosscut Nos. 14 and 15 of the No. 1 Section, on the 4 East Mains. The pillar burst caused a large section of the right pillar's rib to explode instantaneously and be displaced approximately six to eight feet into the No. 6 entry and filled the No. 6 entry to within approximately 30 inches of the mine roof. The exact amount and extent of the rib material that was expelled into the entry could not be determined because much of it was removed during recovery of the victims. The burst was accompanied by a loud noise, which witnesses likened to a large explosion, and severe ground shaking. The atmosphere around the accident scene was also filled with fine coal dust, hampering visibility.

The adjacent No. 80 coal pillar, located in the same row on the pillar line between the Nos. 7 and 8 entries, was also involved and was heavily damaged by the burst event. Minor burst damage was also noted on the coal pillars located just outby the pillar that was being mined, between the Nos. 6 and 8 entries, in crosscut No. 14.

The original estimated height of the No. 6 entry at the accident scene was 78 inches and the entry height after the accident was measured to be only 66 inches.

Therefore, the roof in the area of the accident converged an estimated 12 inches, but remained intact due to its inherent strength with only small visible cracking.

After the accident, the last open crosscut was timbered on both sides of the No. 6 entry and two MRS units positioned in the crosscut between the Nos. 5 and 6 entries had been moved to the edge of the No. 6 entry in order to provide better support of the intersection. The No. 6 entry in by the last open crosscut intersection had been center-cribbed to provide roof support during recovery of the victims. Refer to Appendix C for a drawing of the accident scene.

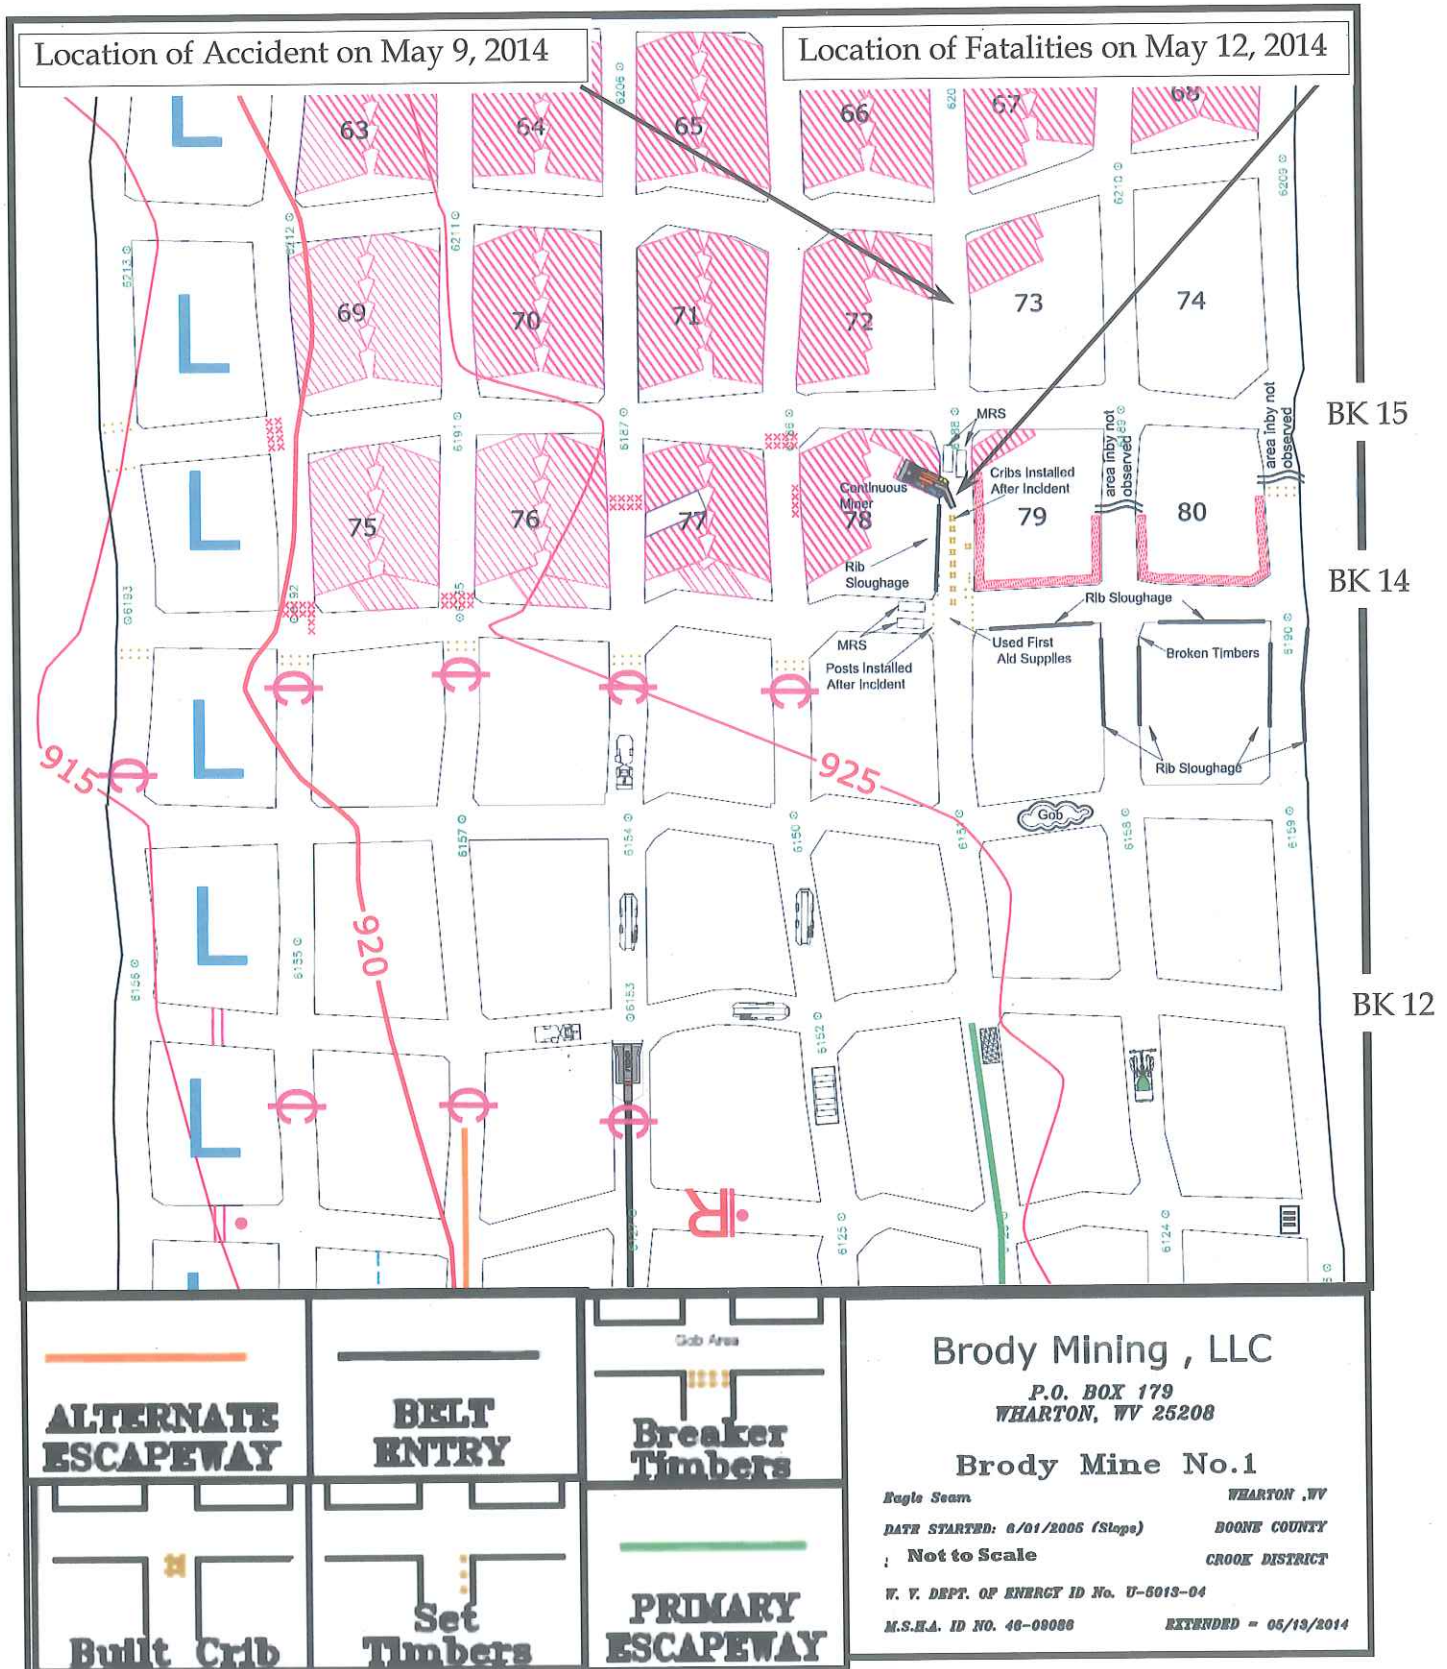
**APPENDIX D**  
**Sketch Showing Location of May 9<sup>th</sup> and 12<sup>th</sup> Accidents**

Based on interviews of the miners, the "bumping" noise they described, and the accident report prepared by the company, it was determined that the accident that occurred on May 9, 2014, was actually a rib burst. Although this event should have been reported to MSHA as an accident, because it disrupted mining for more than one hour, it was not reported and MSHA cited the mine operator. Consequently, mine management took corrective actions as if the accident was a rib roll, instead of a rib burst and failed to take actions to prevent a another burst.

A review of the mine operator's examination records of the No. 1 Section from April 28, 2014 through May 12, 2014, was conducted as part of the accident investigation. The first report of bad rib conditions was recorded on May 9, 2014. The bad rib conditions were reported to be located in the No. 7 entry of the section on the pre-shift examination report for the evening shift, which was prior to the rib burst that occurred in the No. 6 entry on May 9, 2014. The examination records indicate that the No. 7 entry was dangered-off and jacks were set in the
