REPORT OF INVESTIGATION

Fatal Roof Fall Accident
February 20, 2015

Heilwood Mine
Rosebud Mining Company, Inc.
Heilwood, Indiana County, Pennsylvania
I.D. Number 36-09407

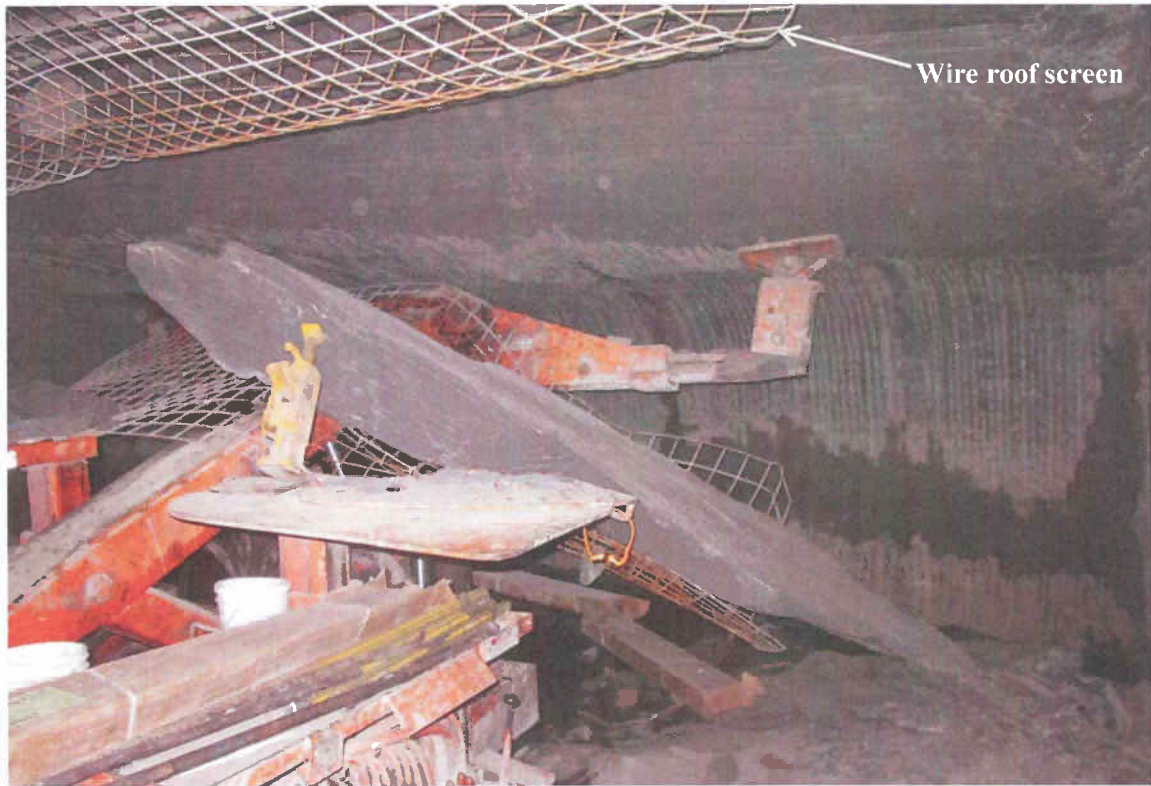
ACCIDENT SITE

**NUMBER 2 SLOPE ENTRY, APPROXIMATELY 170 FEET INBY SURVEY STATION
NUMBER 4794 IN THE A MAINS SECTION**
