REPORT OF INVESTIGATION

Fatal Fall of Face Accident  
March 8, 2015

McElroy Mine  
McElroy Coal Company  
Cameron, Marshall County, West Virginia  
I.D. No. 46-01437

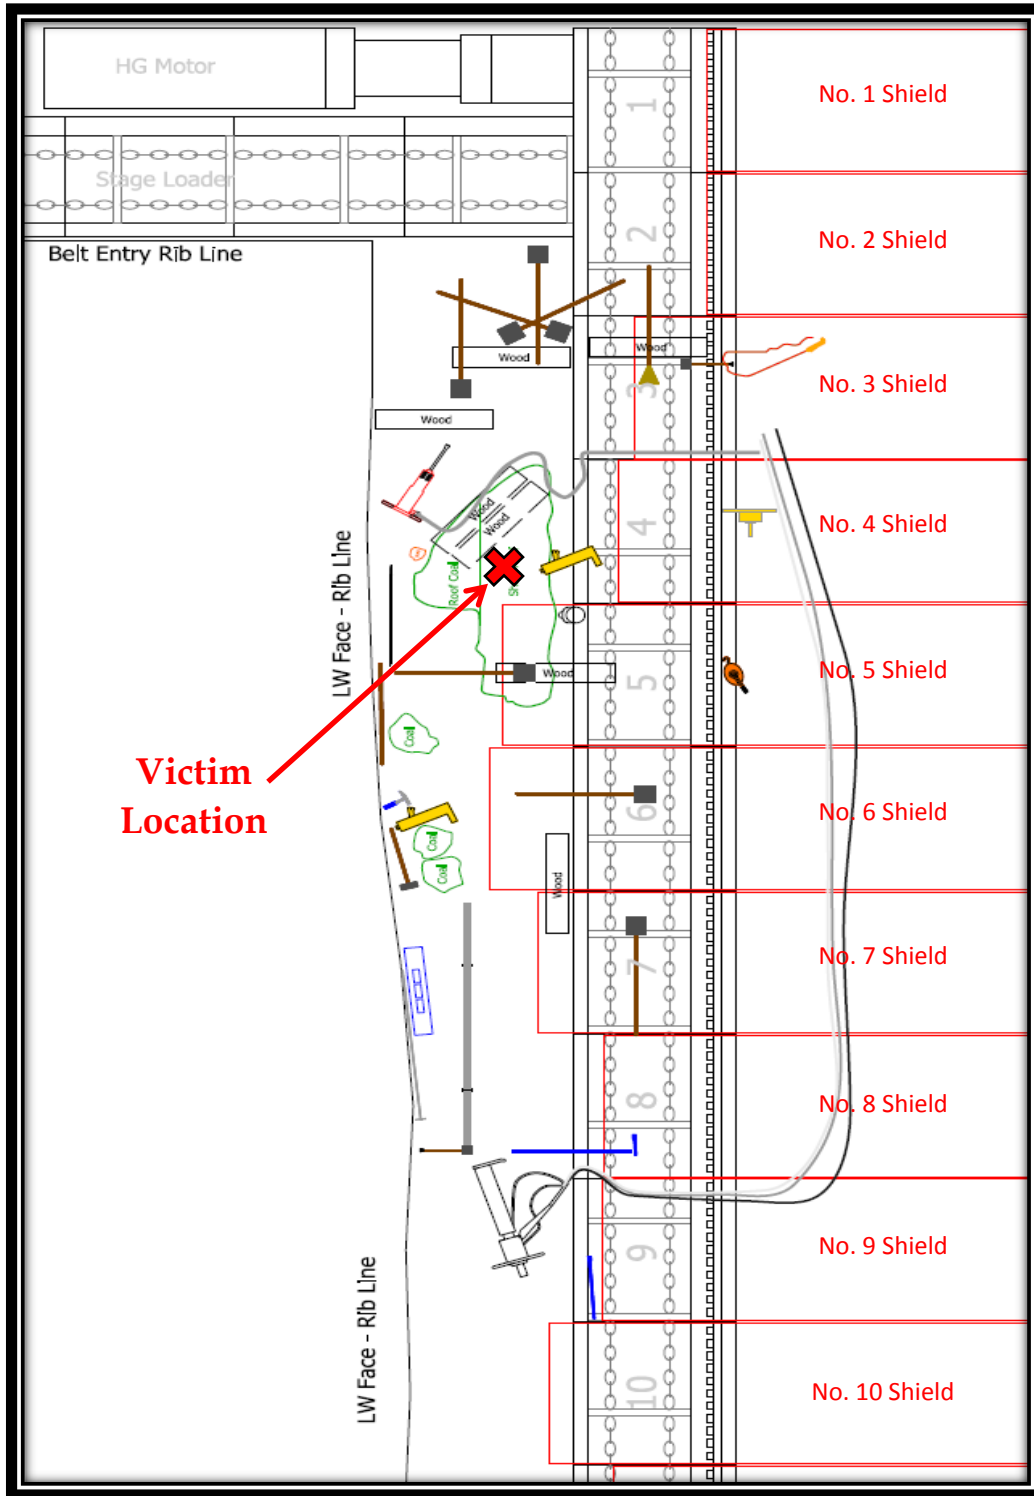
## Drawing of the Accident Scene

At approximately 8:55 p.m., shortly after running shoveled material off the face conveyor chain, a piece of coal and rock fell from the face between the No. 4 and No. 6 shield, striking Garloch, Hennebert, Neitzelt, and Josh Roth, Shuttle Car Operator. The material was approximately 10 feet long, five feet wide, and up to two feet thick. Roth, who was standing at the edge of the No. 5 and No. 6 shield, was struck in the left shoulder and knocked to the ground. A piece of the material pinned his leg, but it was quickly removed by crew members standing nearby. Neitzelt and Hennebert were knocked to the ground and pinned by the fallen material. Coworkers freed Neitzelt and Hennebert when Kozak and John Beattie, Faceman, noticed that Garloch was under the rock.

The accident occurred on the 12-East Longwall face at the No. 4 shield, approximately 12 feet from the headgate end of the face. The longwall equipment mines the coal block between the 12-East headgate section and the 11-East tailgate section. The longwall panel is approximately 1,400 feet wide and 6,800 feet long. At the time of the accident, the headgate had retreated to survey station (spad) No. 29+48 and the tailgate had retreated to spad No. 29+10. The last open crosscut was located at the No. 29 block, between the No. 2 and No. 3 entries.

The increased face height caused the heavier shale rock (approximately 170 lbs/ft<sup>2</sup>) to put pressure on the weaker, unconfined coal face (approximately 80 lbs/ft<sup>2</sup>). The pressure caused the coal face to slough off during afternoon shift. As the shift progressed, the movement in the shale strata created a crack in the face at the No. 5 shield. The crack grew larger, forming a separation that could only be seen from the tailgate side looking towards the headgate. The rock fell from the face from the same area where the crack was seen. MSHA Investigators however, cannot definitively say that the crack caused the fall. The material that fell from the face measured approximately 12 feet long, 5 feet wide, and up to 2 feet thick. The piece broke and the material that struck the victim measured approximately 10 feet long, 5 feet wide, and up to 2 feet thick.
