UNITED STATES
DEPARTMENT OF LABOR
MINE SAFETY AND HEALTH ADMINISTRATION

REPORT OF INVESTIGATION

Fatal Surface Haulage Accident
May 28, 2015

No. 11 Allen Branch Job
Apex Energy, Inc.
Phelps, Pike County, Kentucky
I.D. No. 15-19722

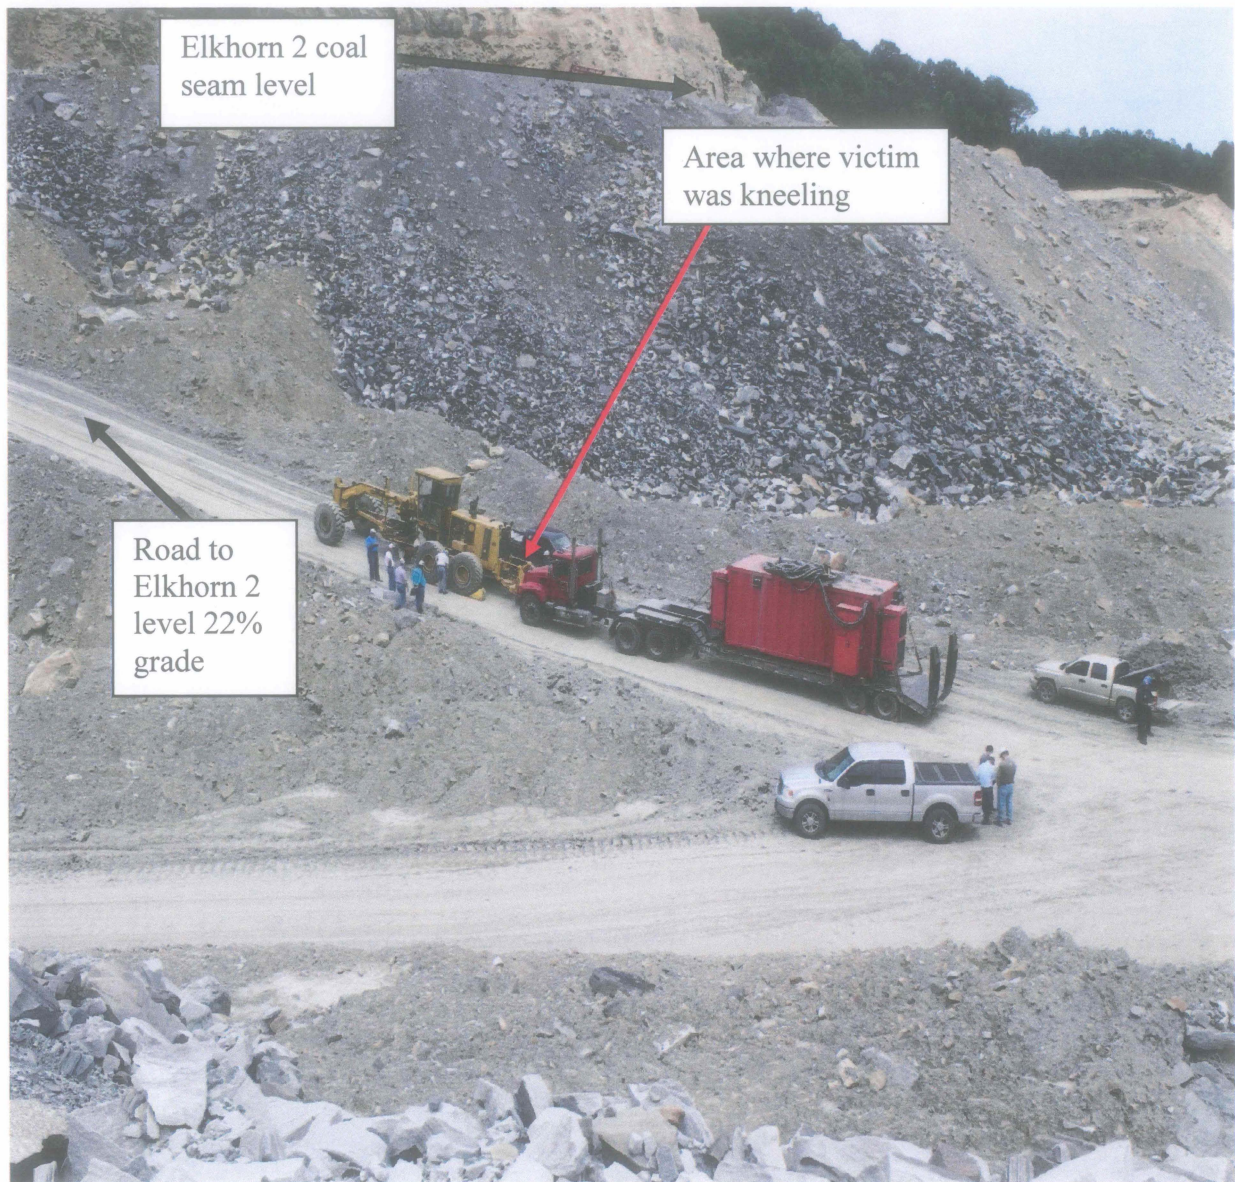
Photograph of Accident Scene

At approximately 11:55 a.m., on Thursday, May 28, 2015, Roy Mullins, a 45-year-old foreman for ST&T Leasing Inc., received fatal injuries when he was pinned between the rear of a road grader and the front of a loaded tractor-trailer truck. The tractor-trailer was transporting the base power module of the highwall mining machine to the mine site. The tractor-trailer was unable to ascend the steep incline without assistance. A road grader was driven to the tractor-trailer to provide assistance. The victim was positioned between the two machines connecting a chain when the grader rolled back, fatally crushing the victim. R. Mullins had approximately 27 years of total mining experience, one year and four months at this mine, and approximately 15 years with ST&T Leasing. Chris Mullins, an equipment operator for Apex Energy, was operating the road grader.

The accident occurred because the service brakes failed on the road grader. The haul road grade was too high for the tractor-trailer and adequate training was not given to miners and contractors regarding proper towing procedures.

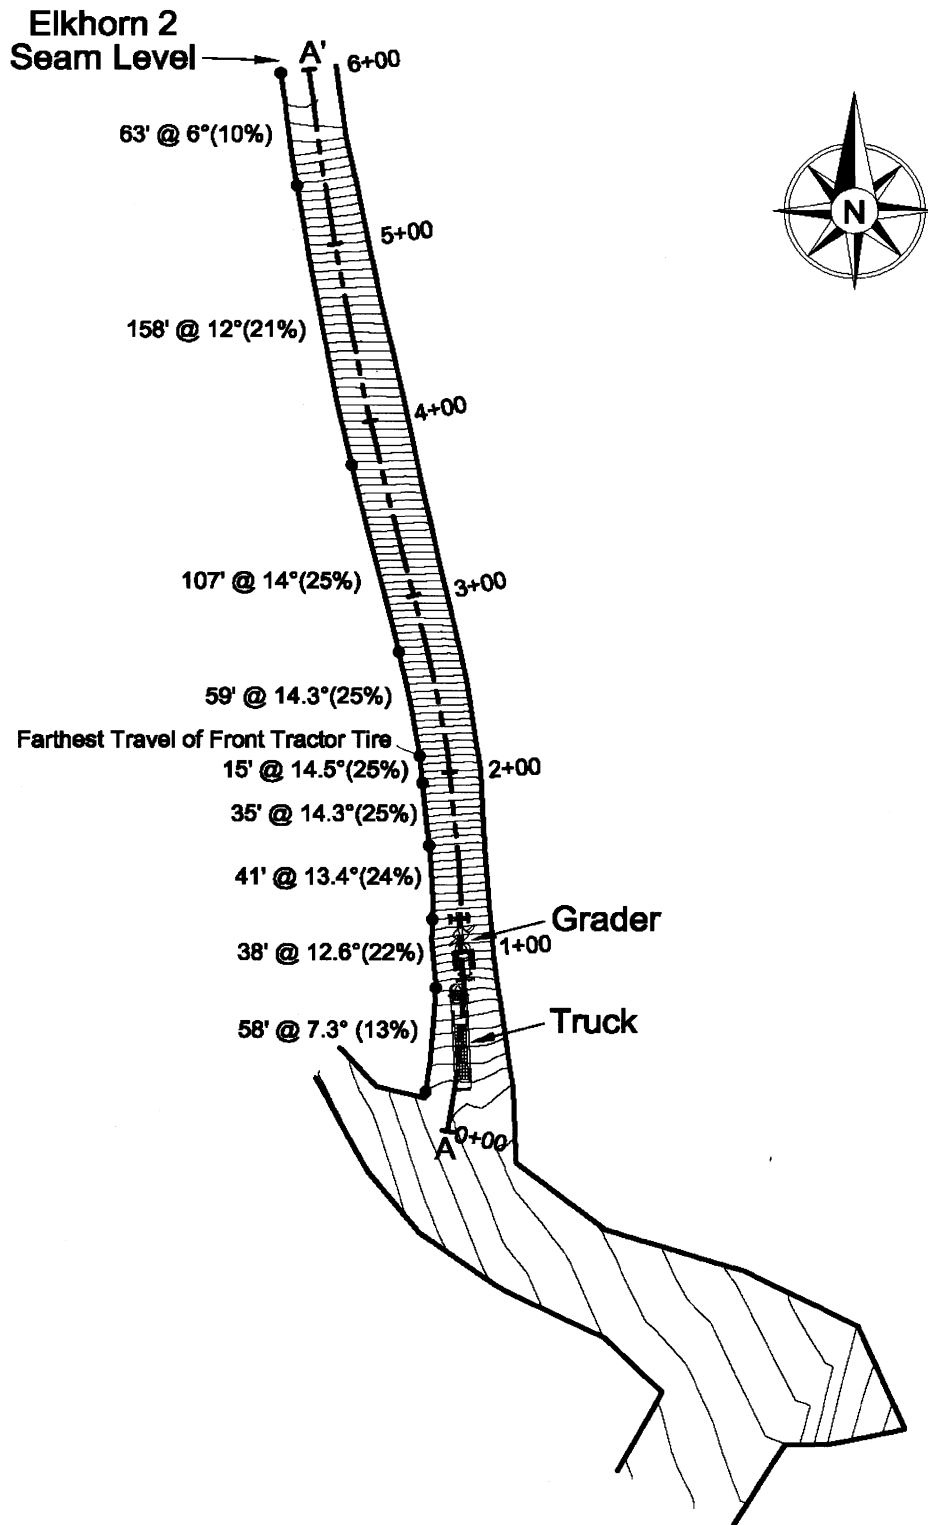
Appendix C
Drawing 1

The steep incline section of road the victim was attempting to ascend was approximately 594 feet in length, with an overall sustained grade of approximately 20%. This road was constructed of spoil material from the overburden that had been removed during previous surface mining. The road surface was firm and dry and was approximately 28 feet wide. The road provides access from the Lower Alma coal seam level to the Elkhorn No. 2 coal seam level, with an elevation change of approximately 120 feet. This was the last steep section of road just prior to reaching the level area on the Elkhorn No. 2 seam mine bench where the highwall miner was to be assembled. At the time of the accident, this road had been used for approximately one year for coal haulage and other general access use. A sketch of the accident scene and steep road incline is included in Appendix C Drawings 1 and 2.

Corrective Actions: The mine operator revised the ground control plan to state that the mine operator will use best efforts to design and maintain access/haul roads to allow equipment operators to travel the roadways without assistance. Mine employees and the trucking contractor, used to transport the highwall miner were trained in the ground control plan revision. The road where the accident occurred has been eliminated from use. An alternate road with a lesser grade has been established to provide access to the Elkhorn 2 seam coal level.

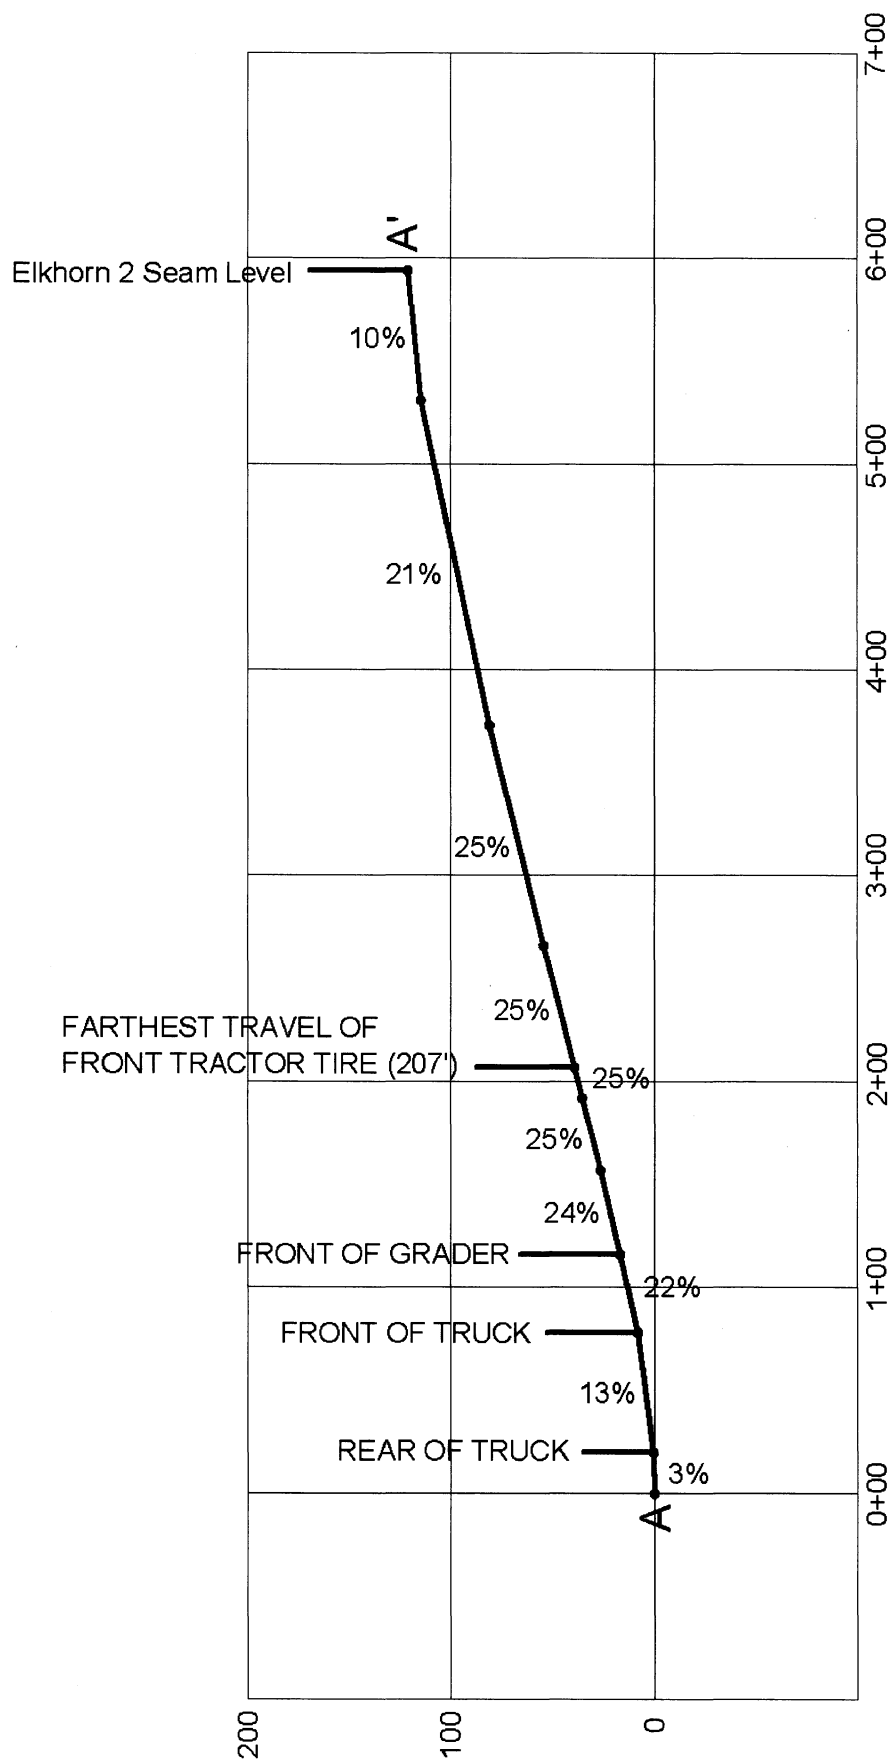
SECTION A - A' PROFILE OF ACCESS ROAD (Not to Scale)

The front of the tractor-trailer was approximately 70 feet from being positioned on the level ground that was located behind the truck. The front of the grader was positioned further up the slope and was about 115 feet from being on level ground at the bottom of the slope. The total distance from the bottom of the road slope to the top, at the Elkhorn 2 seam level, is 594 feet.

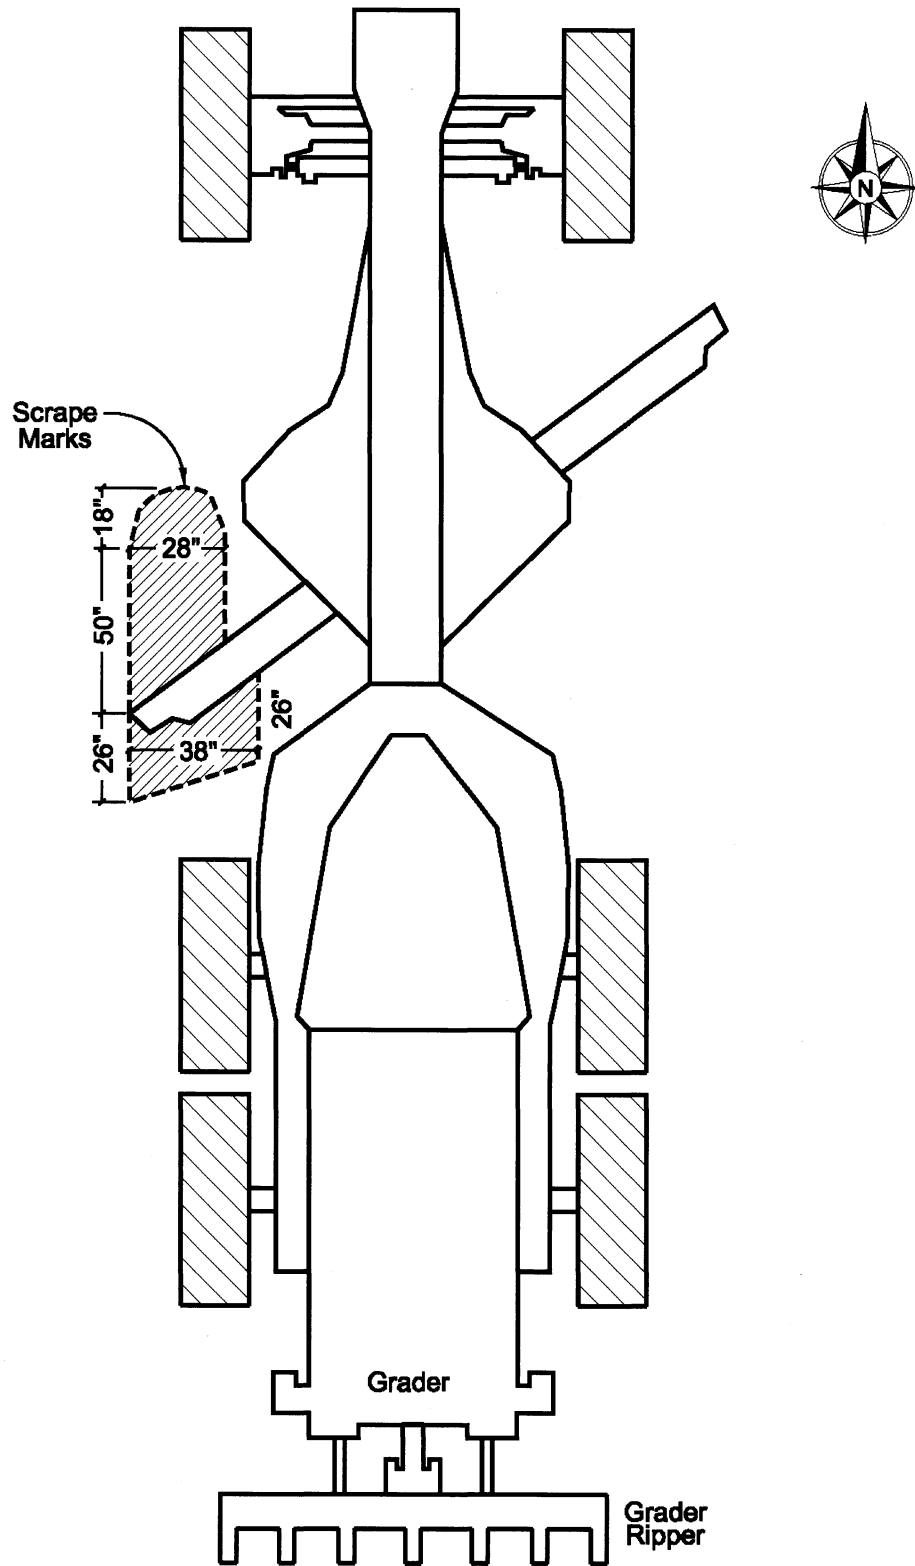
Drawing 3

The tractor-trailer driven by the victim was parked on an approximate 13% grade and the grader was parked on an approximate 22% grade. Tire tracks from the truck were observed at a distance of 207 feet up the steep incline from the bottom level area (Lower Alma). This location was at the steepest section of the road - approximately 25% grade. The rear of the grader was observed approximately 28 inches from the point where contact was made with the front bumper of the truck. The grader blade was down and had left a scrape mark from the initial ground contact point to the point of impact with the truck measuring 94 inches in length (see Appendix C Drawing 3).

The grader is equipped with a ripper attachment that is mounted to the rear of the grader (see Appendix C Drawing 3). It measures 9 feet 10 inches wide from outside to outside. It has seven available receiver holders for ripper teeth to be installed. It was only equipped with two ripper teeth. The tooth on the right side was turned down and the one on the left side was turned up. The one on the right side was barely touching the ground and would not have provided any stopping force as evidenced by no scrape marks on the ground. The third ripper tooth receiver from the left side made contact with the victim. The right side portion of the truck's front bumper was pushed back into the right front truck tire from the force of impact from the grader.

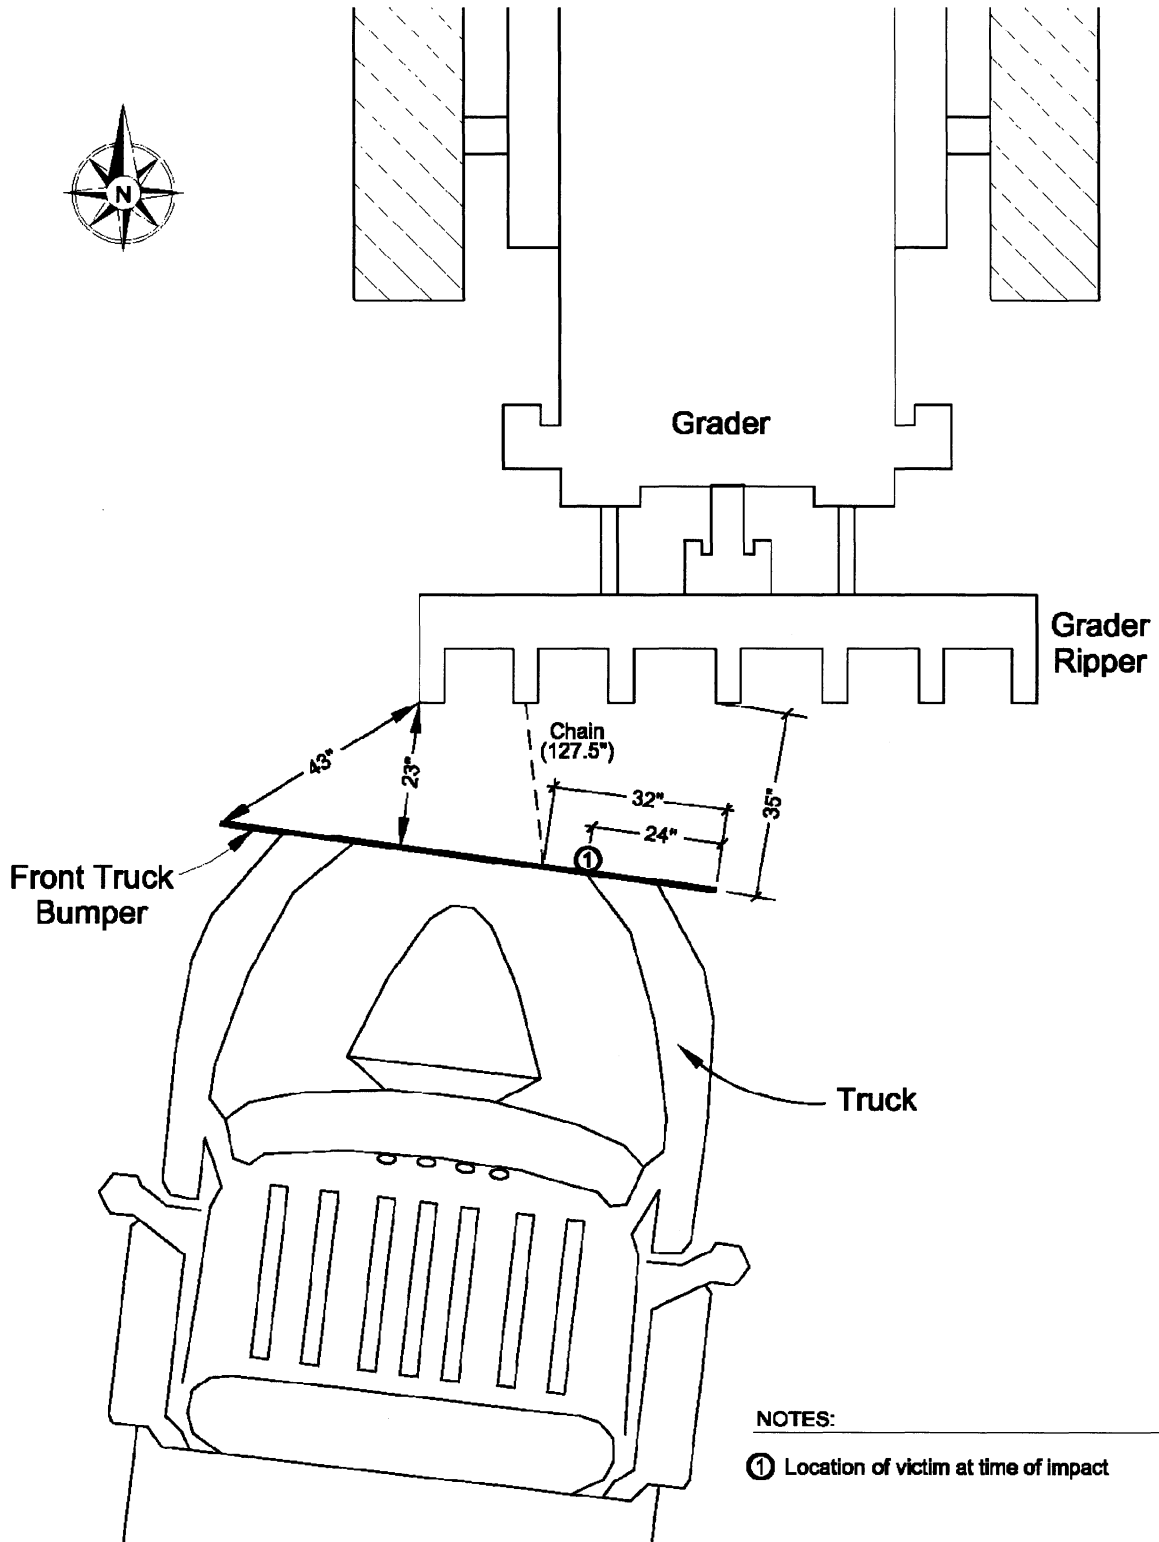
Drawing 4

The end of the chain to be connected to the truck was piled near the hook on the right side of the truck's front bumper, indicating the victim most likely was in the process of attempting to secure the chain on the hook under the front bumper of the truck. The other end of the chain was fastened to the second receiver holder over from the left side end of the ripper attachment (see Appendix C Drawing 4). It was apparent that the victim was in a crouched or squatted position due to the vertical height of the contact point made between the rear of the grader and the front truck bumper. The victim would not have been visible to the grader operator while in this position, due to the blind spots at the rear of the grader.
