REPORT OF INVESTIGATION

Fatal Powered Haulage Accident
May 31, 2015

Gateway Mine
Peabody Midwest Mining, LLC
Coulterville, Randolph County, Illinois
ID No. 11-02408

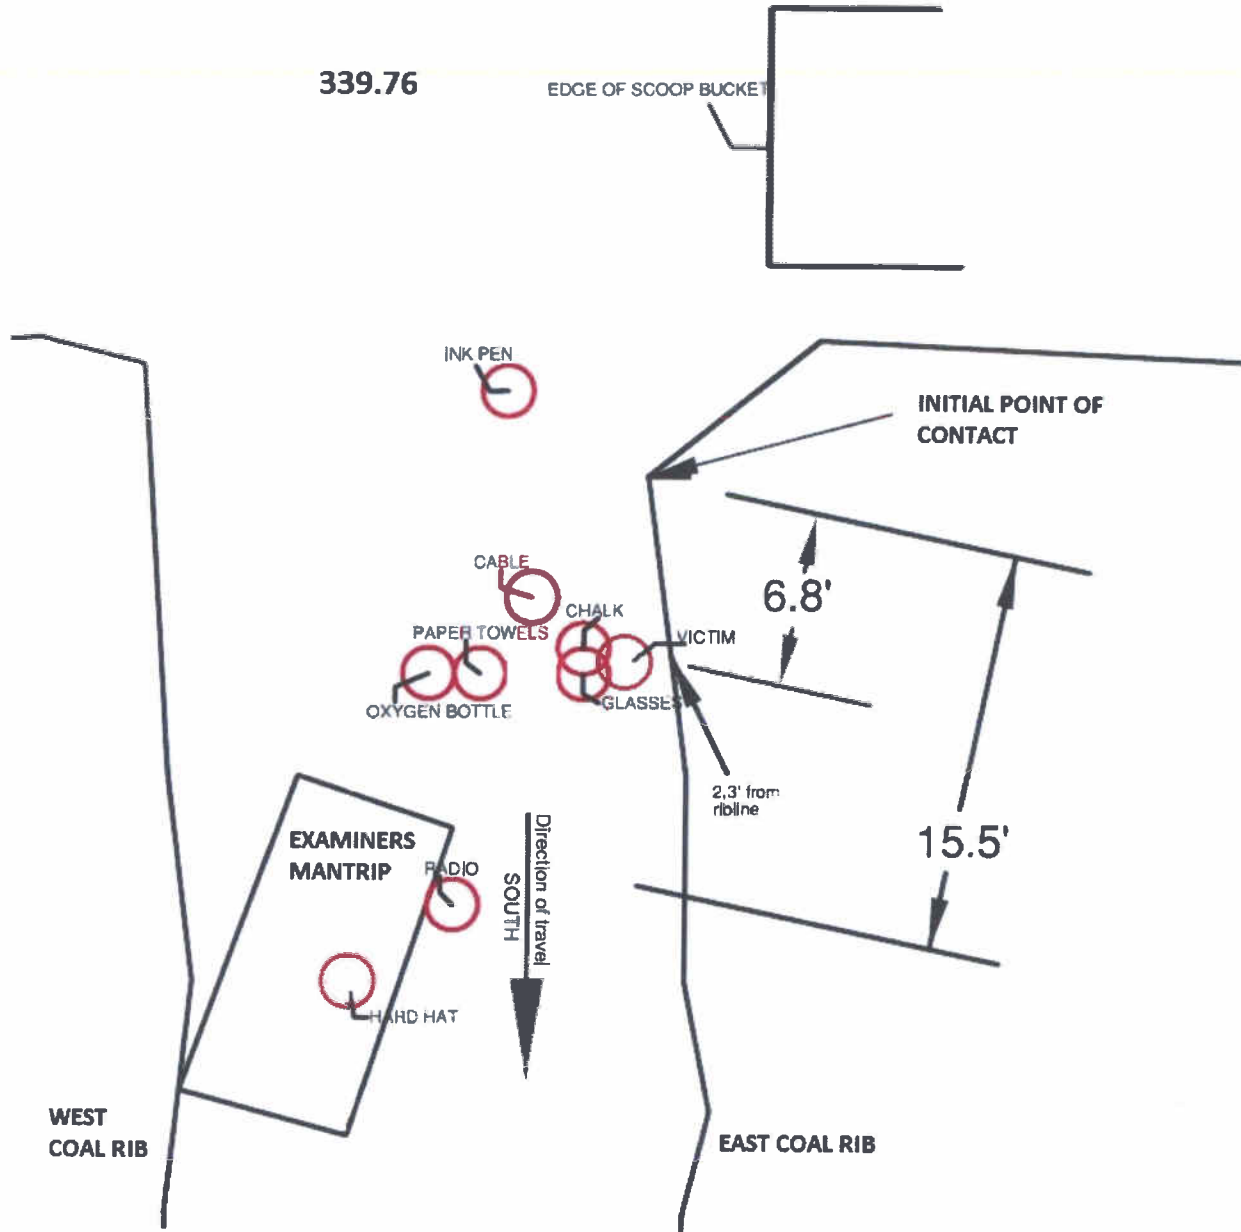
Drawing of Accident Scene (Note: Images not to scale).

At approximately 8:05 p.m. Campbell struck the east coal rib with his diesel mantrip at crosscut 193 (survey point 339.76). Campbell was found lying on the east rib just inby the corner at crosscut 193 by Brandon Halstead, Mine Examiner, at 8:07 p.m. The company No. 124 diesel mantrip was located inby. The right front corner was in contact with the west ribline between crosscut 193 and crosscut 194 (see Appendix A).

The accident occurred on the 1st Main South travelway, which is the secondary escapeway and a main haulage road for the mine. The specific location of the accident was between survey points 339.76 and 338.46 in the number 4 entry. The 1st Main South travelway at the accident scene was in good condition, with no

When investigators arrived at the accident scene, Campbell had been removed from the mine and transported to the Sparta Hospital. The diesel mantrip involved in the accident was observed in contact with the west rib. Tire tracks were observed leading up to the accident scene, but could not be determined to be the victim's tracks due to other diesel mantrips in the area during rescue and recovery. Damp and wet material in the form of rock dust and mud were found at the east coal rib corner at crosscut 193, which had come from the frame of diesel mantrip No. 124 during the impact of the coal rib (see Appendix A). Marks on the east coal rib at crosscut 193 aligned with the marks on the front bumper, and on the operator's side front fender of the diesel mantrip. The mantrip was equipped with a seat belt, but the victim was not wearing it at the time of the accident.
