REPORT OF INVESTIGATION

Surface Coal Mine

Fatal Powered Haulage Accident
March 17, 2015

Rogers Petroleum Services, Inc. (X1A)
Pikeville, Kentucky

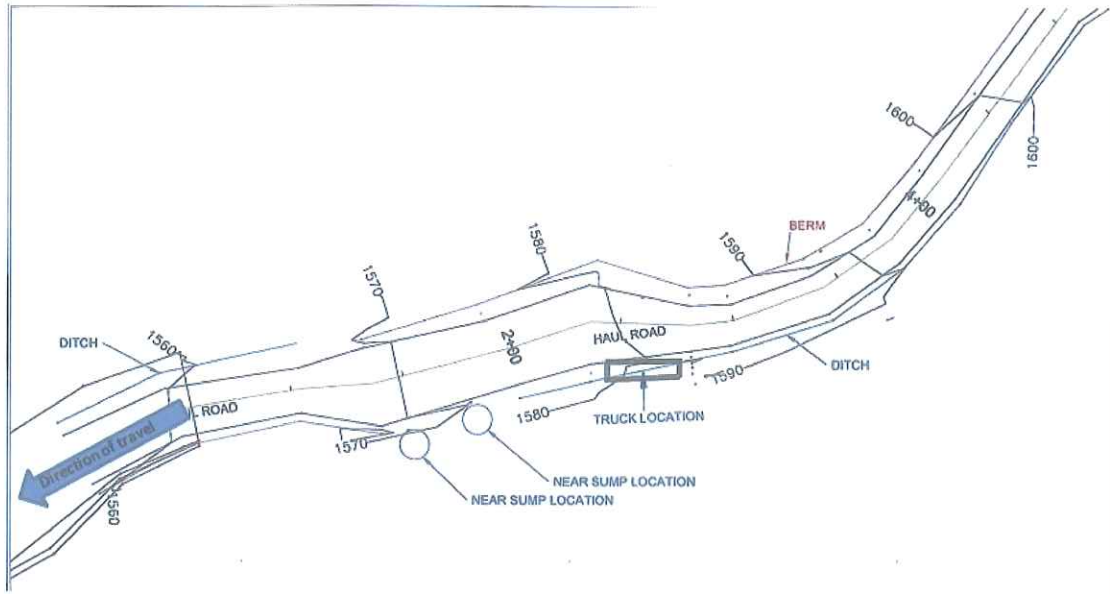
APPENDIX B

The truck overturned and skidded 27 feet to a stop on its top. In order for the high center of gravity 21-ton fuel tanker truck to overturn, the truck had to have been traveling at too high a rate of speed to allow the driver to negotiate a sharp curve near the bottom of the haul road. Since there was no indication the truck traveled onto the berm or hillside, the driver likely made a sharp turn, at a high speed, to follow the road. This indicates that the driver was able to steer the truck, but the speed of the truck was not under control. On site testing of a truck similar to the one involved in the accident, found that up to approximately 17 miles per hour (1st gear, low range through 4th gear, low range) the driver should have been able to safely negotiate the turn in the haul road. Therefore, the accident investigation concluded that the truck was most likely traveling faster than 17 miles per hour.

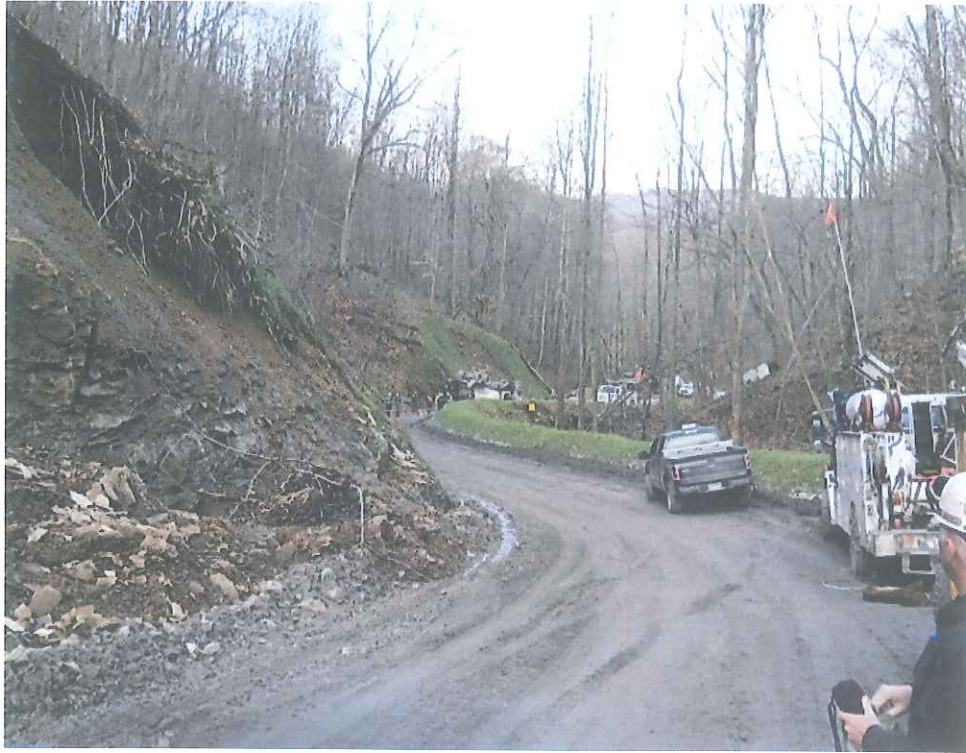
The victim had driven the truck into a descending, sharp, right hand curve on the haul road where it was found overturned. Since there was no indication the truck traveled onto the berm or hillside, the driver likely made a sharp turn, at too high of a speed, to follow the road. This indicates that the speed of the truck was not under control. There were no eyewitnesses to the accident.

View of the accident scene looking down the Eagle Land haul road

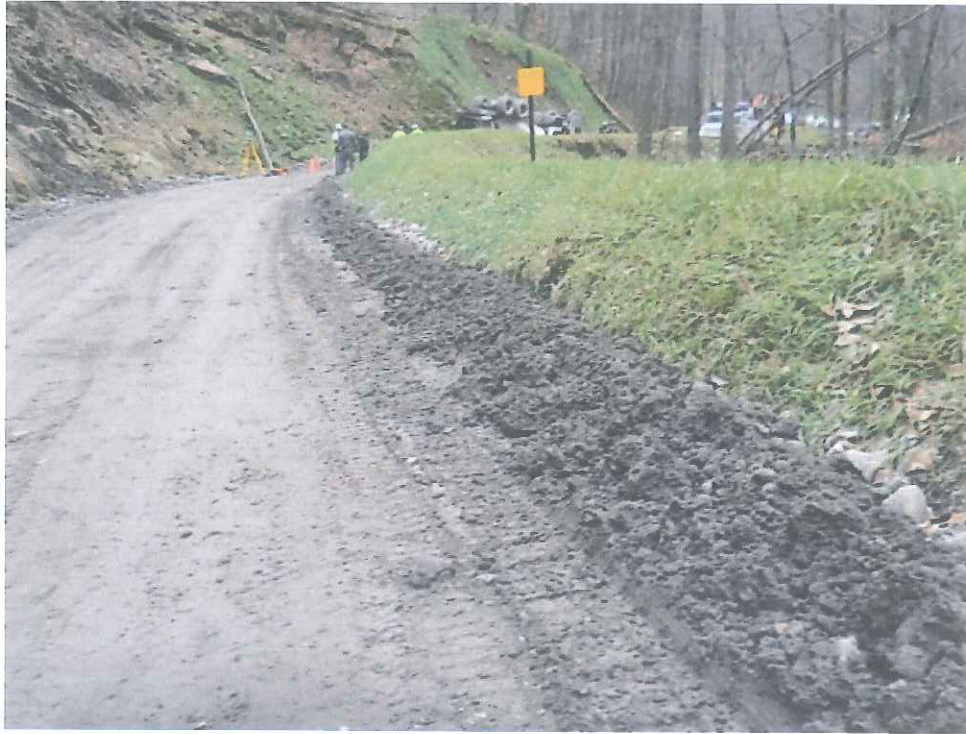
At the time of the accident the road was wet and muddy. The weather was cloudy with no precipitation.

Close up view:
Illustrating the condition of the Eagle Land haul road near the accident scene
