REPORT OF INVESTIGATION

Fatal Falling Materials Accident
June 27, 2015

4 West Mine
Dana Mining Company of Pennsylvania LLC
Dilliner, Greene County, Pennsylvania
Mine I.D. No. 36-09326

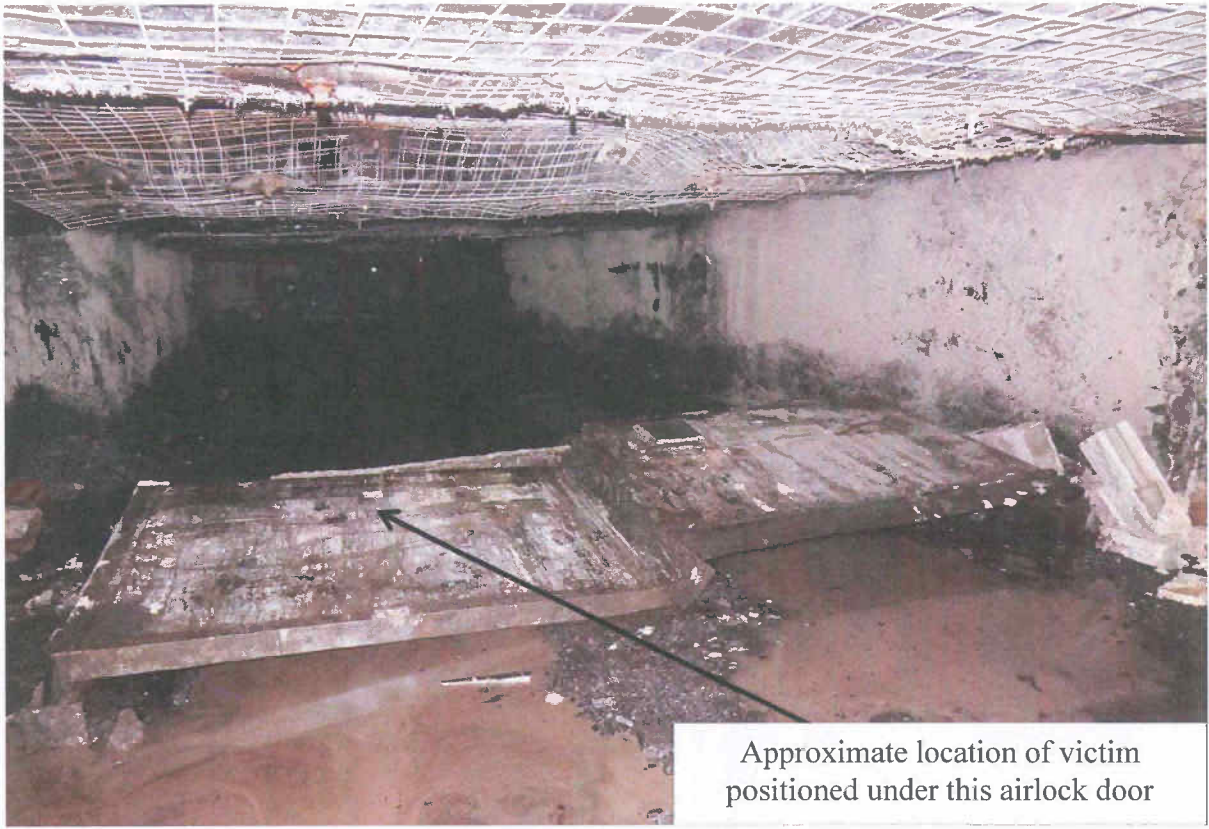
Approximate location of victim positioned under this airlock door

This sudden increase in external airflow pressure caused the outby set of airlock doors to become dislodged due to not being properly installed per manufacturer's recommendations.

It was evident the doors had not been installed correctly. There was mine sealant on the top of the two outside support columns and 5 out of the 6 T-handle set screws were not installed in the lintels and columns. Without the required T handle set screws, the air lock doors would not be adequately secured. This condition was compounded by the improper use of the airlock system. The roof cleat was missing from the top of the left column (looking outby) of the outby set of airlock doors. When the set of inby airlock doors at the number 64.5 crosscut was inspected, similar conditions were found.

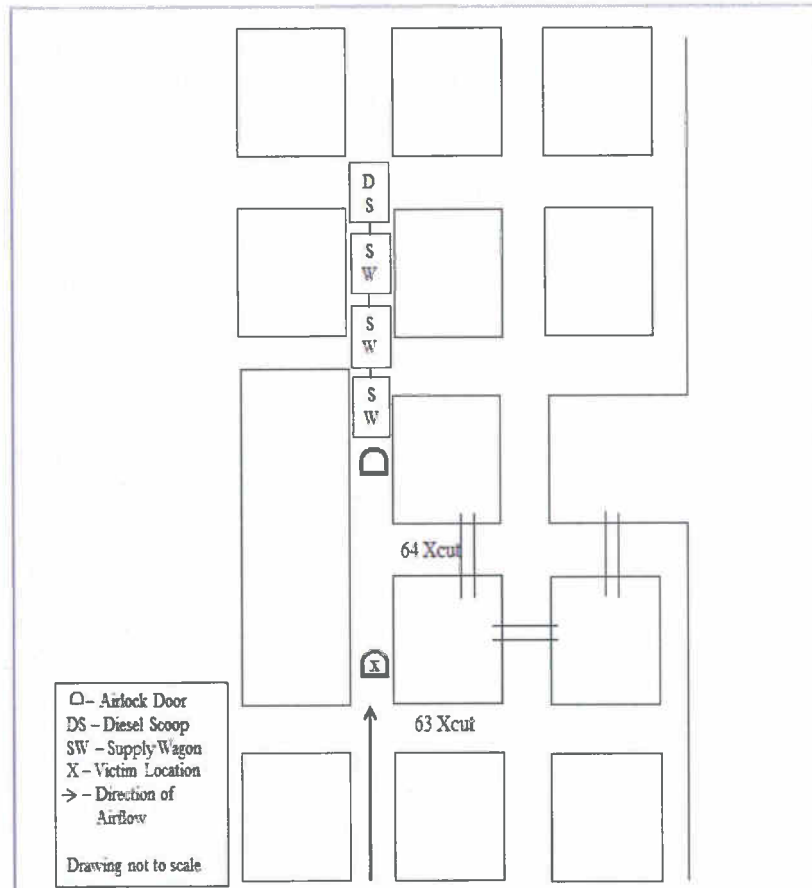
Appendix B Expanded View of the Accident Scene

The investigation determined on the evening of the accident, Kelly opened both sets of airlock doors. He then drove the scoop and 3 attached wagons to a point where the back of the last supply wagon was 12 feet in by the inby set of airlock doors. This was done because the 96 foot train could not fit into the 85 foot length within the airlock. Kelly

then traveled by foot to the outby set of airlock doors. While closing the outby set of airlock doors, they fell on Kelly, pinning him to the mine floor (see Appendix B).

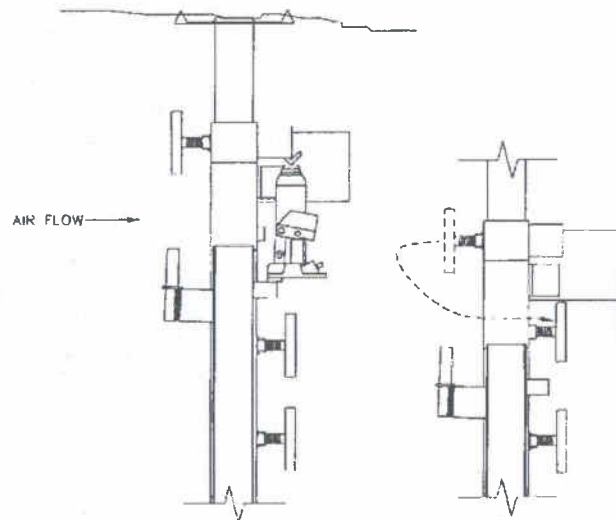
The manufacturer's installation instructions require that a hydraulic jack be used to tighten the columns between the mine floor and roof to secure the frame in place. Afterwards, all T-handle set screws are to be secured very tight to anchor the airlock doors in place. See the manufacturer's installation instructions in Appendix C and airlock door sketches in Appendix D.

manufacturers installation instructions states that, a jack will be used to tighten the columns into the mine roof so that it cannot move or be dislodged and to tighten T-handle set screws very tight with a wrench or hammer. This was a contributing factor in a fatal accident which occurred on June 27, 2015. One set of these airlock doors and the frame weigh 980 pounds.

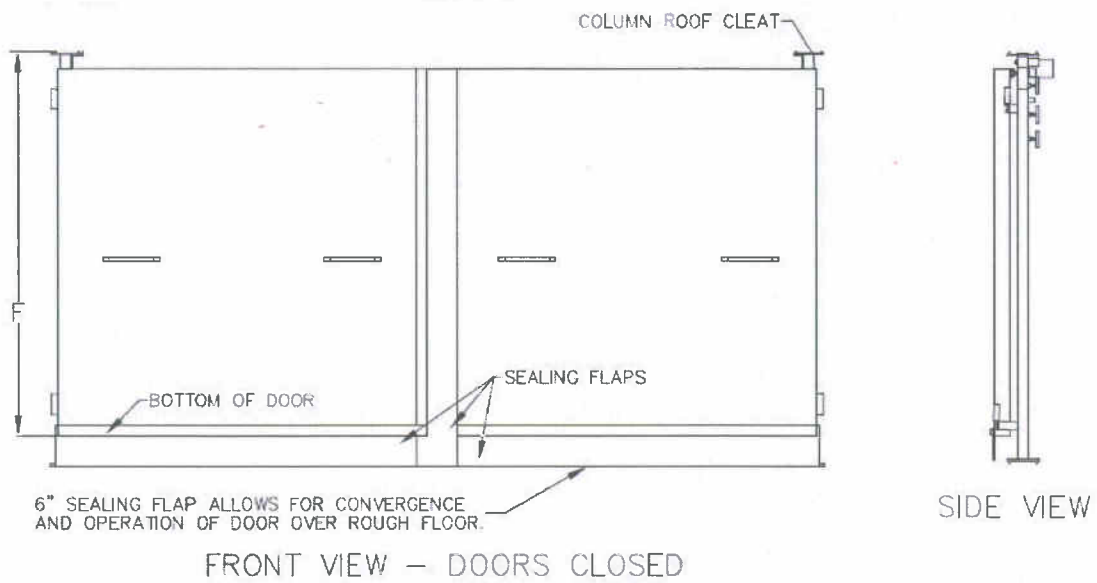
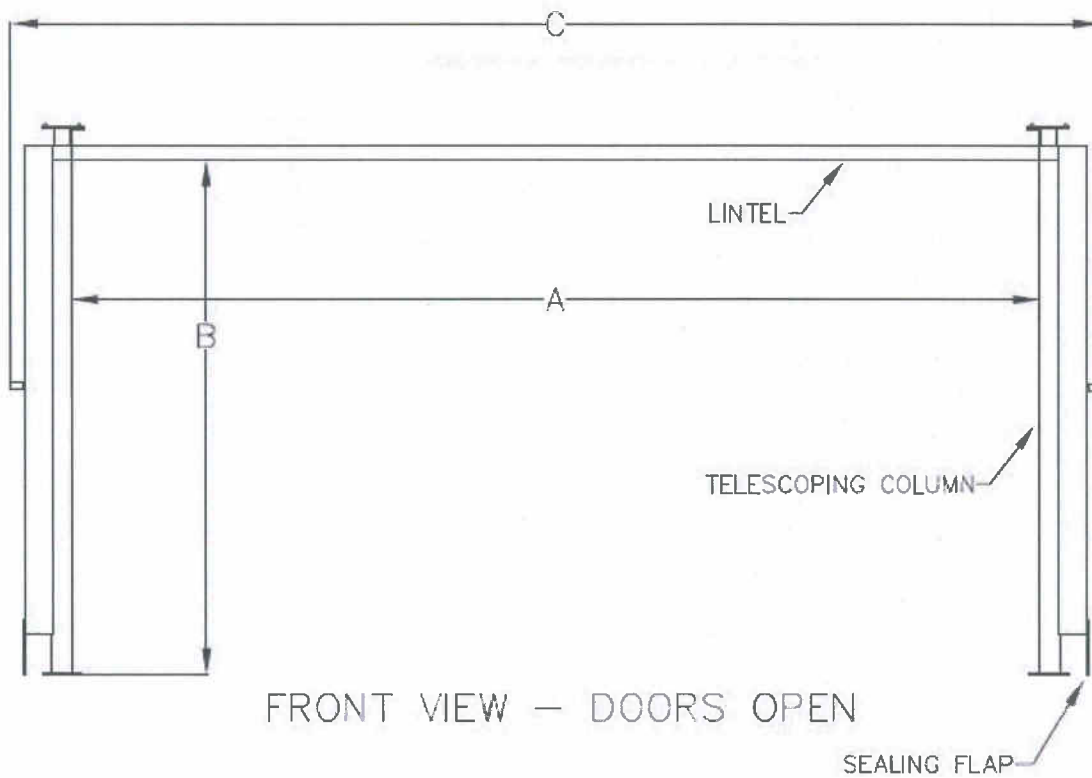
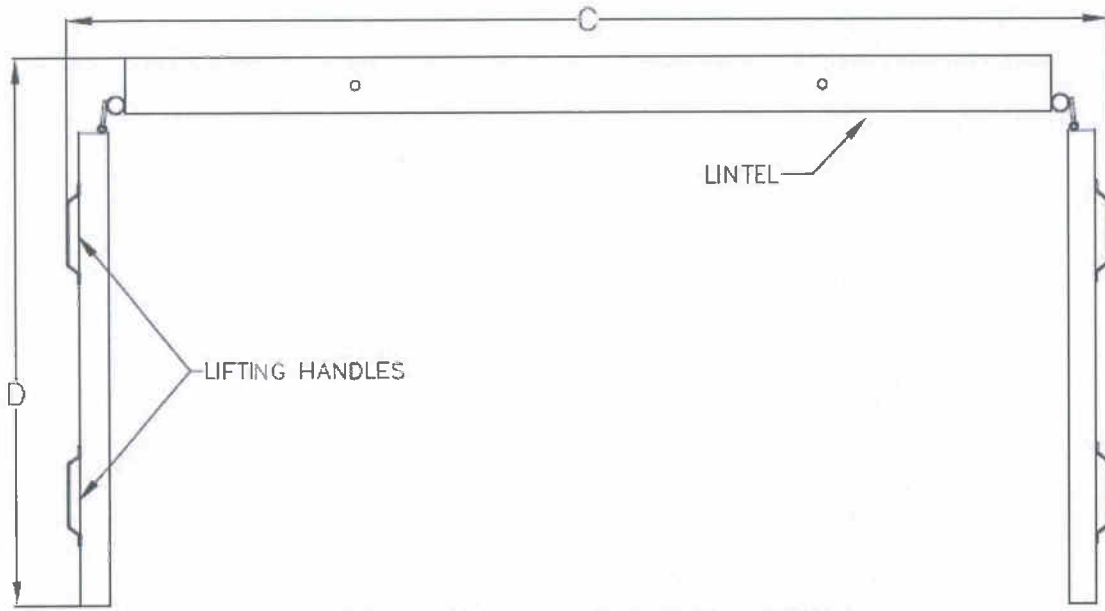
Appendix D Airlock Door Sketches

There was one T-handle set screw present in the left side of the airlock lintel (looking outby) at the outby set of airlock doors, and there was one T-handle set screw present in the left side of the airlock column (looking outby) at the inby set of airlock doors. Both T-handle set screws were not tightened.
