REPORT OF INVESTIGATION

Fatal Machinery Accident
December 8, 2015

MC#1 Mine
M-Class Mining, LLC
Macedonia, Franklin County, Illinois
I.D. No. 11-03189

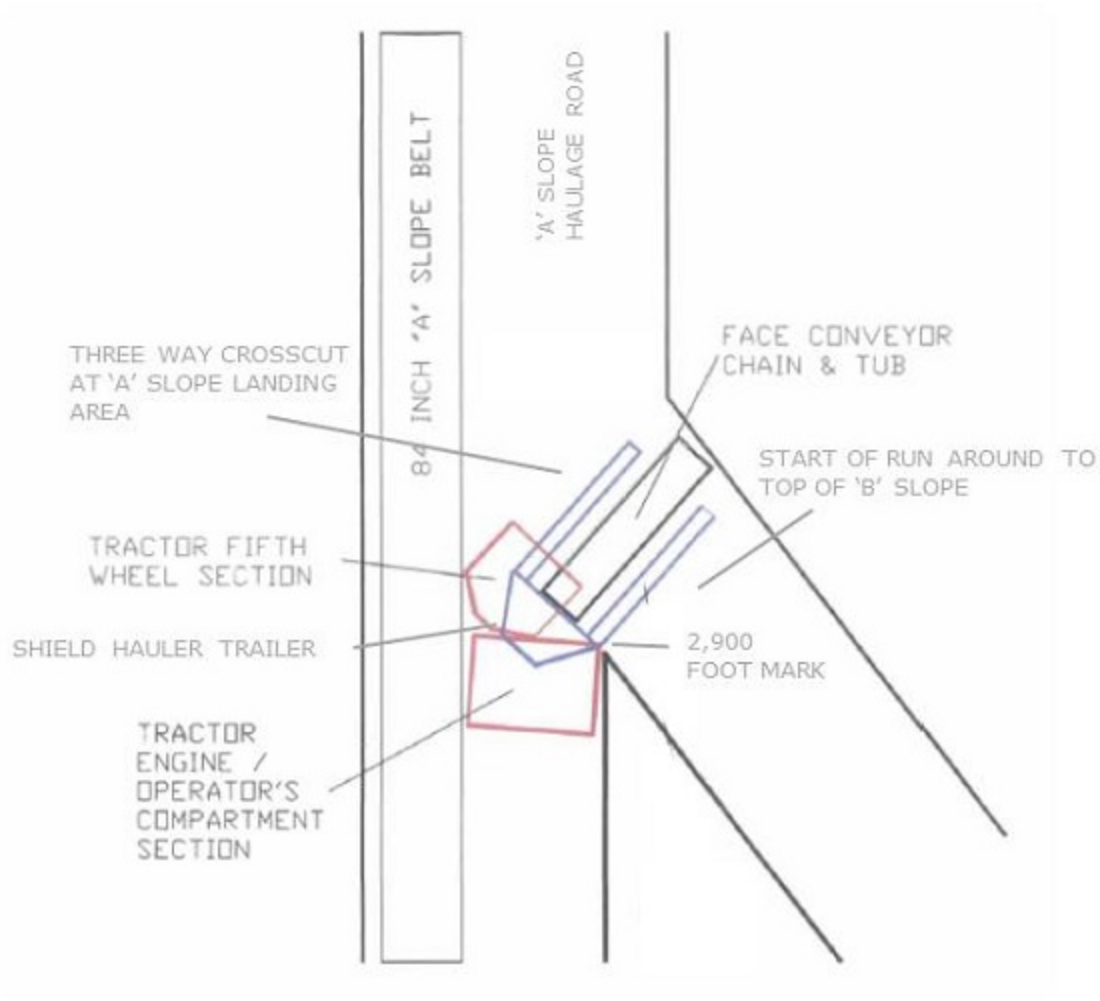
Drawing of Accident Scene

The accident occurred on the belt/haulage "A" Slope entry of the MC#1 Mine south portal inby the 2,900 foot location of the "A" Slope haulage road. When investigators arrived at the accident scene, Rath had been removed from the mine. The No. 5 tractor was broken in half at the center articulation point and the loaded trailer was positioned over the top of the front and rear sections of the tractor. The equipment blocked the "A" slope haulage road and belt at the three way crosscut where the haulage road intersected the "A" slope run around at the 2,924 foot location.

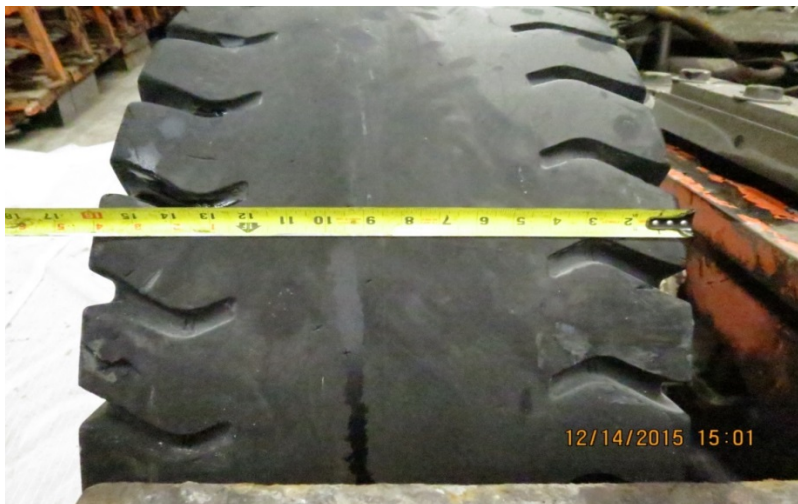
The tractor was using Yokohama Y-67 44X18-20 tires with IND-3 type tread on all four wheels. Visual inspections indicated that the tread conditions for all four of the tires were poor. On the rear tires, the middle section of the tread, between the side lugs, was worn smooth. Photo 4 in appendix D shows the smooth middle section approximately between the 4 inch and 12 inch marks on the tape measure. On the two front tires, the tires were essentially worn smooth across the entire width of the tires. Considerable portions of the side lugs were worn smooth on the two front tires (see Appendix D photo 5). These tread conditions can adversely impact a tire's general performance from a traction and steering standpoint when considering the roadway conditions observed within the accident slope. Photo 6 in appendix D shows a new tire tread for comparison.

An inadequate weekly examination of diesel equipment was conducted on the Fletcher Prime Mover tractor. The tread was worn smooth between the side lugs of all four Yokohama Y-67 44X18-20 tires on the tractor and considerable portions of the side lug tread was worn smooth on the two front tires. This reduced the traction and steering performance of the tires on the wet roadway conditions observed on the accident slope.

Photo 4: View of Tractor's Left Rear Tire Showing Tread Condition

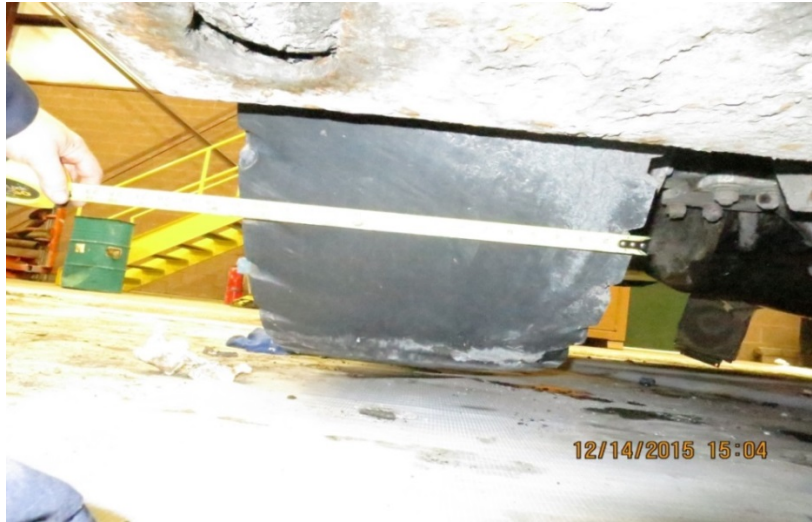
Photo 5: View of Tractor's Right Front Tire Showing Tread Condition
