REPORT OF INVESTIGATION

Fatal Machinery Accident
December 2, 2016

Zhengzhou Coal Mining Machinery (Group) Co. Ltd America (B5251)
Pittsburgh, PA

Oak Grove Mine
Oak Grove Resources LLC
Hueytown, Jefferson County, Alabama
I.D. No. 01-00851

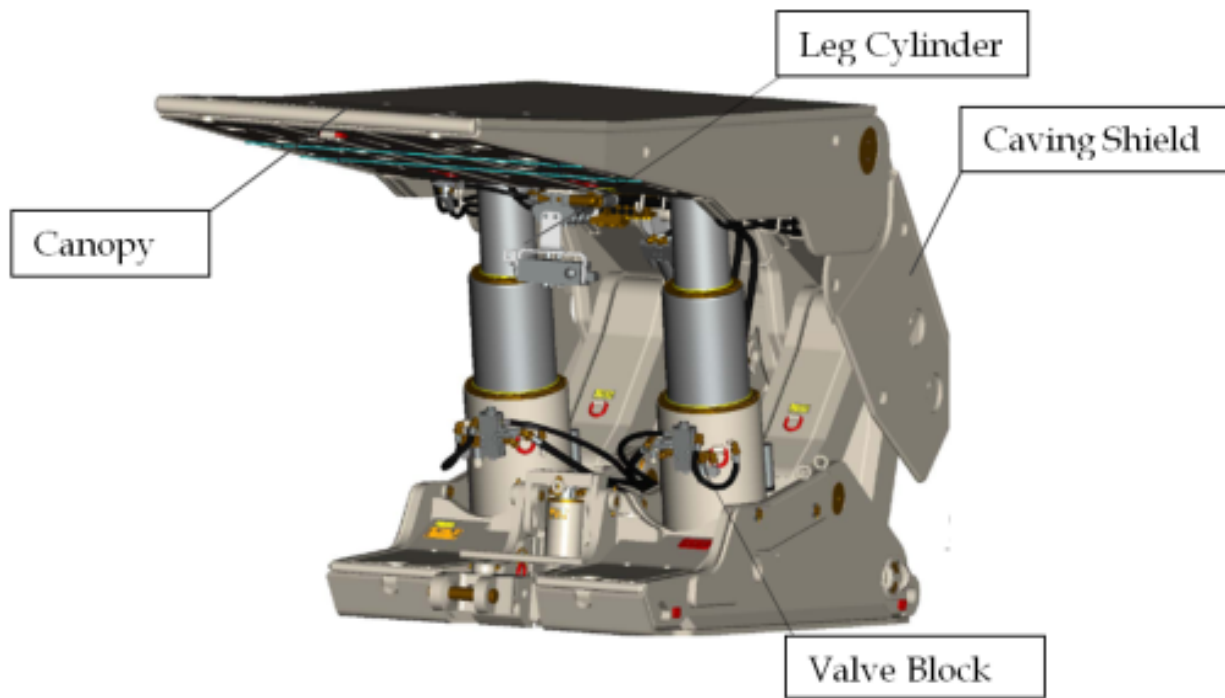
The figure above depicts a ZMJ face shield. The canopy is supported by two hydraulic leg cylinders. A valve block is attached directly to the “cylinder-extend” port of each leg cylinder. Each valve block was etched, indicating it was an FDY400/50 Pilot-Operated Check Valve manufactured by the Zhengzhou Coal Mining Machinery (Group). Co., Ltd. This valve block also has seven other ports where hoses or fittings could be attached to it. There are two “PA” ports and two “A” ports. If hydraulic flow and pressure enters any of the “A” or “PA” ports, the leg cylinder will extend. In addition, there are three “PB” ports. One “PB” port is designed to be connected to the leg “cylinder-retract” port, a second “PB” port is designed to be connected to a return line to the electrohydraulic control valve, and the third “PB” port is an unused

port that is plugged with a staple-lock plug. An electrohydraulic control valve is provided on each shield, and can be used to operate all the functions of the shield.

As long as the longwall pumps are de-energized and no pilot pressure is available, the two pressure ports marked "PA" are protected by the pilot check valve feature. If a hose or plug is removed from a "PA" port, hydraulic fluid will not escape from the hydraulic cylinder, and the cylinder will not retract. When the electrohydraulic control valve is activated to raise the shield, hydraulic fluid under pressure enters the pilot-operated check valve block through a "PA" port, and the leg cylinder extends. The pilot check valve feature allows free flow into the "cylinder-extend" port, but prevents reverse flow unless pilot pressure is applied to unseat the pilot check valve, as would occur when the cylinder is intentionally powered down using the electrohydraulic control valve. When the longwall pumps are shut down, no pilot pressure is available, so the hydraulic fluid inside the cylinder cannot escape through a "PA" port.

Although the pilot check valve will keep the cylinder locked in position if a "PA" port is opened to atmosphere; if either of the two "A" pressure ports is opened to atmosphere, hydraulic fluid can freely escape from the cylinder and allow it to retract. As designed, a low flow yield valve and a pressure gauge were connected with a tee fitting to one of the "A" ports of the pilot-operated check valve block.

If the low flow yield valve or the pressure gauge (or the plugs capping the ports where these devices are intended to be attached) is removed, oil can freely escape and the leg cylinder can retract. Removing a low flow yield valve or pressure gauge from an "A" port of only one leg cylinder would not cause the shield to collapse, since the other leg would continue to support the weight of the canopy. However, the moment a low flow yield valve or pressure gauge (or the plugs capping the ports where these devices are intended to be attached) is subsequently removed from an "A" port on the second leg cylinder of the same shield, both leg cylinders would retract, and this would cause the shield to collapse. This did occur at the time of the accident based on the missing plugs found by miners during the rescue immediately after the accident. The DN-10 staple-lock plug where the pressure gauge was to be installed had been removed from the right-side (tailgate-side) leg cylinder, while the DN-12 staple-lock plug where the yield valve was to be installed had been removed from the other leg of the same shield. These plugs were reinstalled during the rescue attempt to allow the shield to be elevated hydraulically.
