REPORT OF INVESTIGATION

Fatal Powered Haulage Accident  
January 4, 2016

Lower War Eagle  
Greenbrier Minerals, LLC  
Man, Wyoming County, WV  
ID No. 46-09319

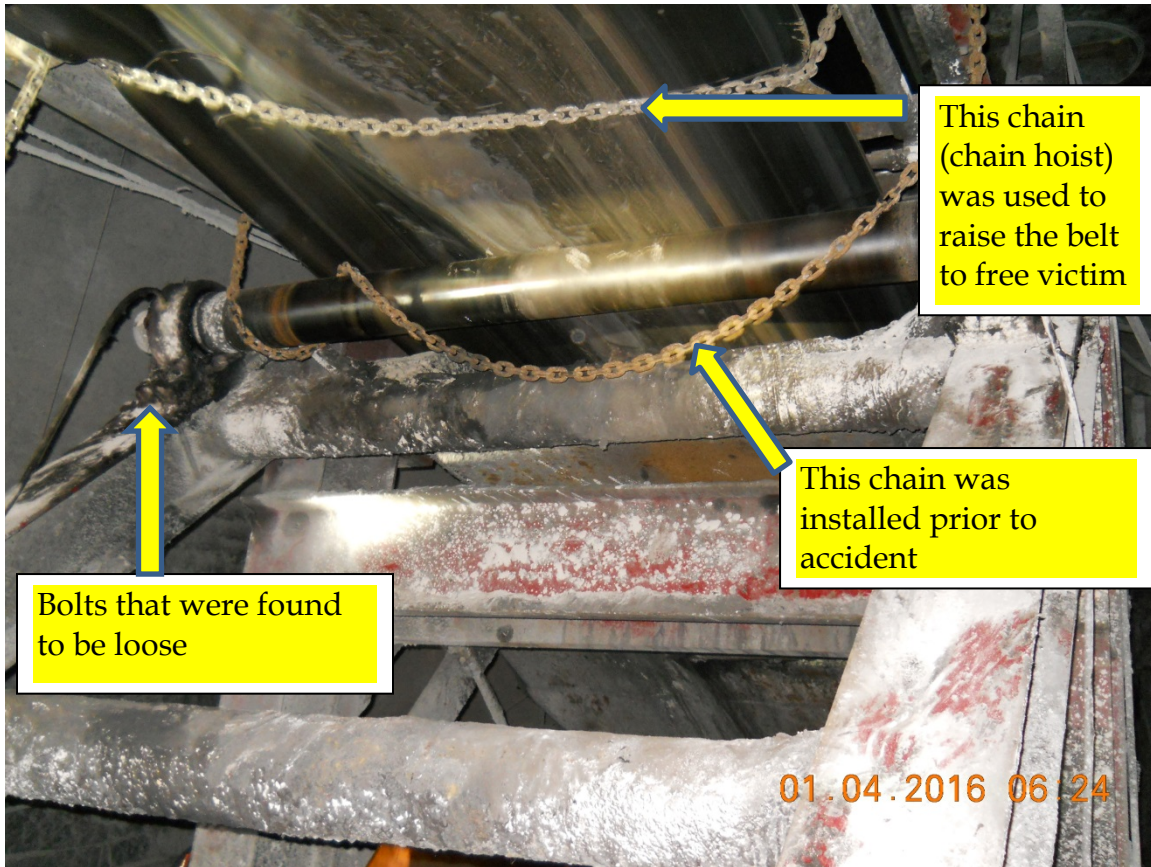
Pictures at Accident Scene

While performing maintenance work with the belt running, Sprouse became entangled with moving machinery components (belt roller and belt) causing fatal injuries (see Appendix A).

The belt in this mine is supported from the mine roof to the metal belt structure with  $\frac{3}{8}$  inch chains. The bottom belt hold-up roller (6 inches diameter by 84 inches in length) located on the top of the A-frame was 120 inches from the mine floor. The hold-up roller involved in the accident was observed having a  $\frac{3}{8}$  inch chain approximately 15 feet in length wrapped around the roller and connected on each side of the belt chain hangers with a clevis pin and chain hook (see Appendix A). A ratchet and socket was found at this location that fit the bolts that secured the bearing to the belt drive frame. Two of the four bolts that secured the bearing and roller onto the frame of the belt drive on the travel side were loose indicating the victim was most likely loosening the bolts at the time of the accident (see Appendix A)

The victim sustained fatal injuries when he was caught between the conveyor belt and hold-up roller of an underground belt conveyor. The victim was performing maintenance work with the belt conveyor running. This work should have been performed only after electrical power was removed from the belt drive unit and the belt was blocked against motion.

1. The action plan included any areas of the belt drive, belt head or tail pulleys where a person could reach moving parts shall be guarded.
2. All employees were trained on lock and tag out procedures, guarding, and general belt safety. Qualified employees shall personally lock and tag-out using their own lock. The tag will have a date, time, and qualified person's name. Employees shall block any moving parts against motion before work can begin.
3. At no time will any person remove another person's lock and tag.
