REPORT OF INVESTIGATION

Fatal Rib Fall Accident

January 16, 2016

4 West Mine

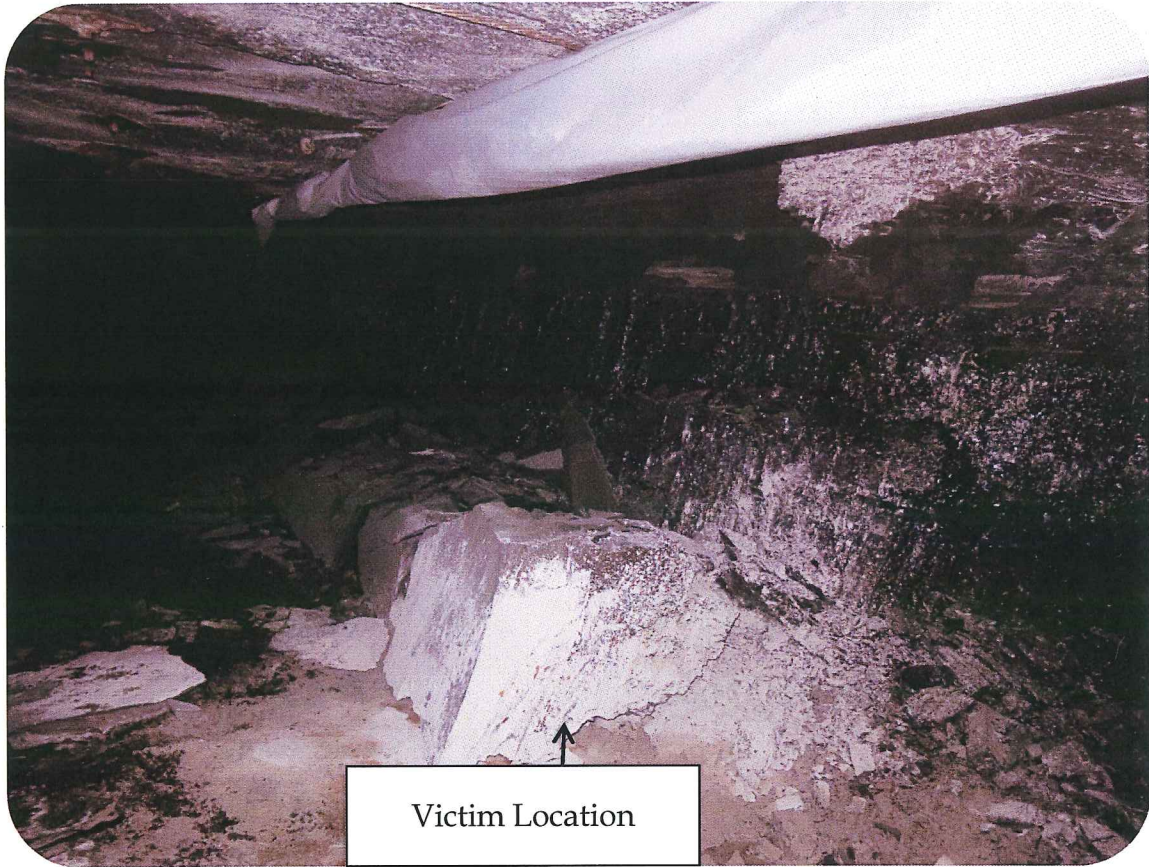
The accident occurred along the right rib of the entry, approximately 5 feet in by the corner created by the crosscut. The coal seam height averages 5.5 feet at this location. However, the mining height was approximately 7 feet due to approximately 2 feet of shale being mined above the coal seam. It is sometimes necessary to mine the shale on advance to remove roof fractured by the multiple seam stress. This practice provides a solid surface for the roof bolters to install permanent support. The measured entry width was between 21 and 22 feet. The excessive entry width was a result of rib failure. Measurements taken at the roofline indicated the entry width was 18 feet prior to rib failure.

The right rib of the No. 2 entry, which failed during mining of Run A, was present in several pieces which extended past permanent roof support. The fallen rib material was measured and determined to be 29 feet long, approximately 3 feet high, down to a tapered point, and 2.5 feet thick at the thickest point, also tapering to a point. The portion of rib that struck Neice measured 3 feet high, 4.5 feet in length and 2.5 feet thick. It was comprised of 2 feet of rock and 1 foot of coal and weighed approximately 4,500 pounds.

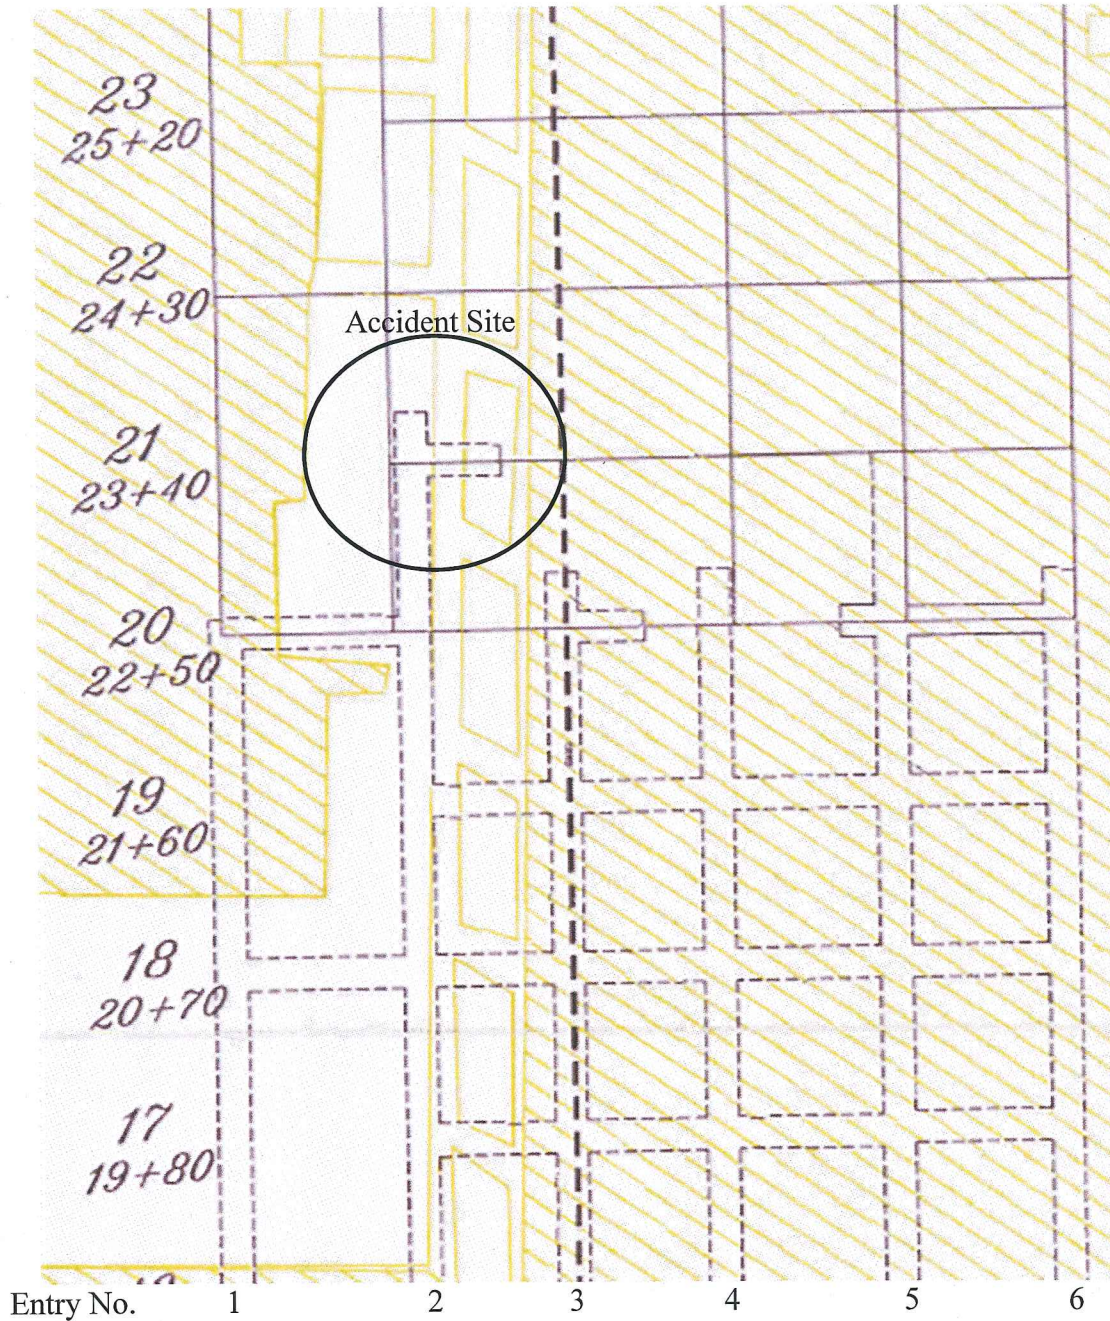
Appendix A  
Expanded View of the Accident Scene

Teets and Seibert bolted crosscut 21 between the No. 2 and No. 3 entries that was mined on the previous shift (See Appendix A). They bolted the No. 2 entry next and Neice

The I Sub-Main section is located above remnant pillars and gob areas in the Pittsburgh seam. A large remnant pillar is shown directly beneath the number 2 Entry between 19+80 inby to 23+40 including where the face of the entry was at the time of the accident (see Appendix A). The presence of the large remnant pillar, transferring stress to a concentrated area, caused the coal in the ribs of the No. 2 and No. 1 entries to slough under the stress. The sloughage of the coal removed the natural support to the rock above leaving an unsupported rock brow 24 inches in height. The remaining entries, No. 3 through No. 6, on the right side of the I Sub-Main section, are located above a gob area without remnant pillars and do not display the adverse conditions present in the No. 1 and No. 2 entry.

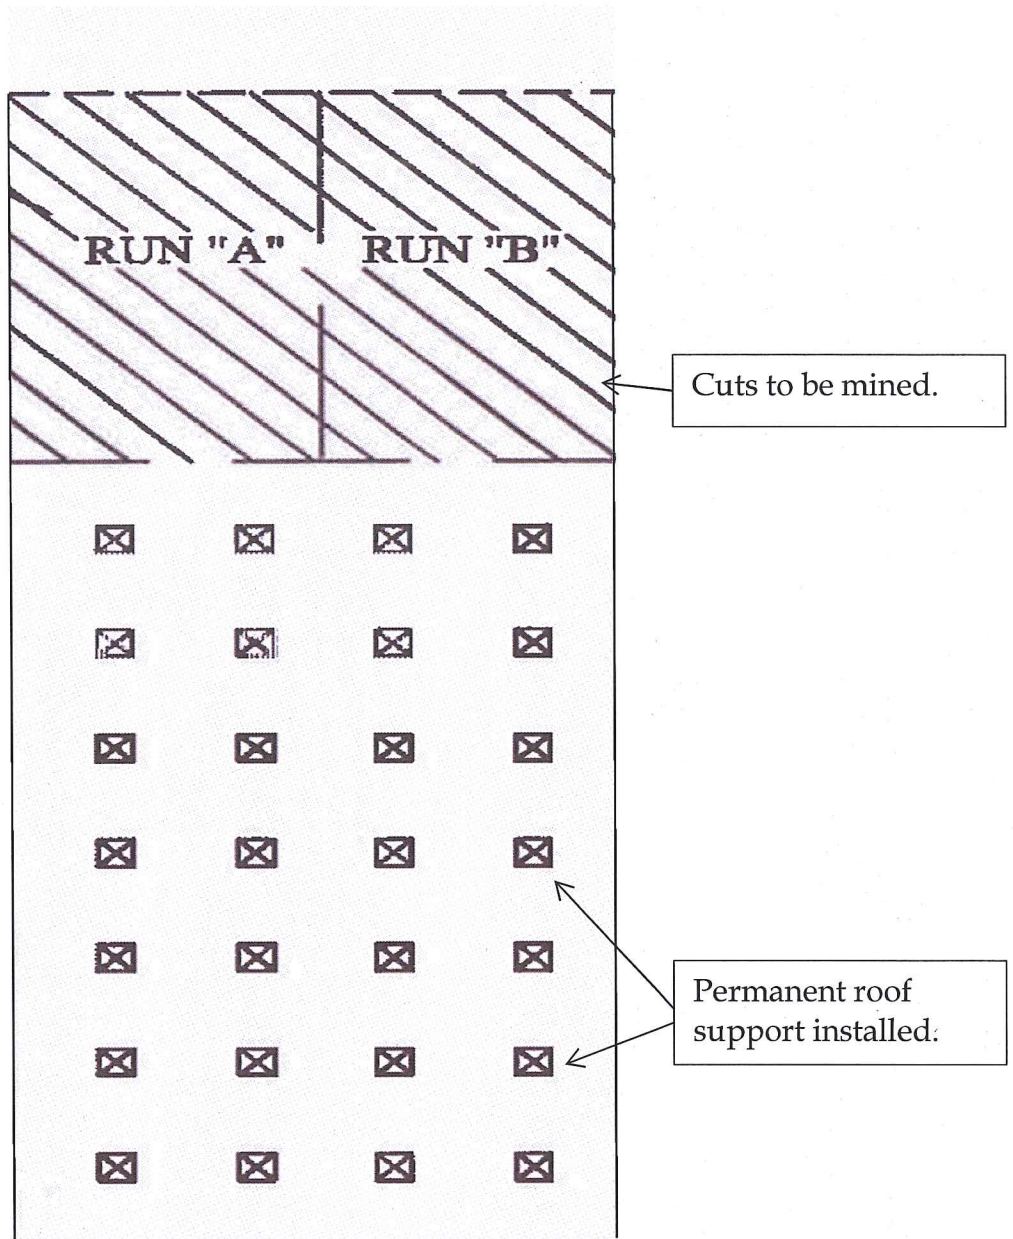
**Appendix B**  
**Excerpt from the Approved Roof Control Plan**

Rib control minimum standards, in effect at the time of the accident, can be found on page 16 item 33 of the currently approved roof control plan as follows.

*33. When overburden exceeds 700ft and mining height exceeds 7ft. the area from the feeder to the last open crosscut shall have additional rib support installed, in the form of ribs bolts, at intervals not to exceed 8 feet. All rib bolts will be a minimum of 36" in length.*

These provisions in the approved roof control plan did not require rib supports to be installed inby the last open crosscut.

Corrective Action: The approved roof control plan was revised to identify remnant pillar areas in the underlying mine that could contribute to poor rib conditions. The revised plan requires rib support to be installed in-cycle in these areas inby the last open crosscut.

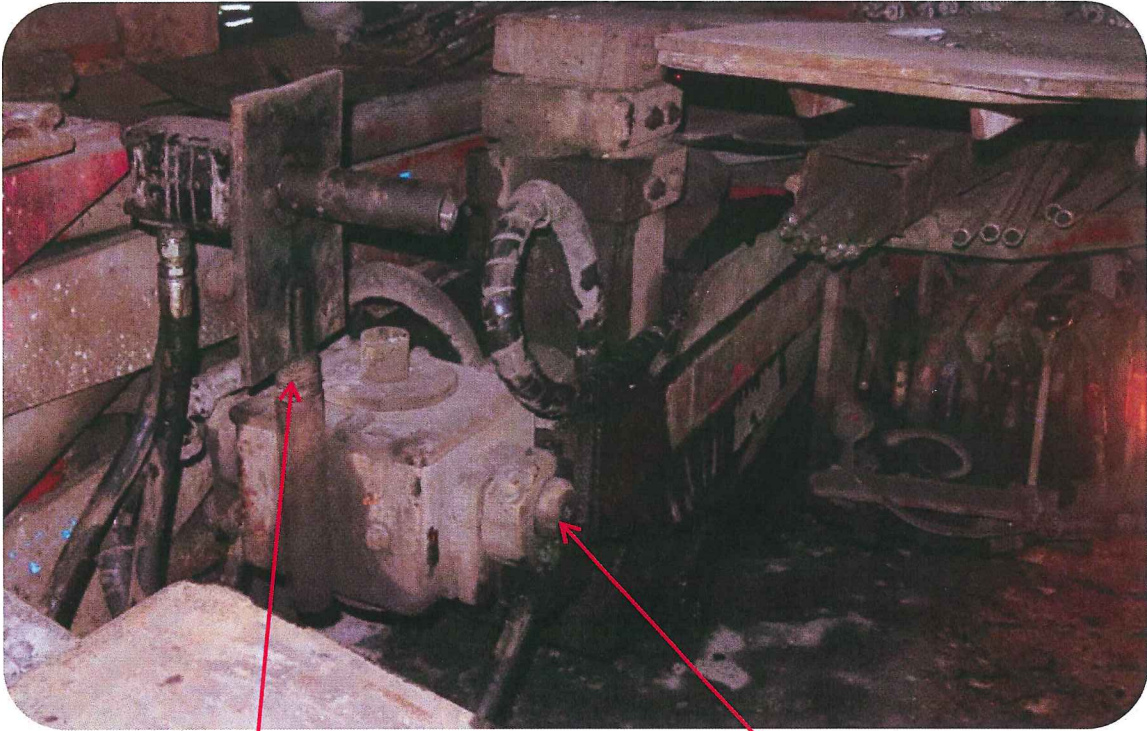
**Appendix D**  
**Roof Ranger II**  
**(Horizontal Drill Pot Attached)**

The Fletcher Roof Ranger II-15 Roof Bolter (RR-II) is used throughout the mine on development sections. The RR-II does not have a designed capability to install bolts horizontally (rib bolts). Mine management retrofitted a drill pot attachment using the roof bolting machine’s hydraulic system and drill mast swing function as a feed to install rib support (see Appendix D) from the outby end of the machine.

Horizontal Drill Pot Installed on  
the Mast of Fletcher Bolter

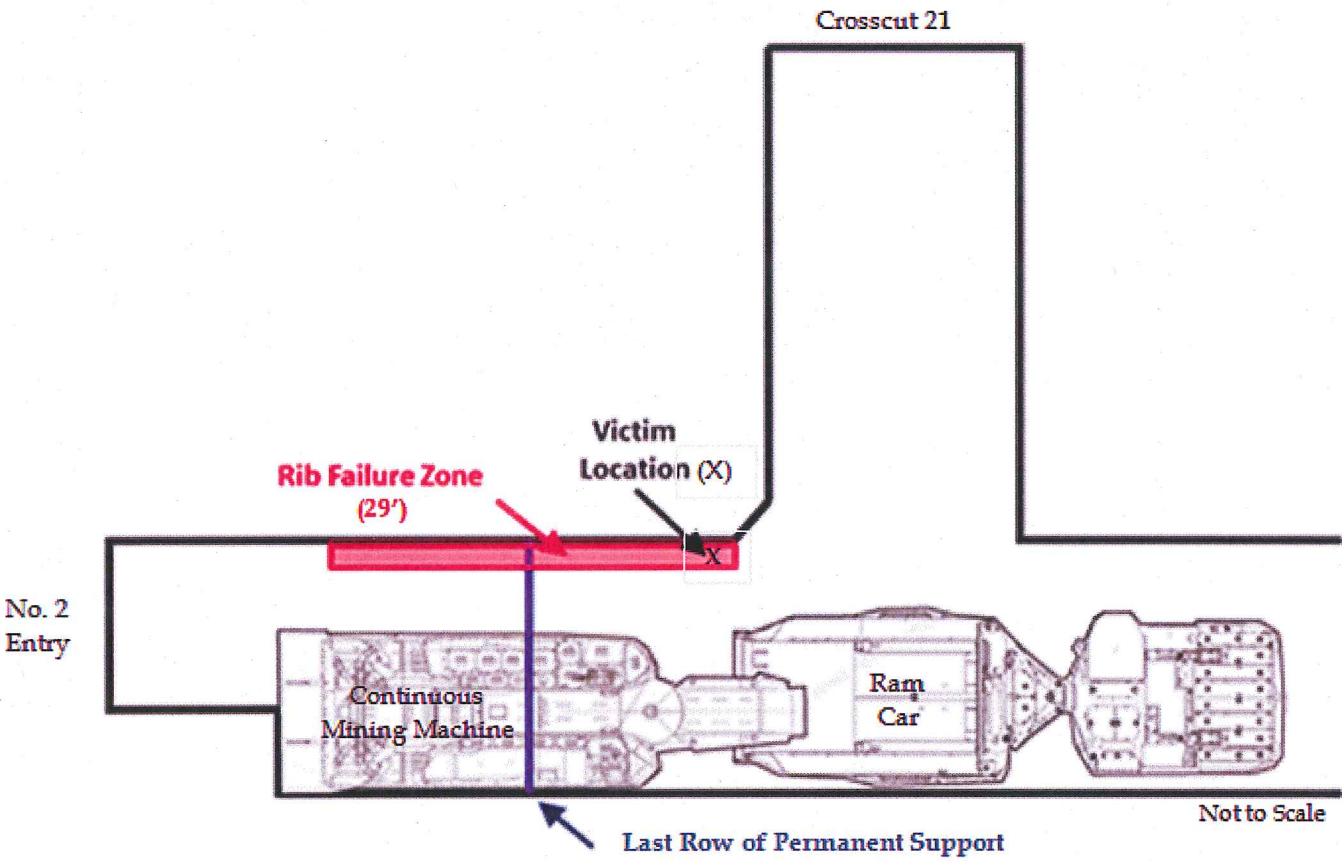
Appendix E  
Drawing of Accident Scene

The accident occurred in the No. 2 entry of "I" Sub-Main Section, MMU 004-0 at permanent reference 23+56. The face of the No. 2 entry was being mined when the accident occurred. The face was extended beyond the last row of permanent supports for a distance of twenty-seven feet on the Run B and eighteen feet on the Run A. A three-way intersection was present at 23+40 which was created by a crosscut driven for a distance of forty-five feet, when measured from the center of the No. 2 entry toward the No. 3 entry.
