REPORT OF INVESTIGATION

Fatal Machinery Accident
January 19, 2016

Dotiki Mine
Webster County Coal, LLC
Clay, Webster County, Kentucky
ID No. 15-02132

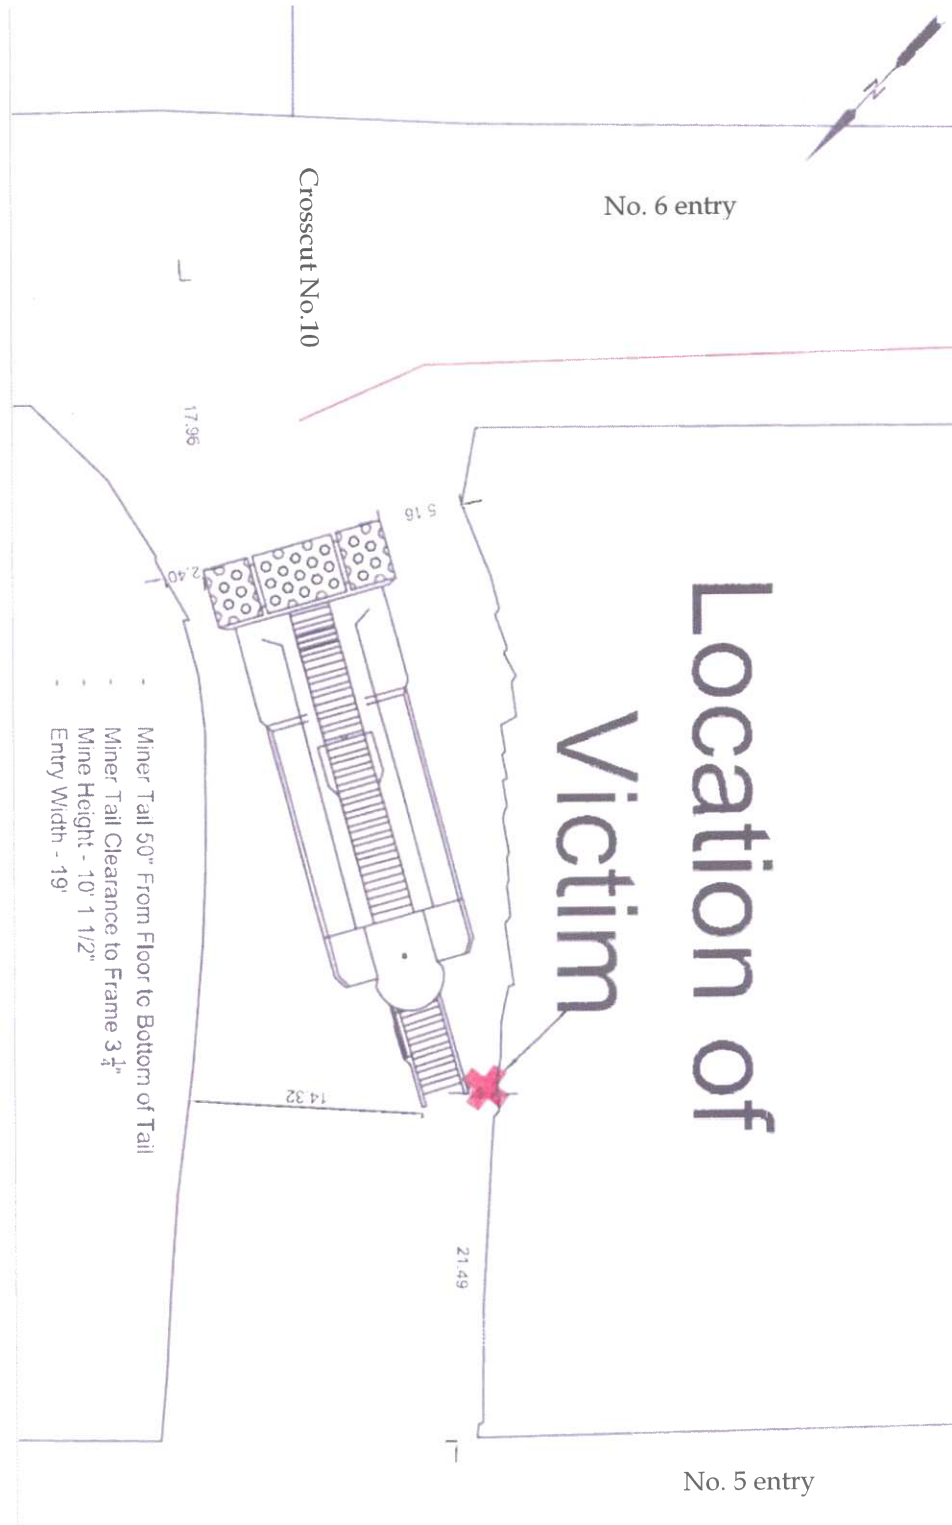
Figure 2

At the location of the accident, the crosscut measured 19 feet wide and 10 feet ½ inches in height. The conveyor boom of the continuous mining machine was located 1 foot 9 inches from the inby rib. The cutting drum of the continuous mining machine was located 2 feet 5 inches from the outby rib corner angled into the notch (see Appendix C, Figures 2 and 3).

Dimensions of the Accident
(Not to scale)

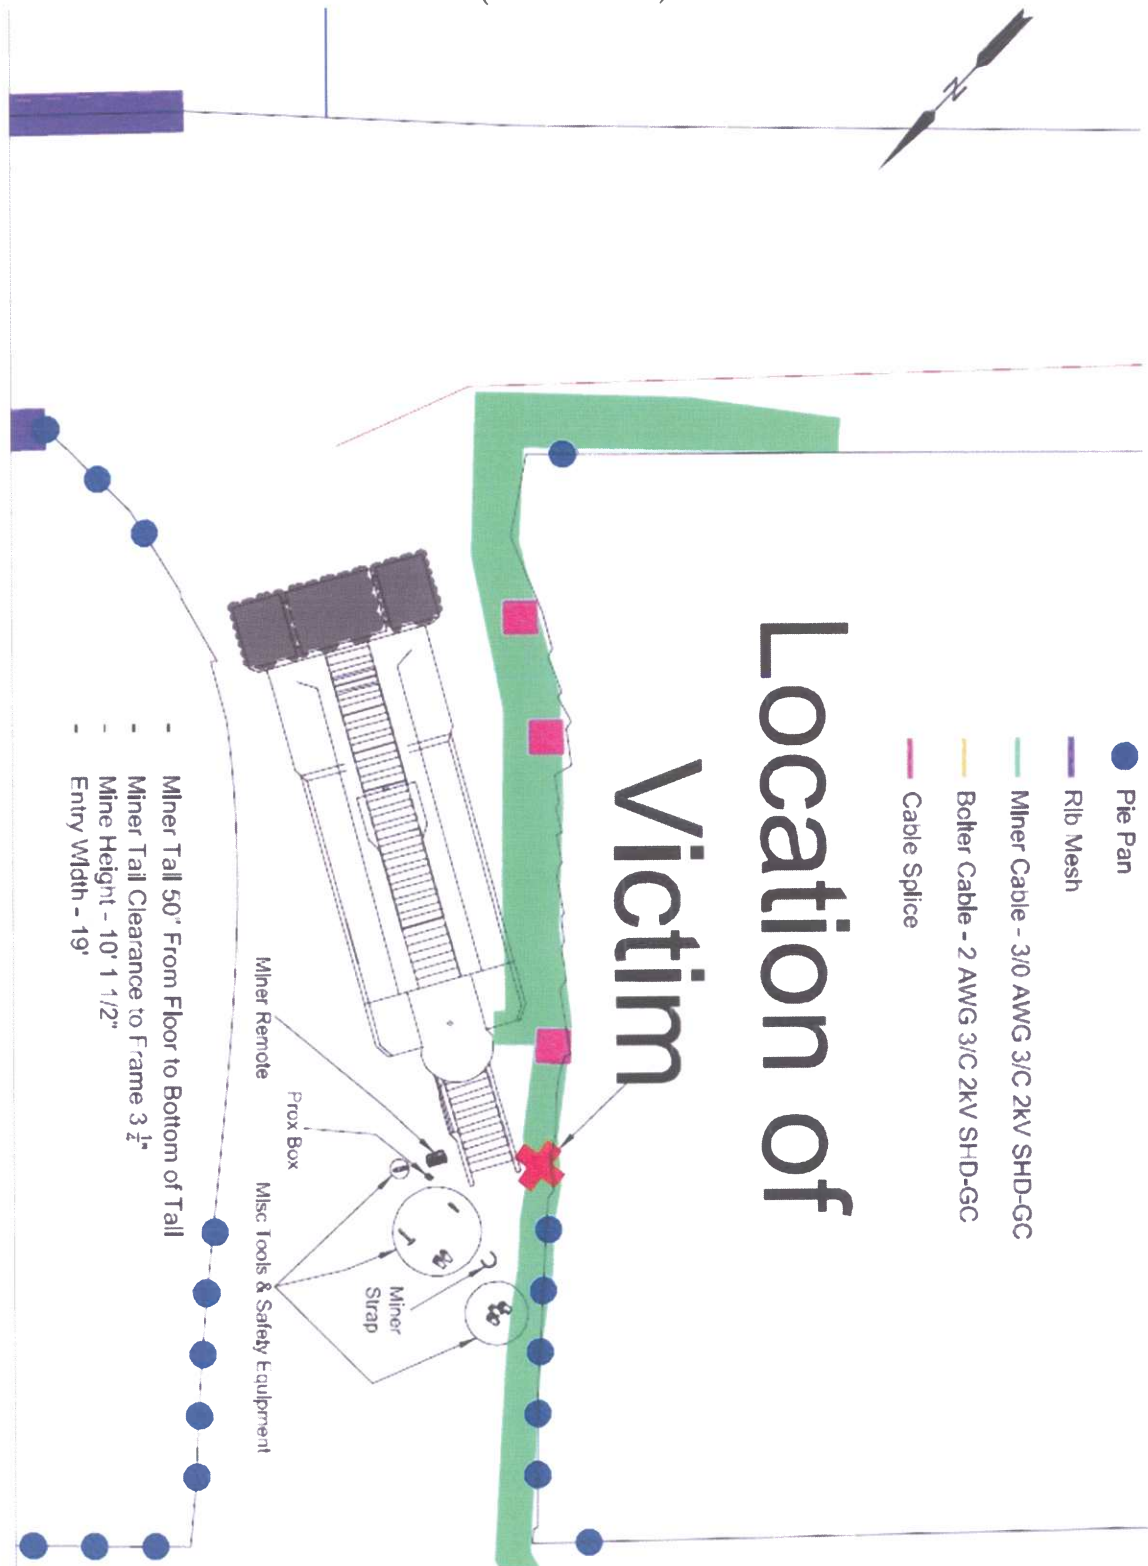
Figure 3

Location of Equipment after the Accident
(Not to scale)

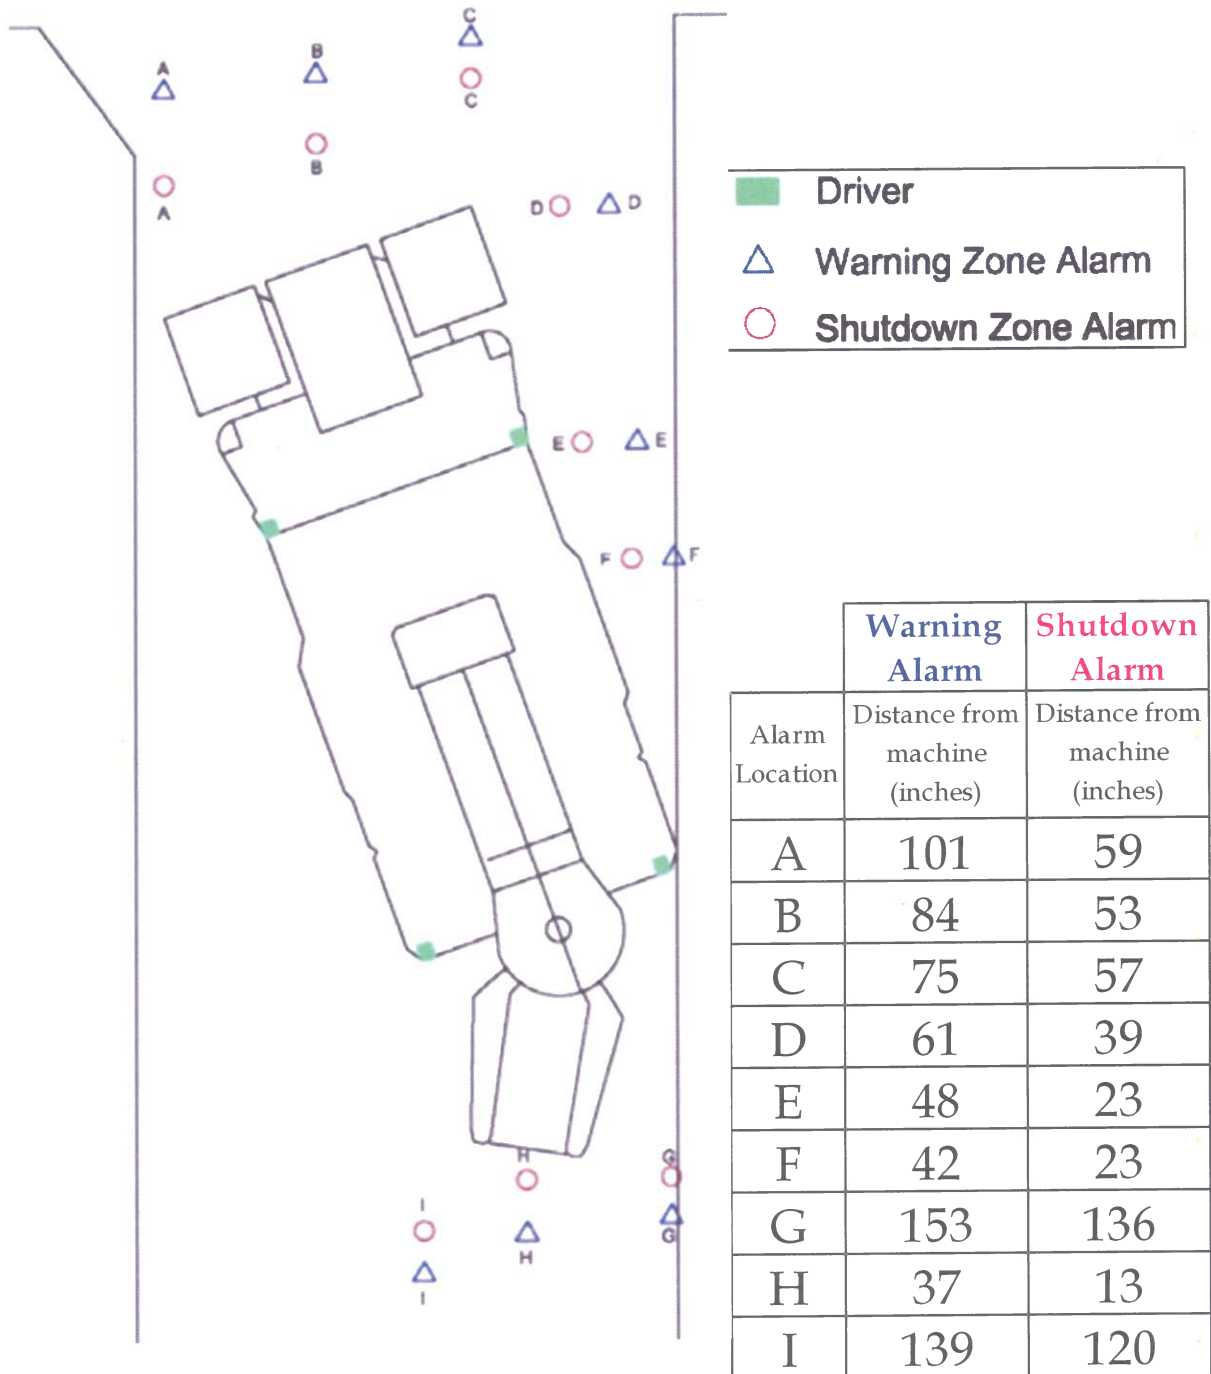
Appendix D
Proximity Detection System
Distance Test Results
(Not to scale)

The continuous mining machine was examined by the investigation team and functional tests of the remote control station, tram and conveyor boom systems were performed. Technical Support's examination and inspection of the PDS equipment, both machine-mounted and miner-wearable, resulted in no observed physical damage or abnormalities that would affect proper operation of the PDS. Tests of the PDS were performed and distance measurements of the warning and shutdown zones were recorded. The PDS static measurements and dynamic tests indicate the system was operating as designed (see Appendix D).

Note: Location (H) is measured from the end of the tail.
Locations (G) and (I) are measured from the rear of the machine.
