REPORT OF INVESTIGATION

Fatal Fall of Rib Accident  
March 25, 2016

Huff Creek No. 1  
Lone Mountain Processing, Inc.  
Holmes Mill, Harlan County, Kentucky  
ID No. 15-17234

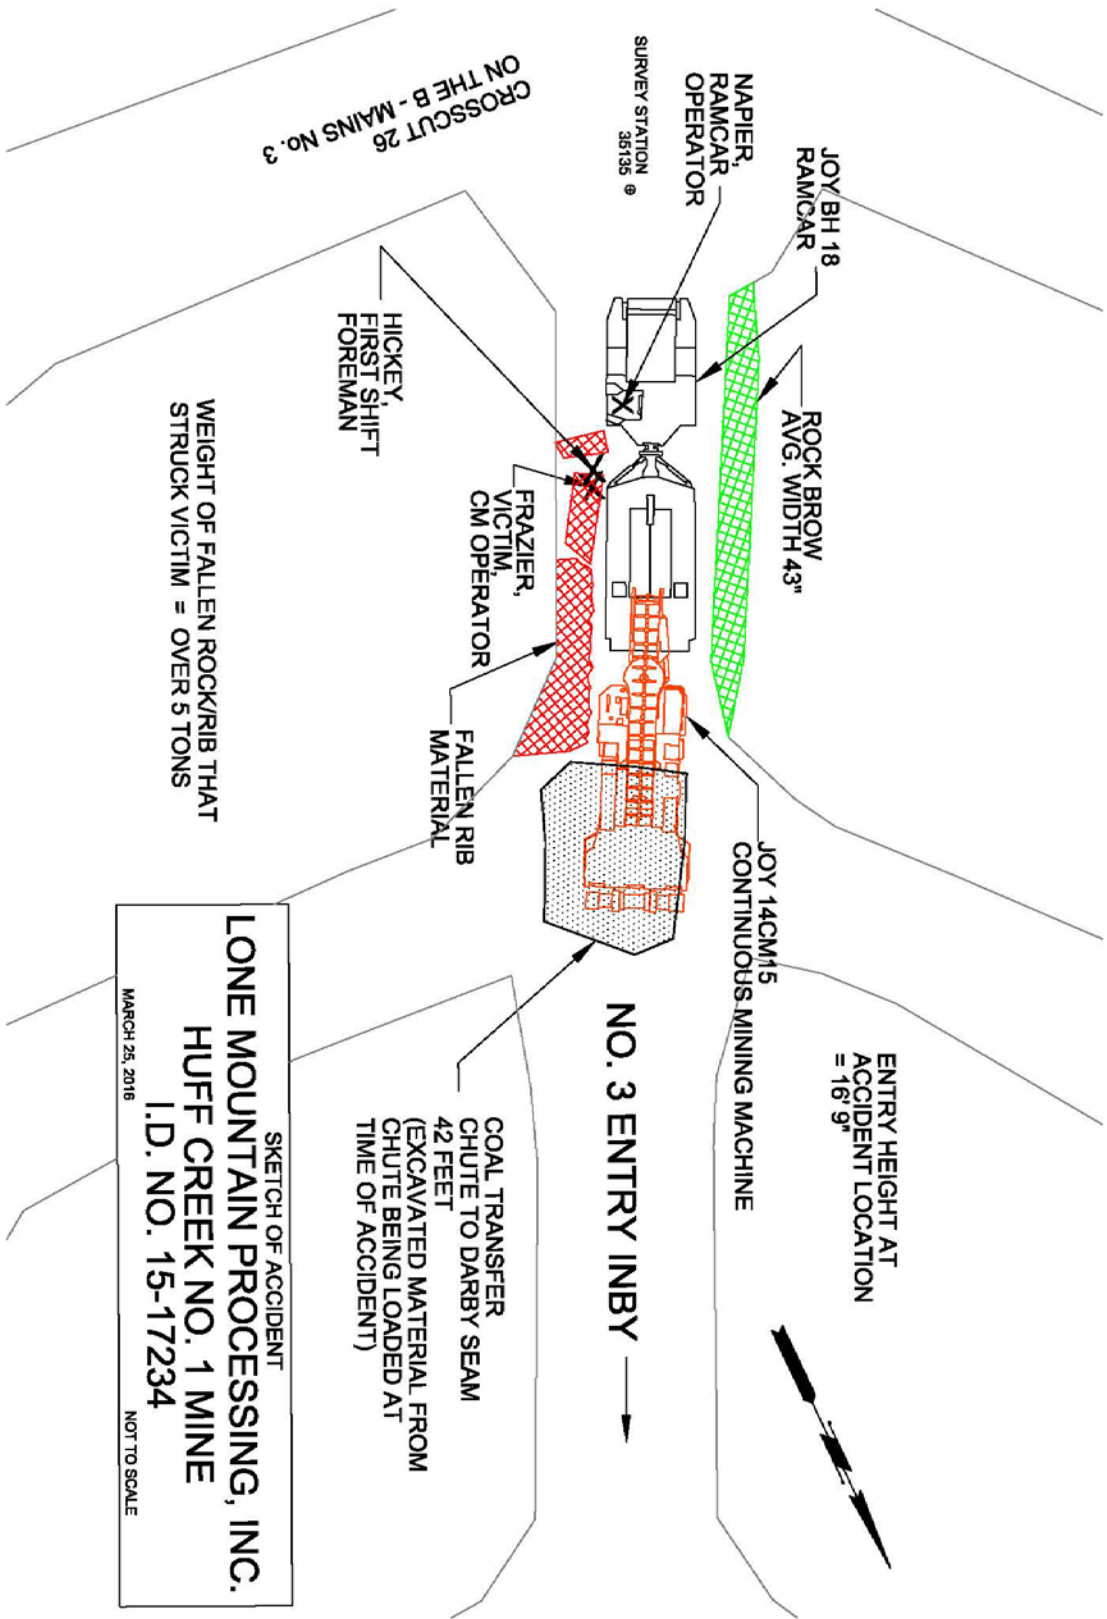
SKETCH OF ACCIDENT  
**LONE MOUNTAIN PROCESSING, INC.**  
**HUFF CREEK NO. 1 MINE**  
**I.D. NO. 15-17234**  
 MARCH 25, 2016  
 NOT TO SCALE

WEIGHT OF FALLEN ROCK/RIB THAT  
 STRUCK VICTIM = OVER 5 TONS

COAL TRANSFER  
 CHUTE TO DARBY SEAM  
 42 FEET  
 (EXCAVATED MATERIAL FROM  
 CHUTE BEING LOADED AT  
 TIME OF ACCIDENT)

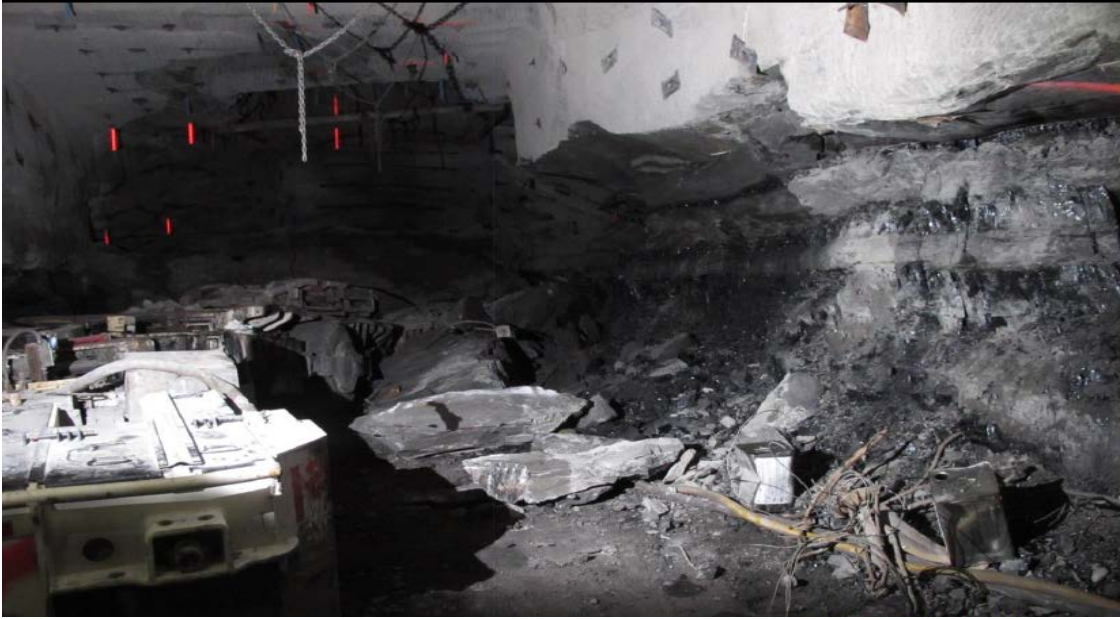
PHOTOGRAPH OF THE ACCIDENT SCENE

At 8:16 am, on Friday, March 25, 2016, Mark Frazier (victim) was fatally injured while operating a continuous mining machine in an outby area of the mine. The victim was loading material from a coal transfer chute construction site in the B-Mains No. 3 portion of the mine. A large section of rock rib/brow fell trapping him between the frame of a battery-powered ramcar and the mine floor. The rock rib/brow measured approximately 44 feet in length, 4 feet in width, and 2 feet in thickness. The portion of the rock rib/brow that struck the victim measured 8 feet in length, 4 feet in width, and 2 feet in thickness and weighed over 5 tons.

Observation of the rib conditions at the accident location revealed that the coal portion of the ribs had severely sloughed out creating 4-foot deep overhanging rock brows on both sides of the No. 3 entry. The ribs were spot bolted, but the overhanging brows had no vertical support. Three factors which likely contributed to the rib sloughage were high overburden, high mining height, and time. The area had over 1,900 feet of overburden with a mining height of about 17 feet. The entries and crosscuts in the location of the accident were originally developed in 2006. The portion of the rock rib/brow that fell on the victim measured 8 feet in length, 4 feet in width, and 2 feet in thickness and weighed over 5 tons.

Corrective Action: An Action Plan has been implemented to provide additional rock rib/brow support including the installation of 14-foot tensionable cable bolts, 100 ton Heitzman jacks, and meshing. The 100 ton Heitzman jacks were also used to narrow the width of the area. On May 10, 2016, MSHA personnel inspected the area and deemed the work to support the brows and narrow the entry to be complete and the area safe to travel.
