REPORT OF INVESTIGATION

Fatal Machinery Accident
June 6, 2016

The American Coal Company New Era Mine
The American Coal Company
Harrisburg, Saline County, Illinois
I.D. No. 11-02752

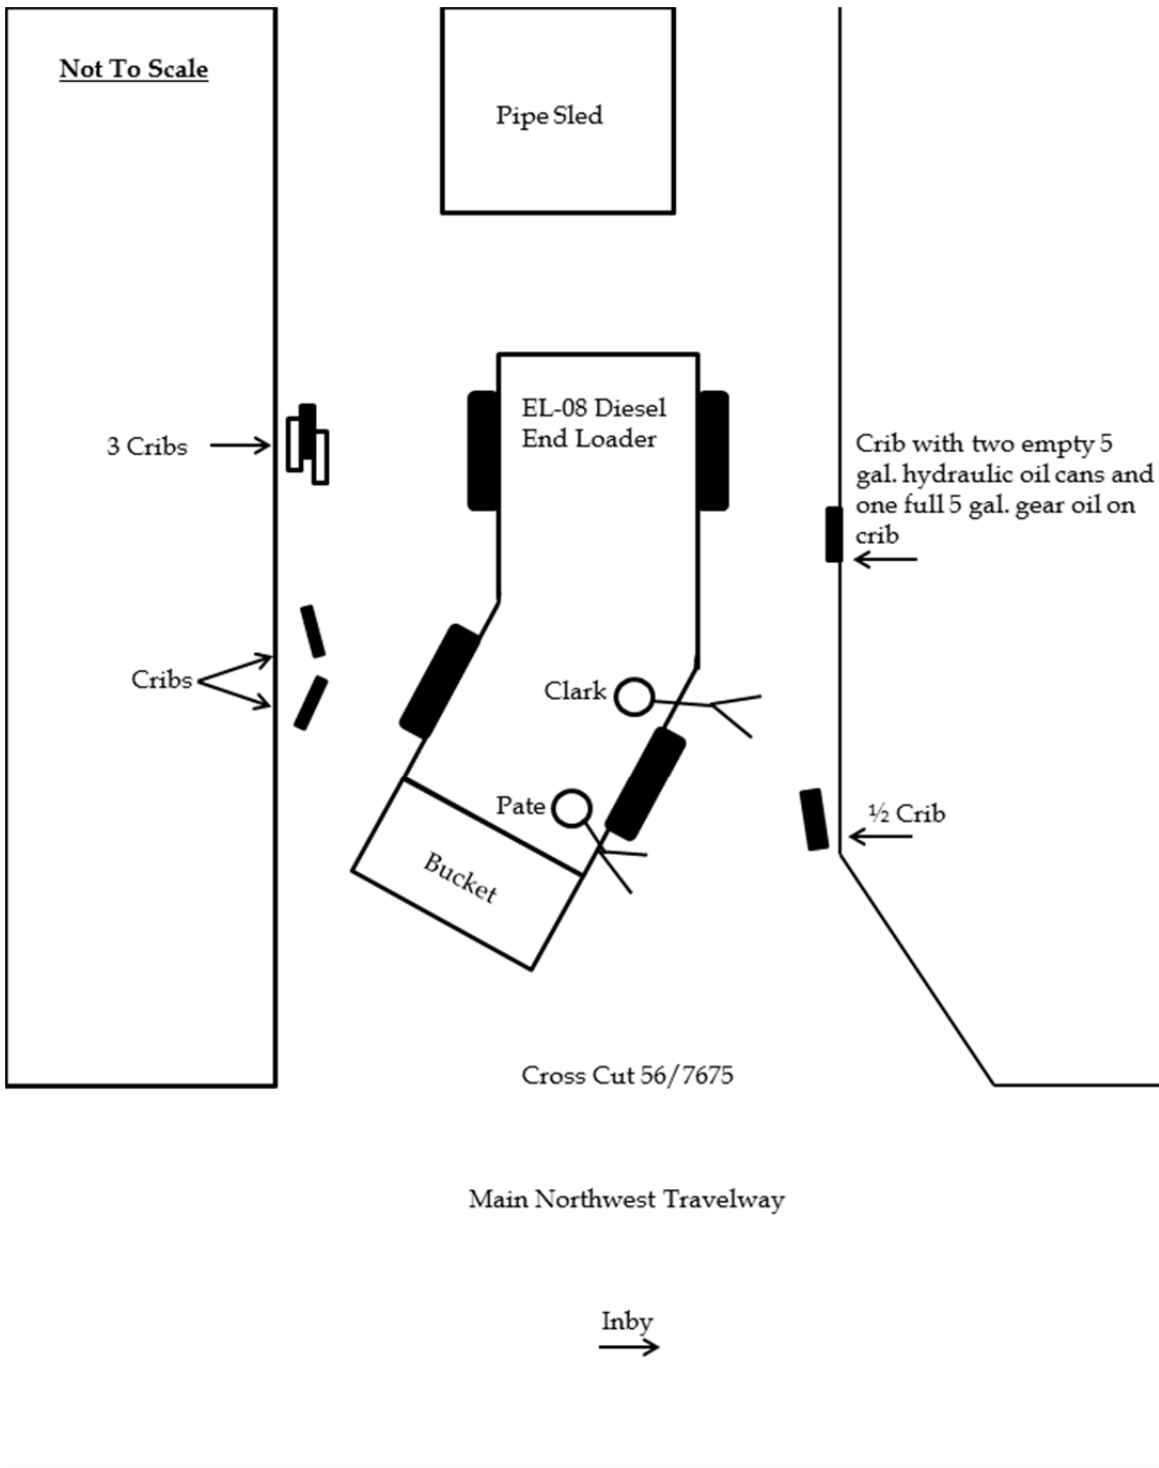
Accident Scene Drawing

The accident occurred on the Main Northwest travelway near the Main Northwest intake shaft, at crosscut 56/7675W between the number 3 and number 4 entries. The crosscut was 7 ½ feet high and 18 feet wide. Other materials located in the crosscut were seven 36 inch wood crib blocks, two empty 5 gallon hydraulic oil cans, one full 5 gallon can of gear oil, and a pipe sled which was located behind the end loader.

The end loader was observed backed into the crosscut with the bucket facing the travelway. The end loader's bucket was tilted forward in contact with the mine floor and no cribs were observed under any portion of the machine. Oil was observed on the mine floor from crosscut 56/7675W along the number 4 entry inby to crosscut 56A/7760W, a distance of 85 feet. Three empty 5 gallon hydraulic oil cans, a large area of oil soaked mine floor, and pools of oil in the operator's side tire track were observed in this crosscut. The trail of oil continued inby along the number 4 entry to crosscut 57A/7880W. Tire tracks were compared with the tires on the end loader and matched the tire pattern left in the mud and oil at both areas. See Appendix C for a drawing of the accident scene.
