REPORT OF INVESTIGATION

Fatal Powered Haulage Accident
May 16, 2016

Leer Mine
ACI Tygart Valley
Grafton, Taylor County, West Virginia
I.D. No. 46-09192

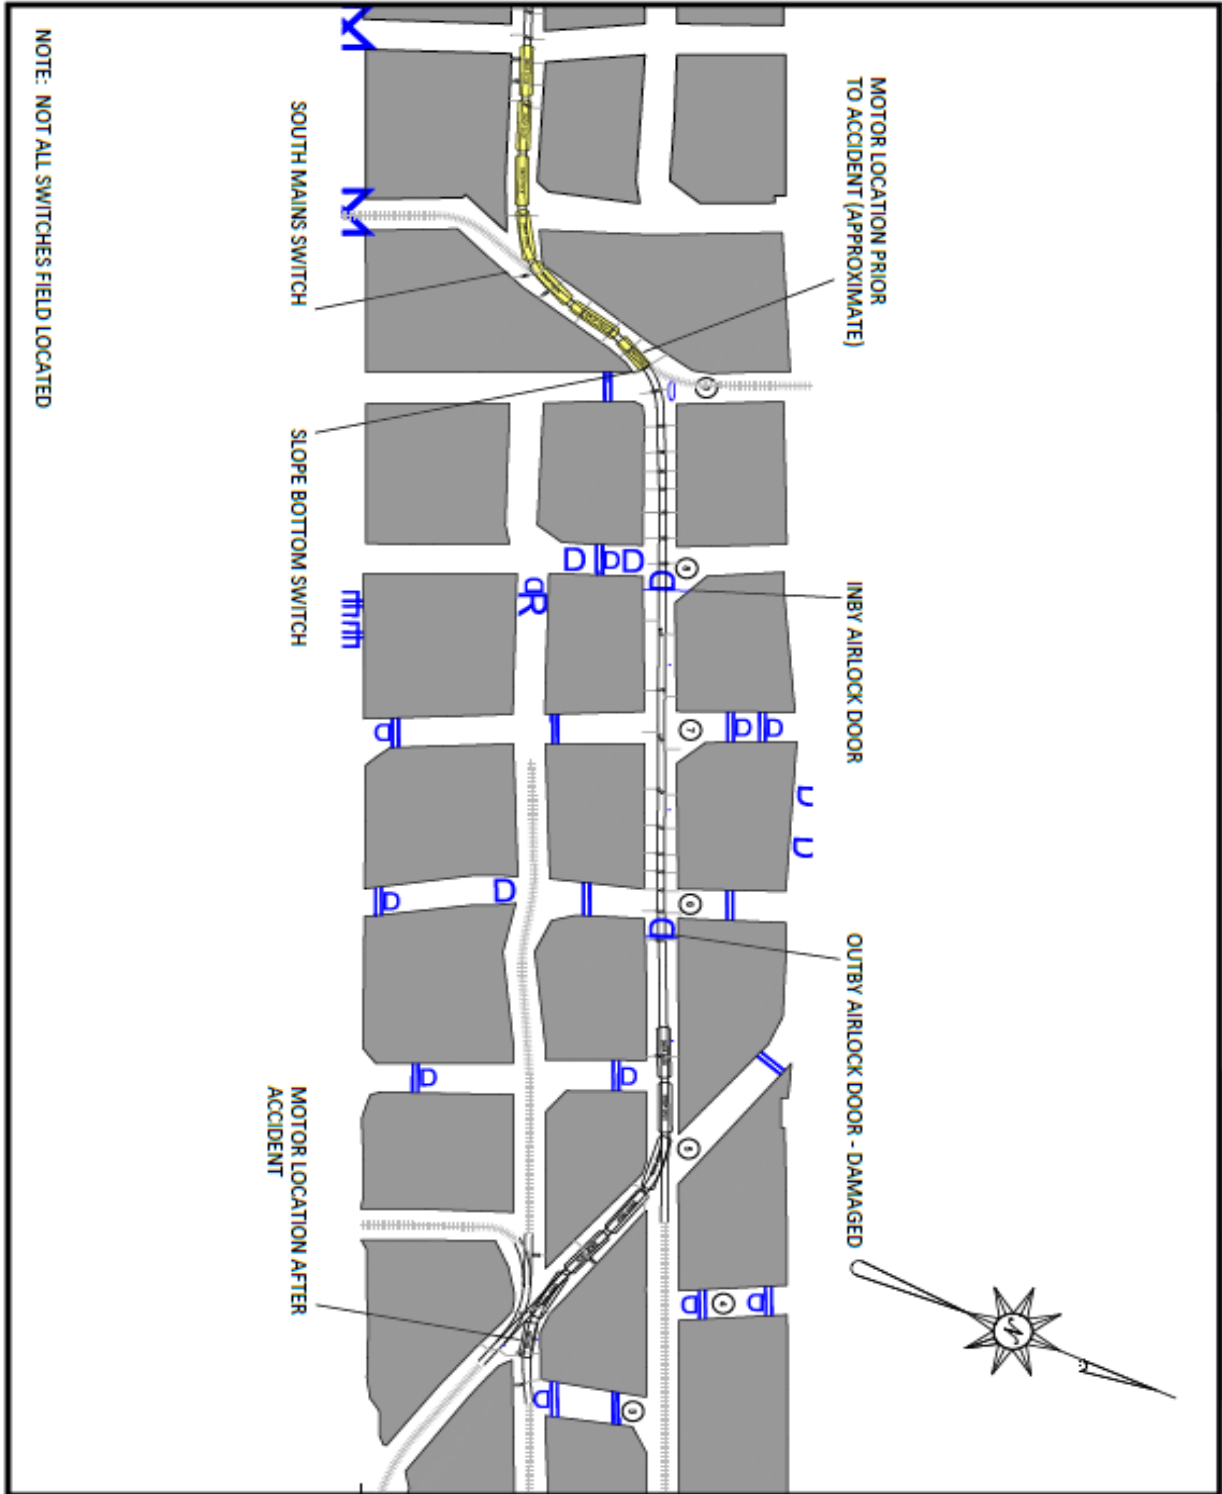
Appendix A Drawing of Accident Site

Meddings was the lead motorman and Beeman was operating the No. 4 (inby) locomotive following the train, but was not coupled to the cars. They both arrived at the slope bottom. Beeman could not see the No. 5 locomotive due to a turn in the track entry (see Appendix A).

The steel rails were inspected and found dry with no irregularities. There is an approximately 4.8 percent drop in elevation from the slope track switch to the location where the train stopped. There was no evidence on the rails leading up to the closed outby airlock door that the brakes had been applied. The investigation team determined the train stopped on its own because of the rolling resistance of the track in the "S" curve and the fact that the grade in the track leveled out.

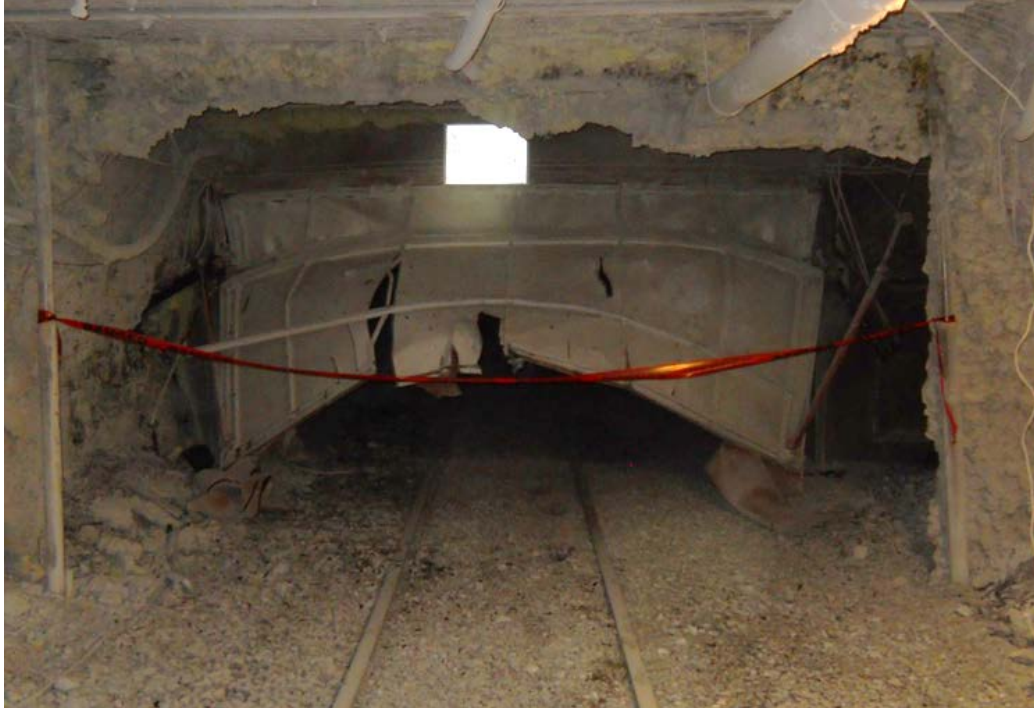
Appendix C
Photograph of Outby Airlock Door

Krist Door Service Inc. manufactured and installed the steel airlock doors. They were installed in a pair. The door openings measured seven feet high and fifteen feet wide. The manufacturer estimates each door weighs 630 pounds. Each door is hinged horizontally at the top with two hydraulic jacks mounted to the door sides. The doors are opened and closed by depressing a remotely located “up” or “down” switch. This starts an electrically powered hydraulic pump that causes the hydraulic jacks to open or close the door. The doors are electrically interlocked to prevent both doors from being opened at the same time. This could not be tested initially due to the extent of the damage to the door, but was subsequently tested and determined to work as designed.

The airlock doors are mounted with the door bottom slightly inby the top hinge and they open inby so less force is required to open them against the ventilation system pressure. The locomotive crashed through the closed door in a direction opposite to the direction the door opens. This caused significant damage to the door and frame, but the door was not dislodged from the roof or ribs (see Appendix C).

Meddings, the locomotive, and six cars crashed through this outby airlock door. This photograph shows the door from the outby side and is opposite to the direction the train was traveling.

Corrective Action: The mine operator developed and implemented procedures for separating the supply train and traveling through the airlock doors when the train length exceeds the distance between the airlock doors. The new procedures require the locomotive operators to use their hand-held radio to communicate with each other during the car separation procedure, and the motorman passing through an airlock must open and close the airlock door for themselves.
