REPORT OF INVESTIGATION

Fatal Explosion of Gas
July 29, 2016

Road Fork #51 Mine
Spartan Mining Company, LLC
Pineville, Wyoming County, West Virginia
ID No. 46-01544

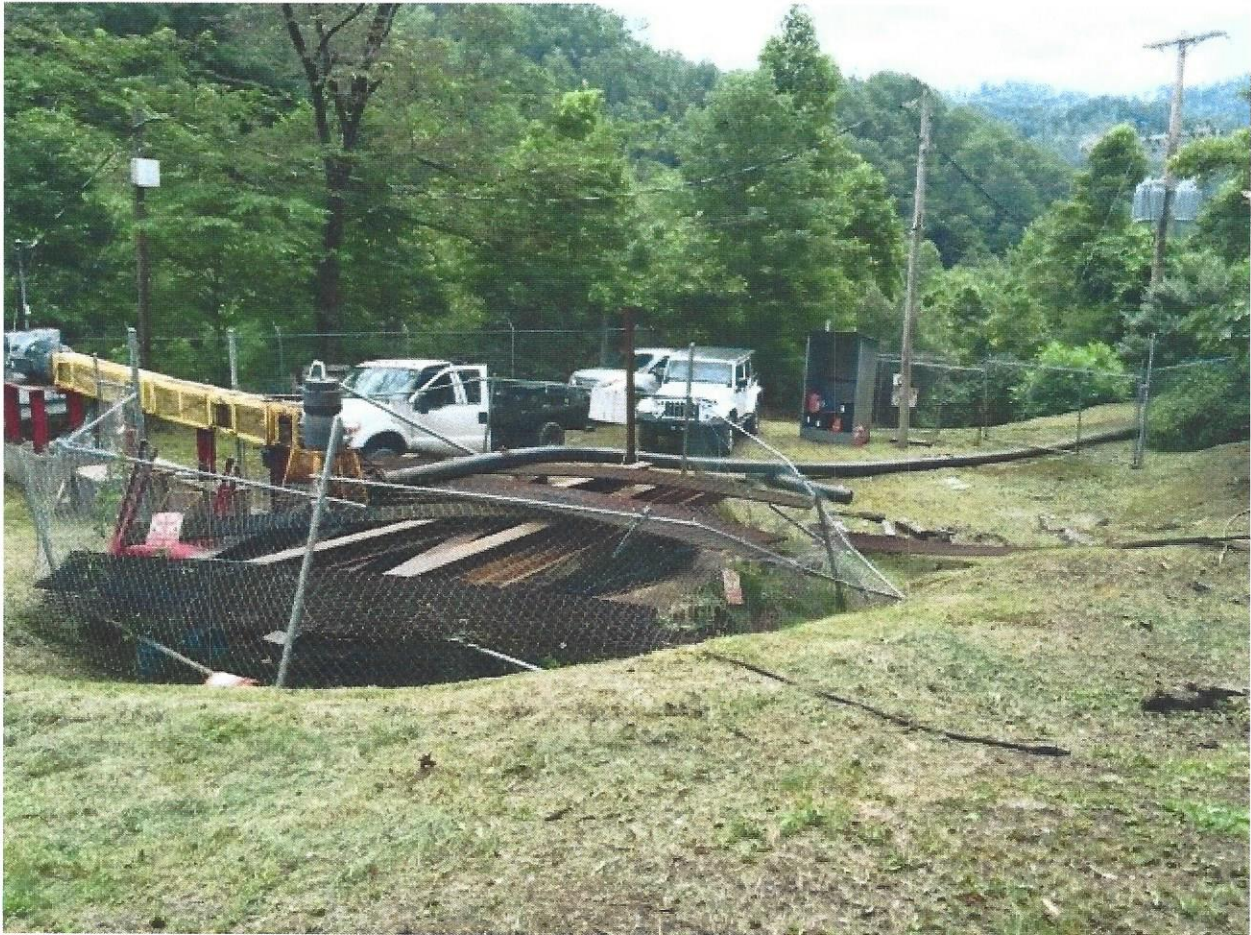
PHOTO OF ACCIDENT SCENE

An explosive mixture of methane gas was ignited when sparks or smoldering metal from the welding operations fell into the shaft. The ensuing flames and forces of the explosion exited through the surface opening. The exact force of the explosion was not determined, however, it moved steel I-beams weighing 1,240 pounds and the heavy gauge expanded metal grating they supported several feet. One piece of the expanded metal grating was propelled outside the #3 shaft perimeter fencing approximately 29 feet.

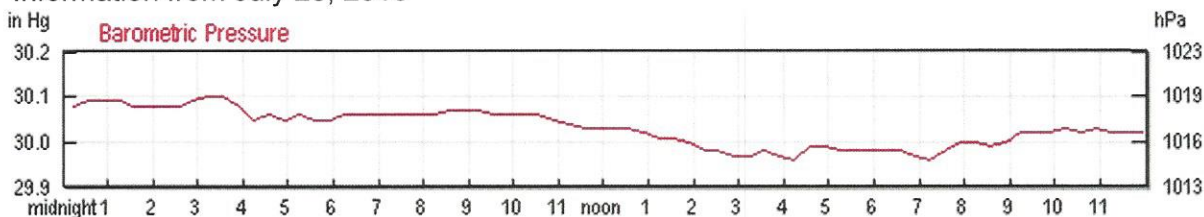
Information from July 28, 2016

The accident investigation team was not able to determine the exact source of the methane gas in this shaft, but, evidence from analytical data obtained in the #3 shaft indicates that one or all of the previously intersected coal seams are potential sources of methane. The #3 shaft had no means of ventilation, so only naturally occurring, barometric pressure changes reduced or increased the amount of methane gas in the #3 shaft.

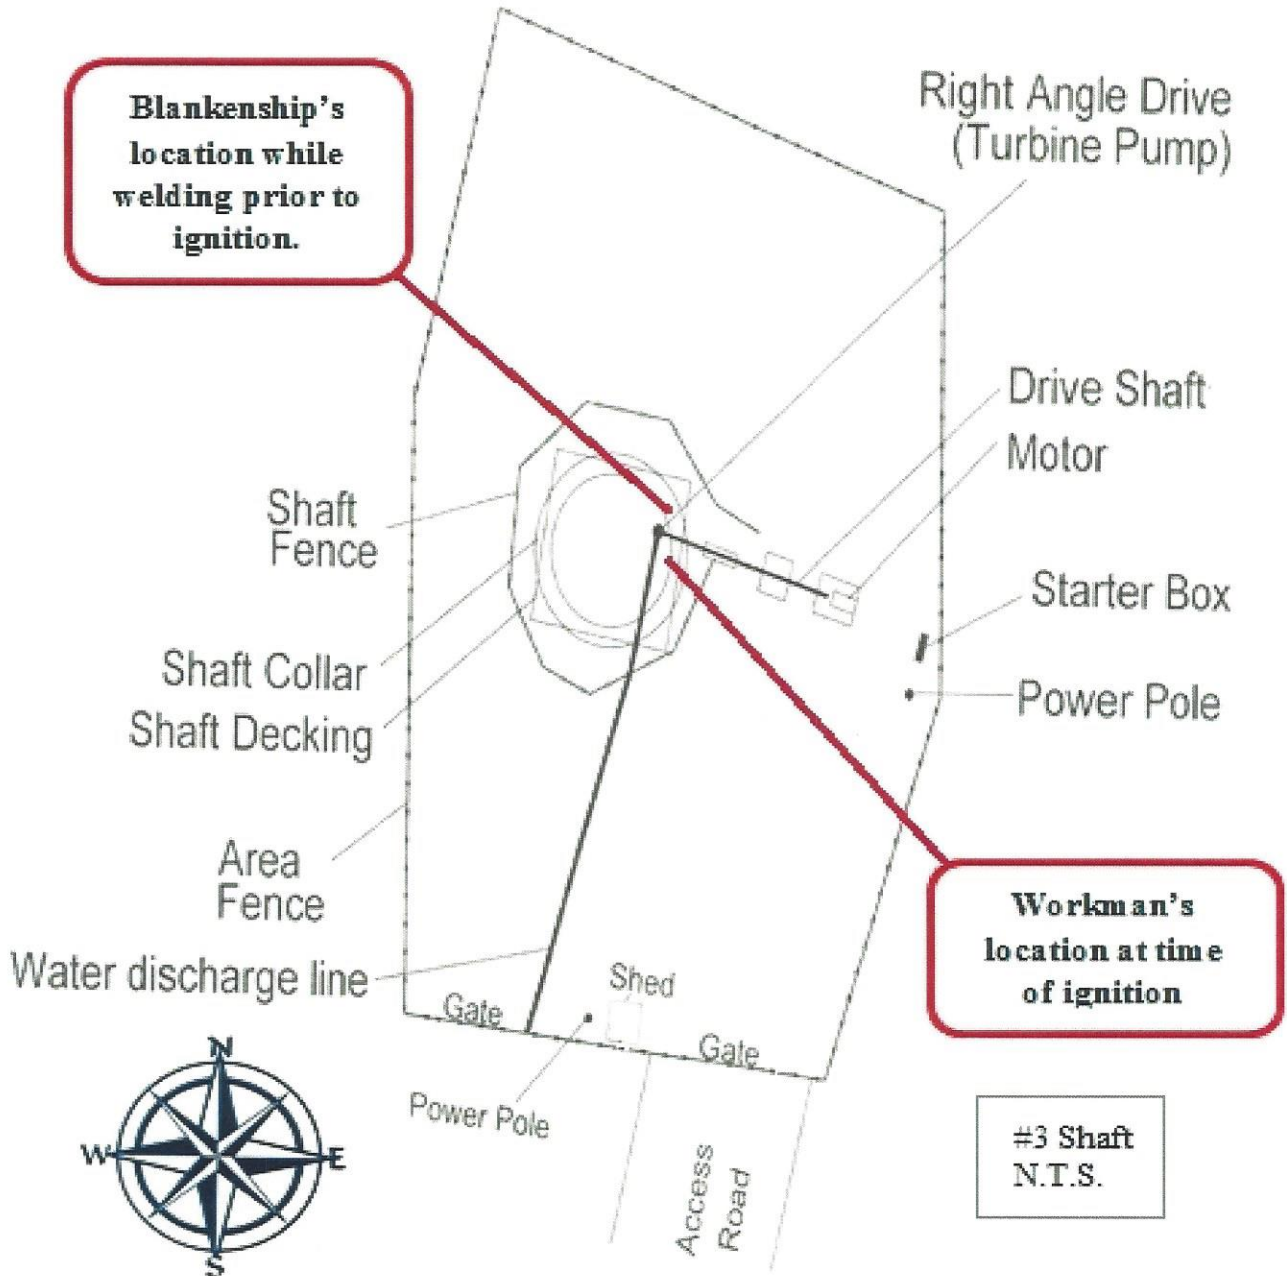
Overhead View Sketch of the #3 Shaft

The #3 pump is installed in a raised bore shaft that was developed in the 1970's to ventilate the original Pocahontas #3 Seam Mine. A total of eighteen seals, constructed near the bottom of the slope, separate the active workings from the worked out area containing the #3 shaft. The #3 pump is installed in the 753 foot deep shaft to pump water from the sealed area so it cannot impound against the seals. The water level was measured, according to company examination records, at least once each week and the pump was turned on or off according to the water level. The approved ventilation plan requires a column of water to be maintained between 34 to 36 feet deep from the bottom of the #3 shaft. This water seal isolated the sealed area and the outside atmosphere. All eighteen seals are 50 psi Minova Tekseal seals that were approved on September 8, 2006. An overhead view sketch of the #3 shaft is located in Appendix D.

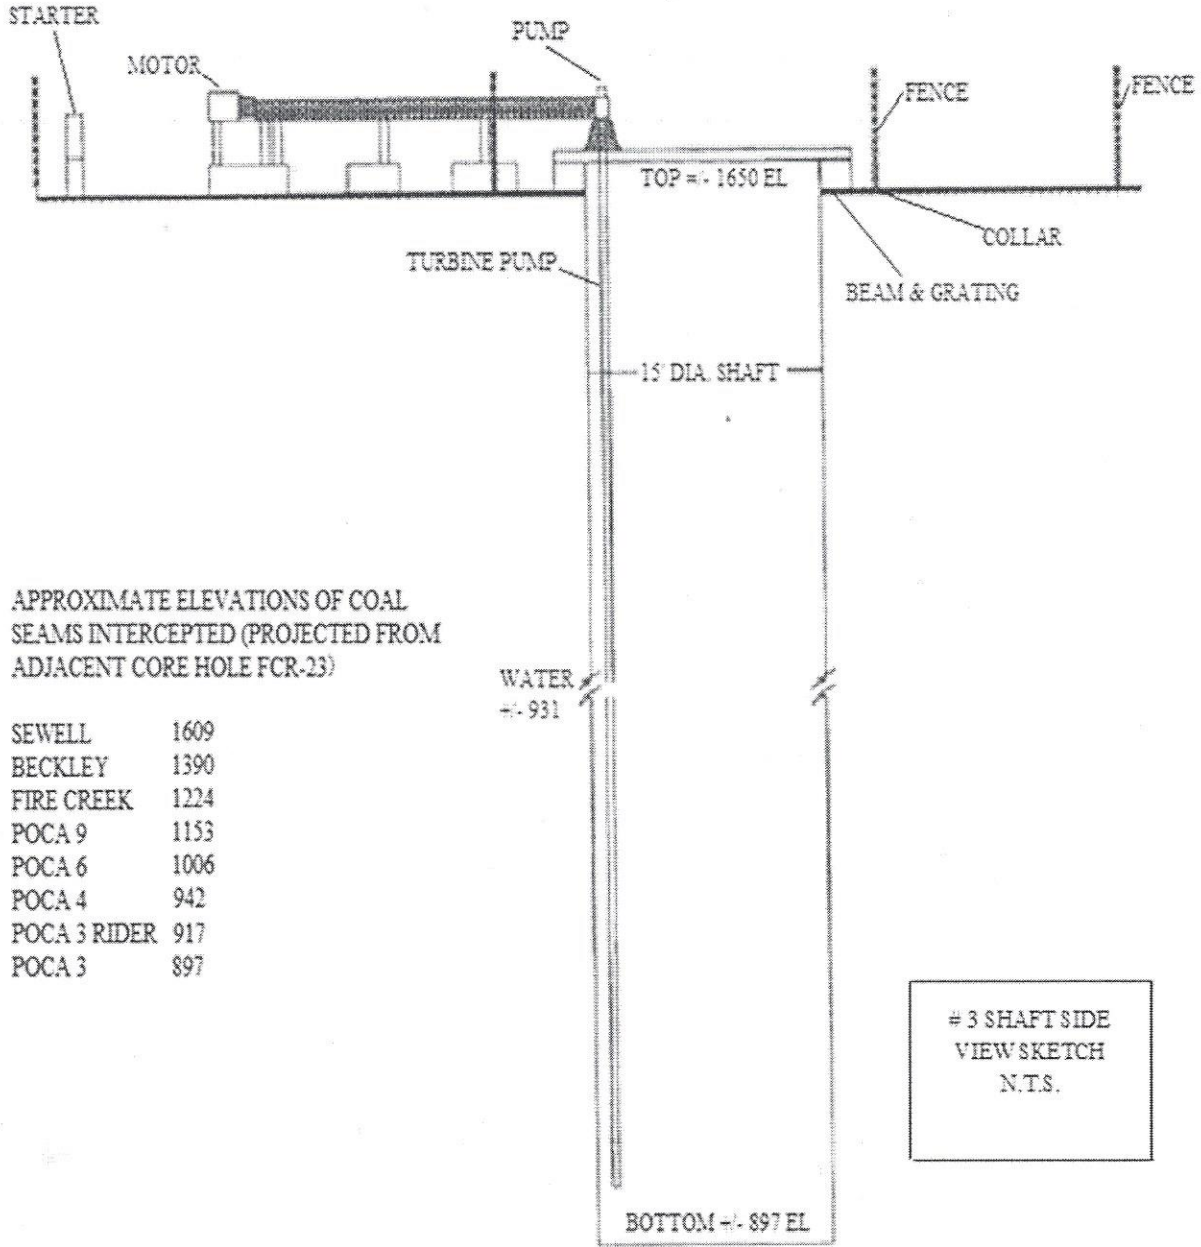
Side View Sketch of the #3 Shaft

As indicated in the side view sketch of the #3 shaft (See Appendix E), seven coal seams were intersected before reaching the Pocahontas 3 seam. On August 1, 2016, MSHA lowered a multi-gas detector into the #3 shaft. From 10 feet to 20 feet deep, 2.8% methane was detected. Analytical results of an air sample collected August 02, 2016, at 700 feet below the collar of the #3 shaft opening indicated the presence of 0.0% methane and 20.83% oxygen. At approximately 600 feet down the #3 mine shaft, the results indicated 4.08% methane and 19.83% oxygen. Methane was also present at depths of 350 feet and 50 feet (see Appendix B).

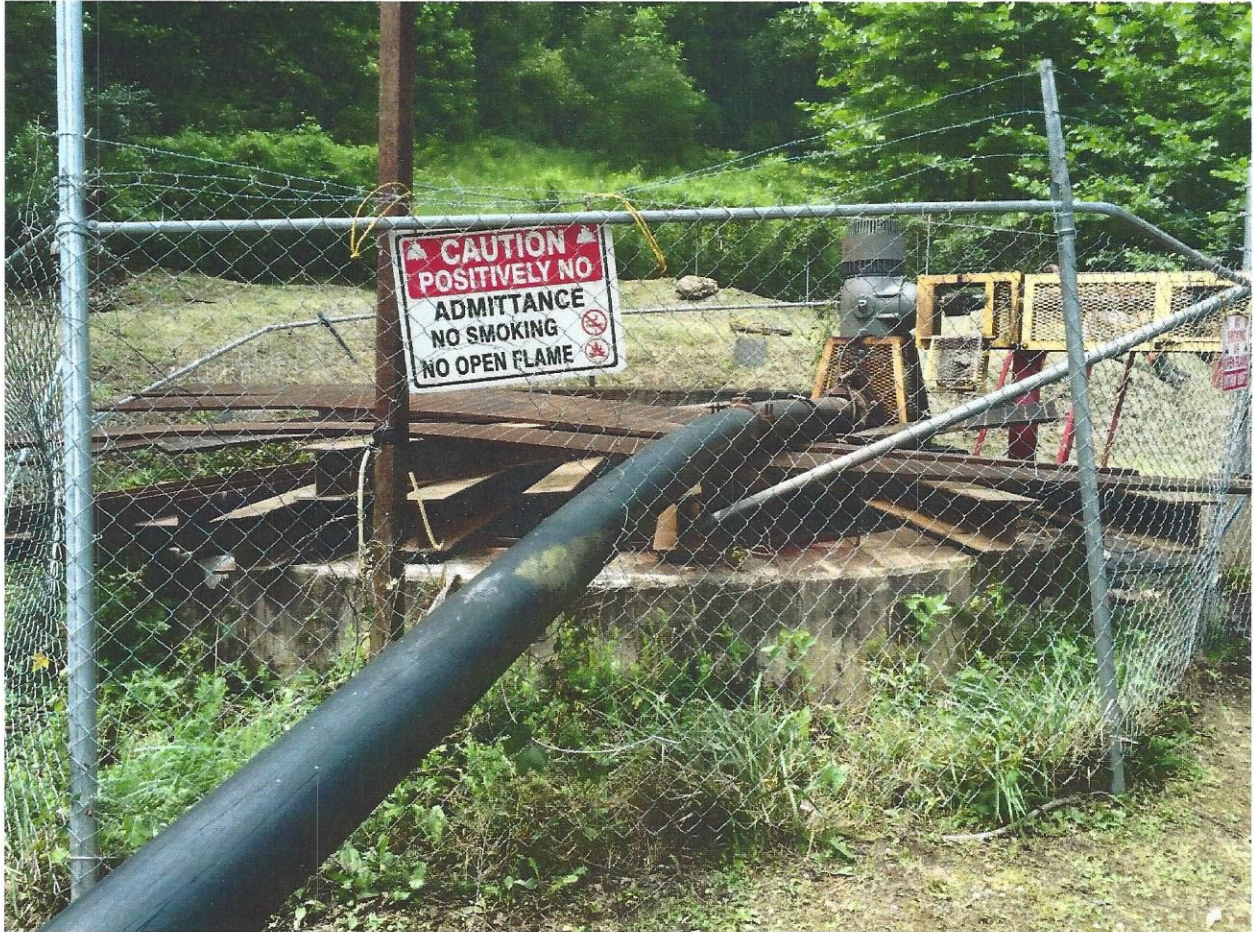
Photograph of Accident Scene

At least four prominent signs stating "no smoking or open flames within 100 feet" were present on the inside perimeter fence surrounding the #3 shaft. No effort to shield the area above the #3 shaft to prevent sparks and or smoldering metal from entering the shaft was made. Examinations conducted did not assure that methane gas was or was not present throughout the entirety of the shaft.

Corrective Action: After the accident, the operator submitted an addendum to the ventilation plan and it was approved by MSHA. This addendum lists safety precautions regarding the #3 shaft. The safety precautions include, but are not limited to, the following: No flame cutting, welding or grinding within 35 feet of the #3 shaft is permitted. If cutting or welding is needed within 35 feet of the shaft, a barrier will be installed to prevent sparks or hot slag from entering the shaft. Also, a cutting and welding plan shall be submitted to MSHA and must be approved by MSHA before cutting and welding is performed. Furthermore, the shaft will be continuously ventilated at all times. The shaft will be continuously monitored for methane at depths of 50 feet, 350 feet, and 550 feet any time work is done on the site. Work will be stopped if methane is detected at 1% or greater.
