REPORT OF INVESTIGATION

Fatal Powered Haulage Accident
May 18, 2017

Pinnacle Mining Company, LLC
Pinnacle Mine
Wyoming County, West Virginia
ID No. 46-01816

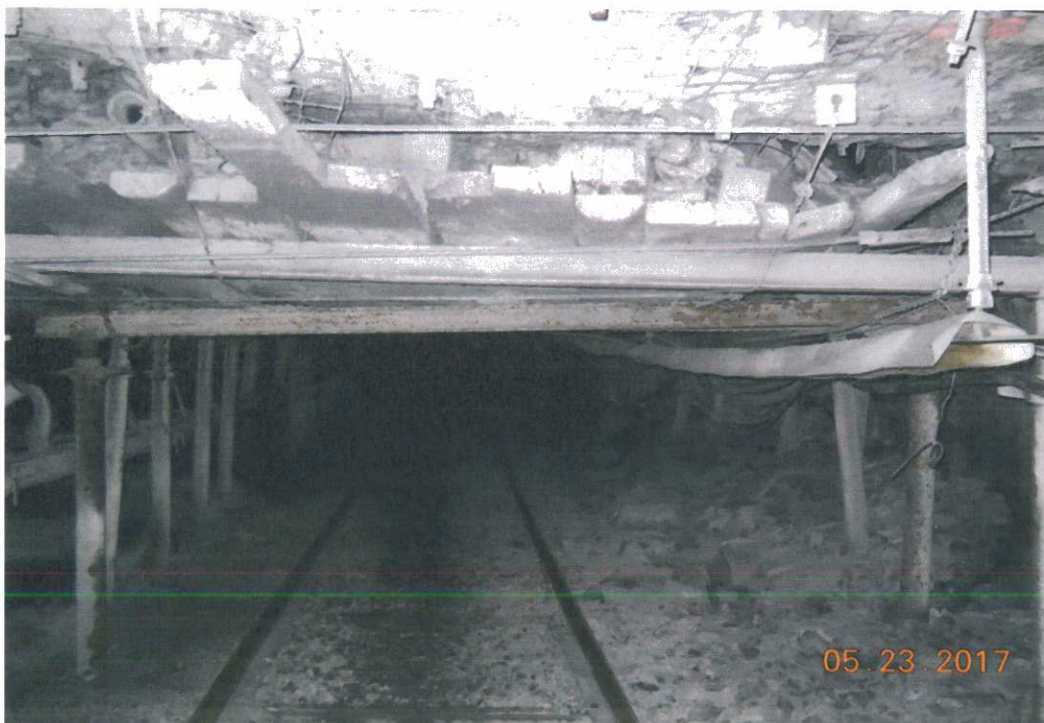
PHOTO OF ACCIDENT SCENE

On May 18, 2017, at approximately 11:00 p.m., Luches Rosser, a 44-year-old Outby Utility Miner, with 6 years of mining experience, received fatal injuries when his head struck a steel beam installed as supplemental roof support. He and another miner were traveling in a trolley-powered supply locomotive when the accident occurred. Rosser was operating the locomotive, which was in motion, when the trolley pole came off the trolley wire. He rose from his seat to grab the trolley pole to place it back on the trolley wire. After sitting back down, his head struck the steel beam. On May 19, 2017, at approximately 12:50 a.m., Rosser was pronounced dead.

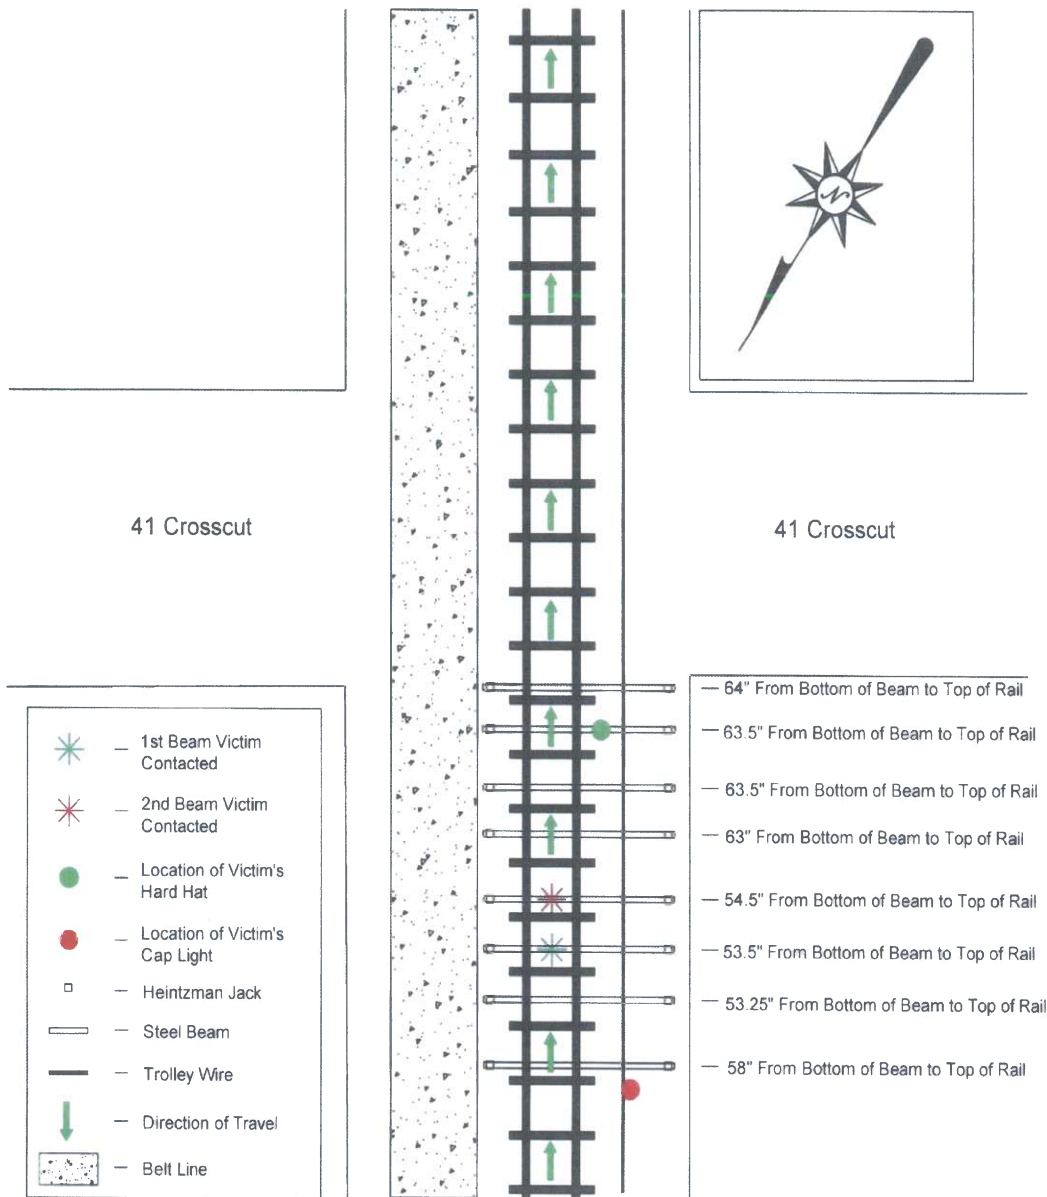
APPENDIX B Accident Scene

condensation. Investigators examined the trolley wire at the accident scene and there was nothing to indicate why the trolley pole came off the wire at this location. The operator had posted low clearance signs measuring only 3 inches by 3 inches approximately 4 crosscuts from the accident area. The distance between the steel beams in the accident area and the windshield of the No. 43 locomotive measures between 10 inches and 14 inches. Rosser would have had to lower his head by bending or leaning over to prevent his head from contacting the steel beams (see Appendices B and C).

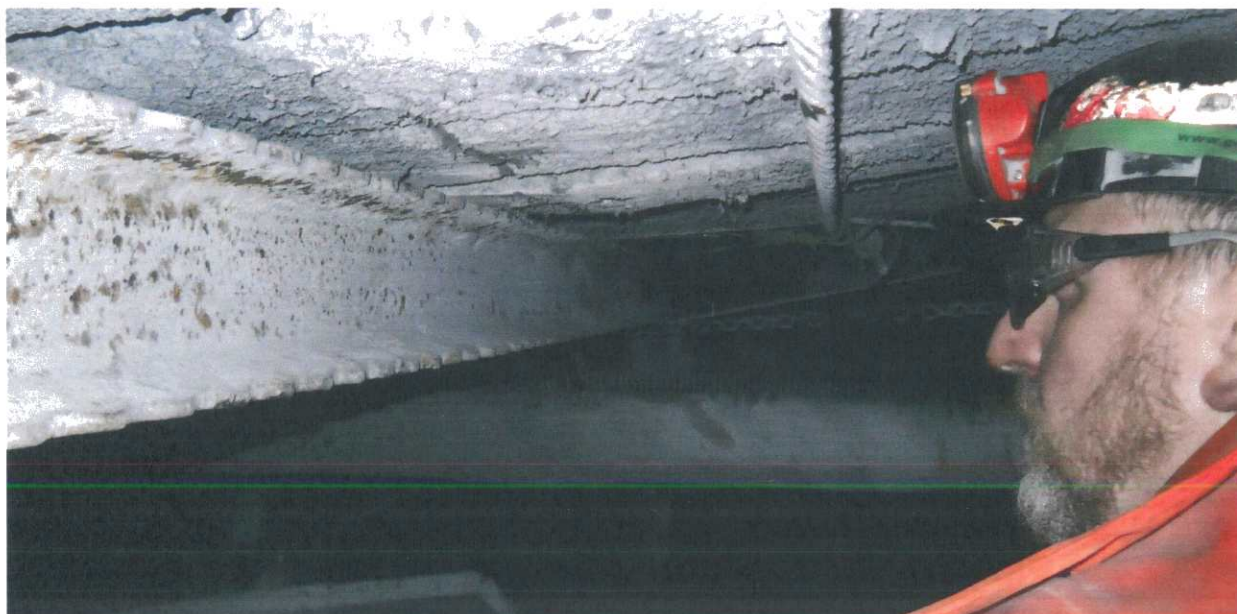
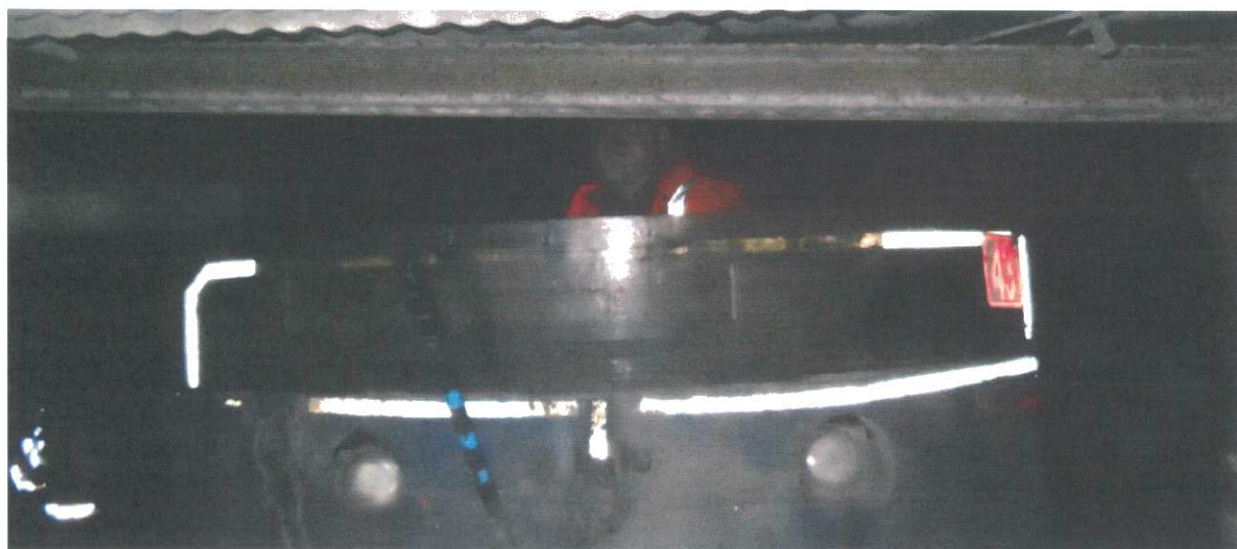
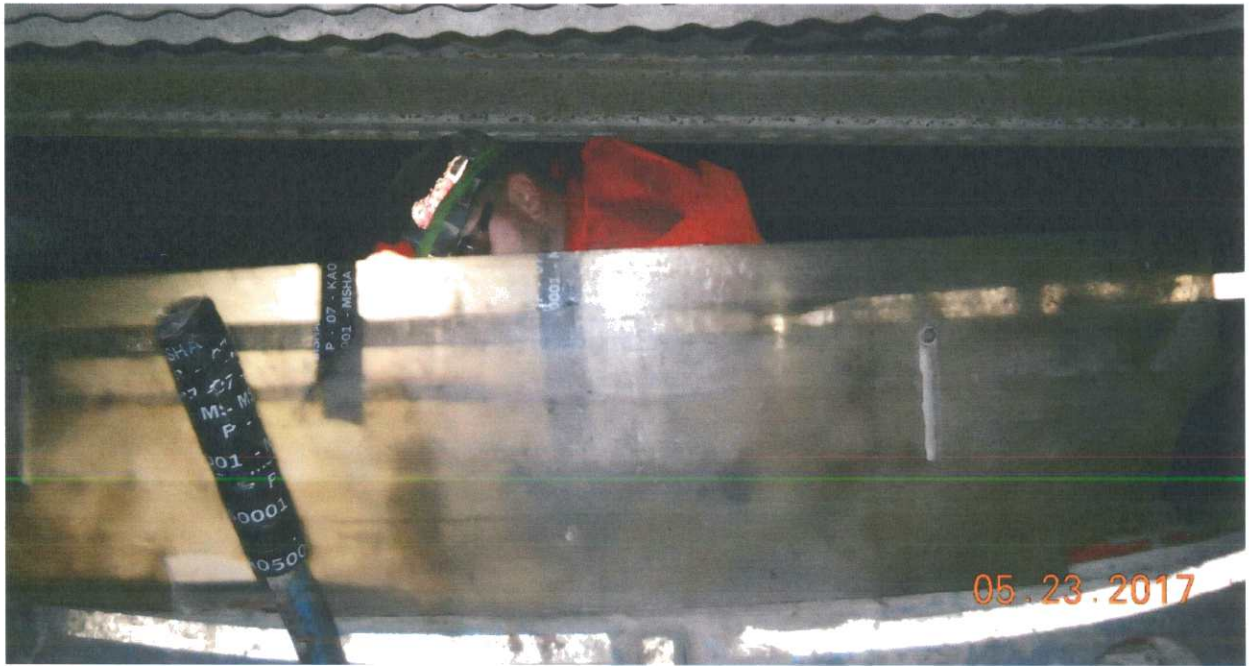
APPENDIX C

Photos that show the proximity of the locomotive operator to the steel beam

Corrective Action: The mine operator trained all miners who operate locomotives and all other track-mounted electric equipment. The training specifically included an instruction that when the trolley pole comes off the trolley wire, the track mounted vehicle must come to a complete stop and the parking brake set prior to placing the trolley pole back on the trolley wire.

Corrective Action: The operator re-trained all underground miners on the provisions of the safeguard no. 3991332 issued August 21, 2013, and on the track haulage training plan.
