REPORT OF INVESTIGATION

Fatal Machinery Accident
July 25, 2017

New St. Nicholas Breaker
Reading Anthracite Company
Pottsville, Schuylkill County, Pennsylvania
ID No. 36-01966

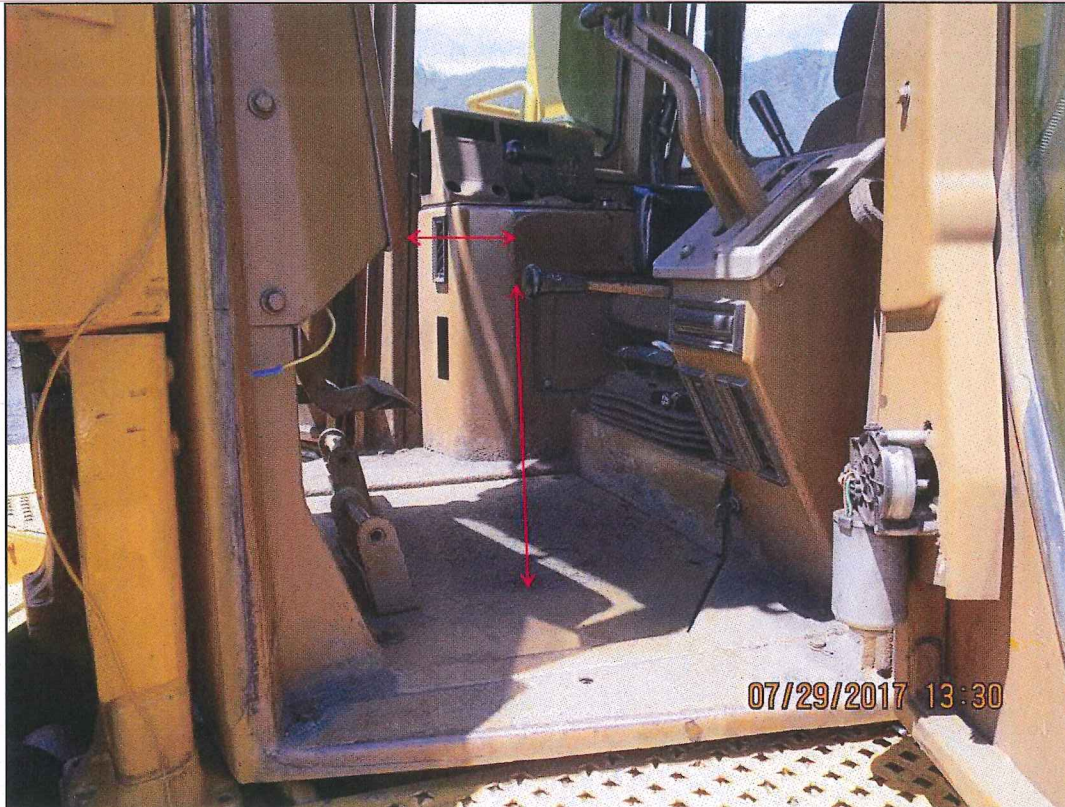
Picture 1

The parking brake control lever is designed so that it partially obstructs the exit door of the bulldozer when the parking brake is in the released position. This serves as a visual reminder to the operator to remain in the cab of the bulldozer until the parking brake is

fully engaged. In the released position, the parking brake lever is parallel with the cab floor and approximately 15 $\frac{3}{4}$ inches above the cab floor and approximately 5 $\frac{3}{4}$ inches from the dash panel (see Appendix B, Picture 1).

Parking brake lever in the released position showing partial obstruction of the exit path where the bulldozer operator exits the cab.

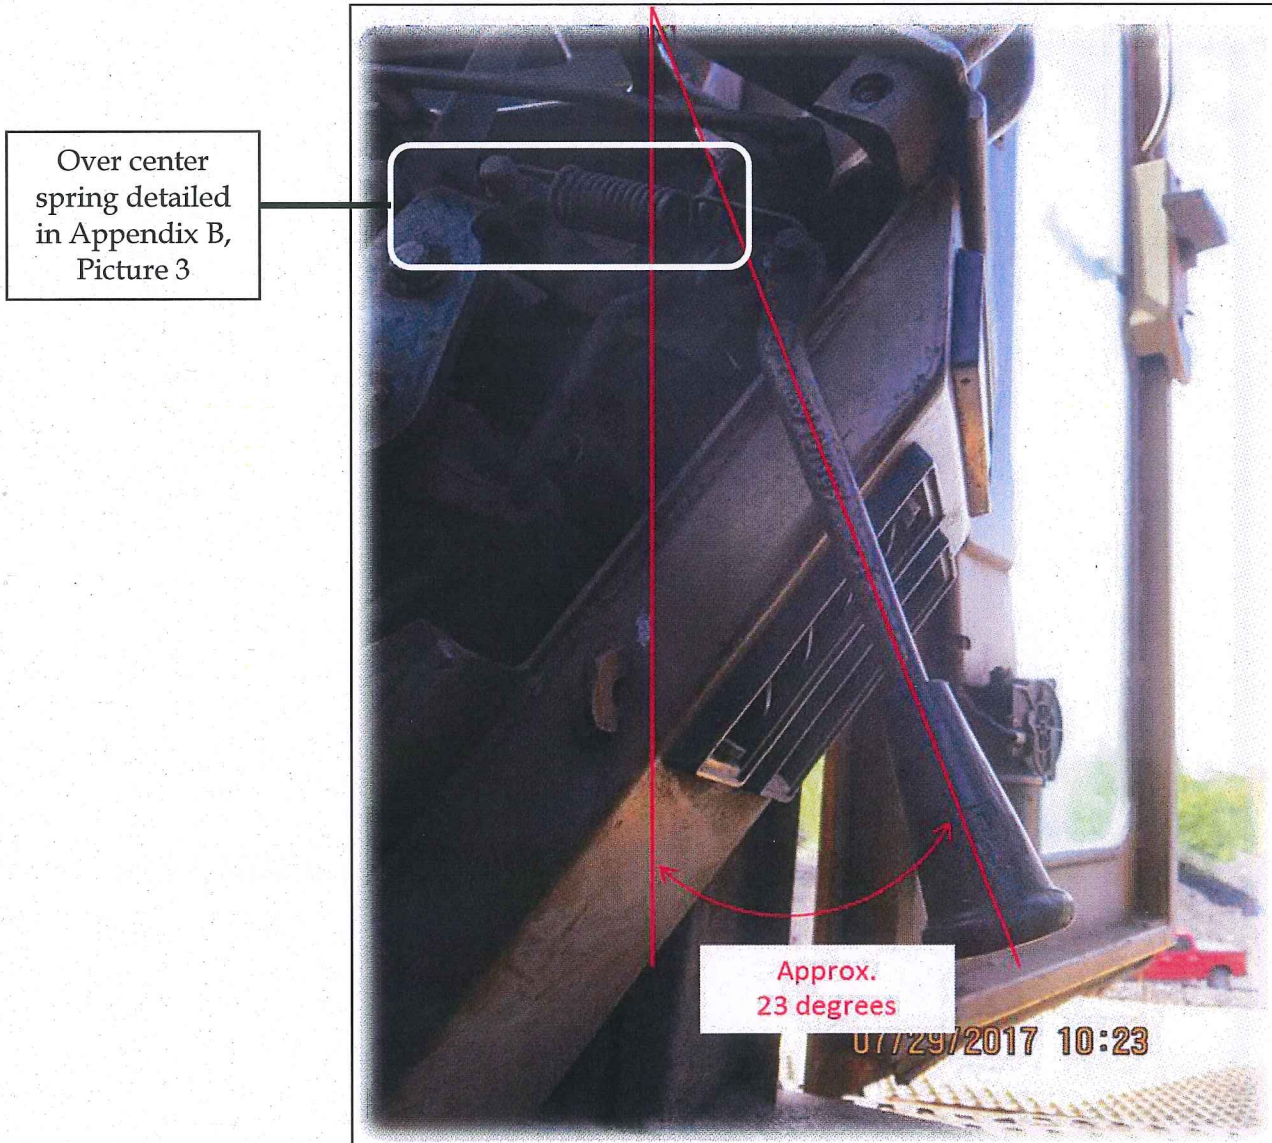
Picture 2

- The parking brake had a “stay point” range where the lever was on the applied side of the parking brake linkage overcenter spring, but was not being pulled into the fully applied position by the overcenter spring. The parking brake would be applied, but the lever would not be snapped completely into position.

Example of 23 Degree "Stay Point" Range of Parking Brake Lever.

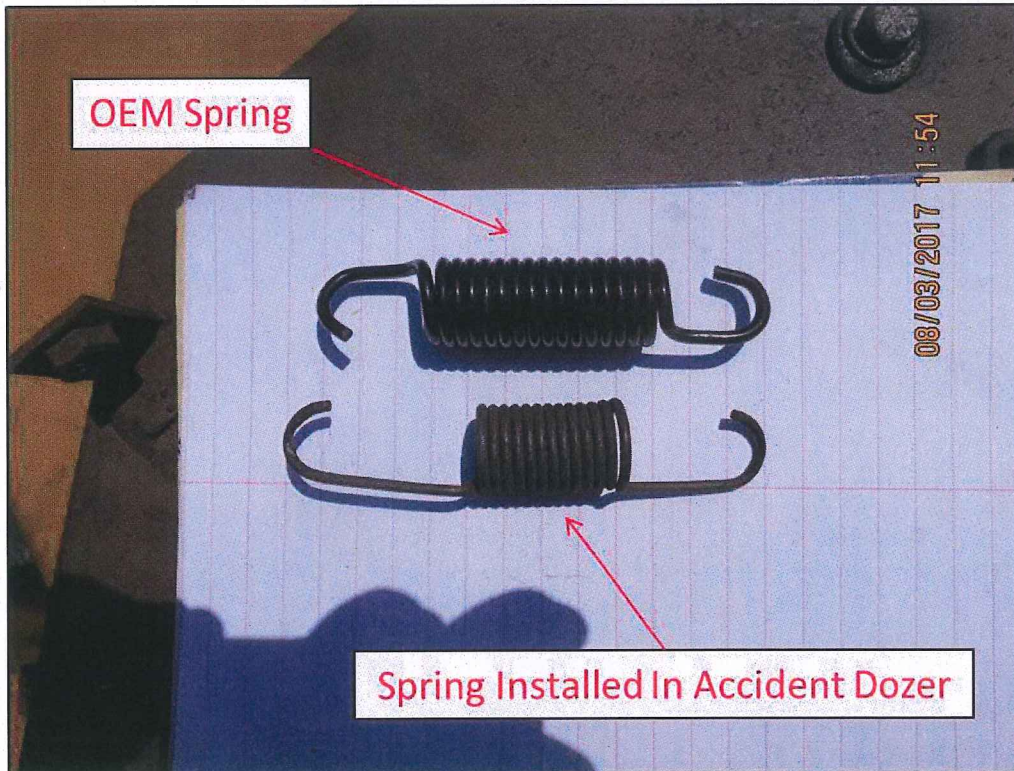
Picture 3

MSHA Technical Support determined that the problems with the operation of the parking brake assembly were due to an incorrect overcenter spring installed in the assembly. This spring provided considerably less spring force than the OEM overcenter spring and made it easier for the parking brake lever to move to the released position. The lever force test demonstrated that replacing the incorrect overcenter spring raised the hand force requirements from approximately 1 pound of force to approximately 6 pounds of force. Photographs taken of the bulldozer, before it was purchased, and when it was transferred to the equipment dealer, indicate that the general condition of the parking brake lever linkage existed prior to the mine operator purchasing the bulldozer. The lack of a positive spring and linkage action to firmly hold the parking brake control lever in the applied position could have contributed to the accident had the victim engaged or attempted to engage the parking brake and it did not hold (see Appendix B, Pictures 3 and 4).

Brake lever over center spring comparison.

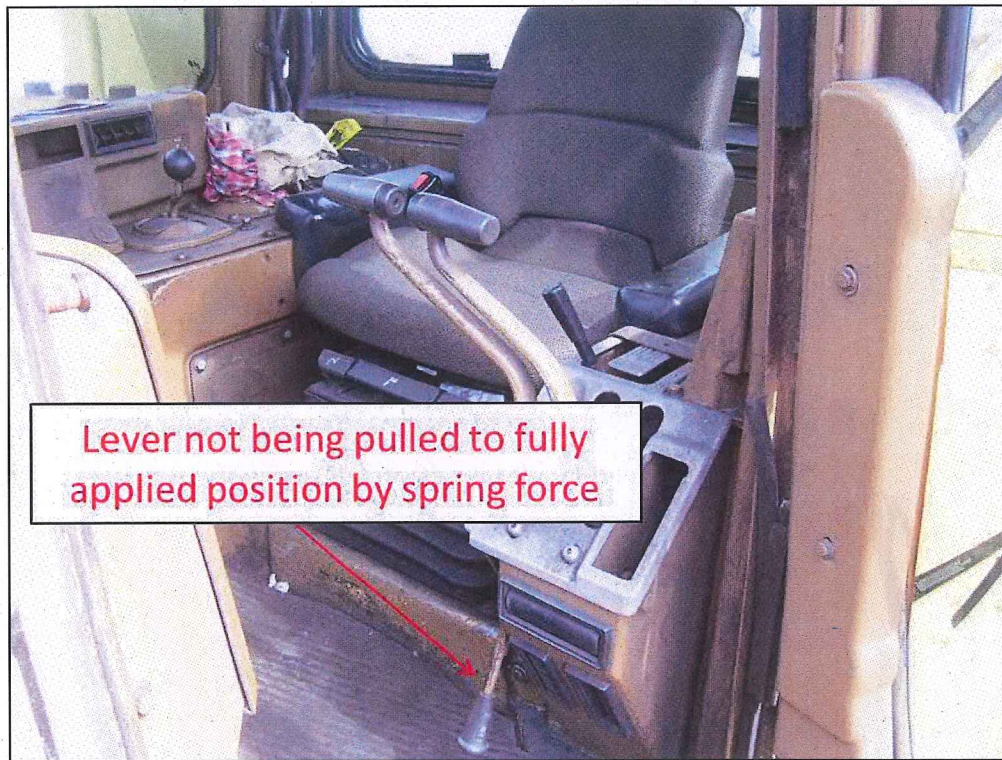
Picture 4

Photograph of Cab Interior Prior to Bulldozer Being Purchased by the Mine Operator Showing Relative Position of the Parking Brake Lever with the Transmission Selector Lever in Neutral (N).
