REPORT OF INVESTIGATION

Surface Area of Underground Coal Mine

Fatal Falling, Rolling, or Sliding Rock or Material of any kind Accident
August 3, 2017

Deserado Mine
Blue Mountain Energy Inc.
Rangely, Colorado
ID No. 05-03505

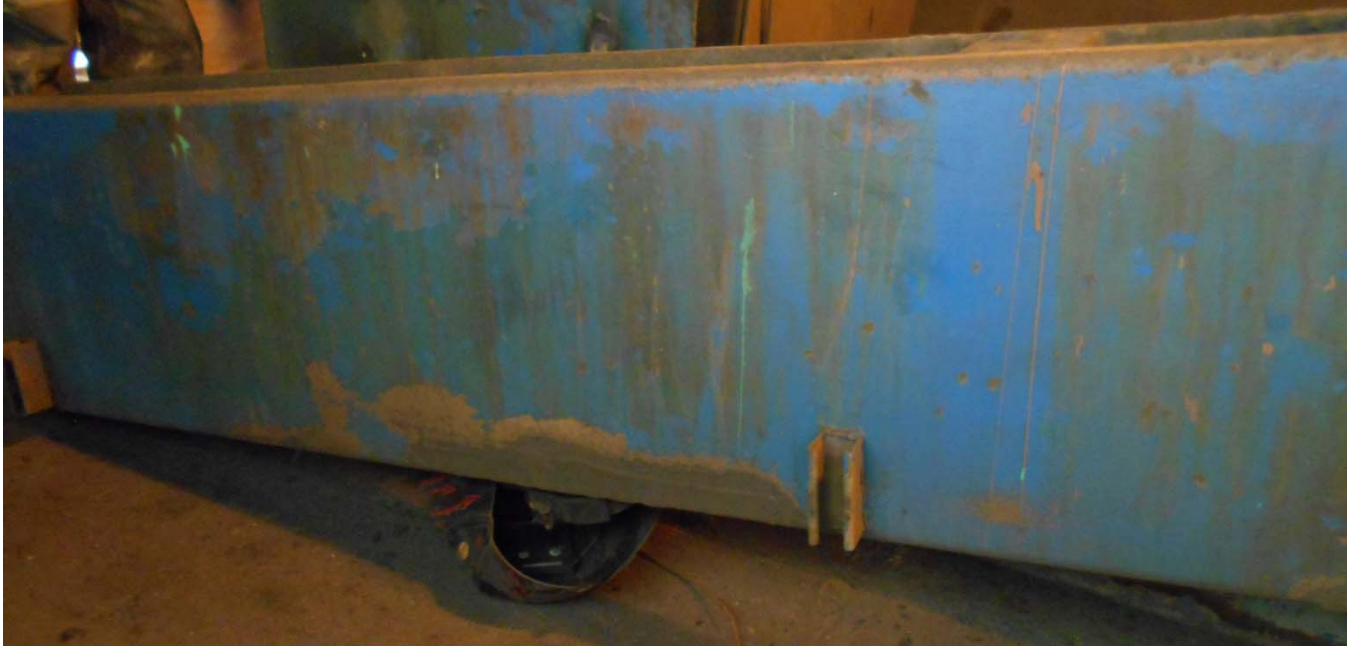
PHOTO OF ACCIDENT SCENE

On Thursday, August 3, 2017, at approximately 1:30 a.m., Jason Stevens, a 32-year-old surface preparation plant mechanic with 12 years of mining experience, received fatal injuries while he was dismantling a 1,400 pound water box associated with the rotary filter. The water box fell and struck Stevens, pinning him to the floor.

The accident occurred because the mine operator did not ensure that the water box being dismantled was securely blocked against motion during the process.

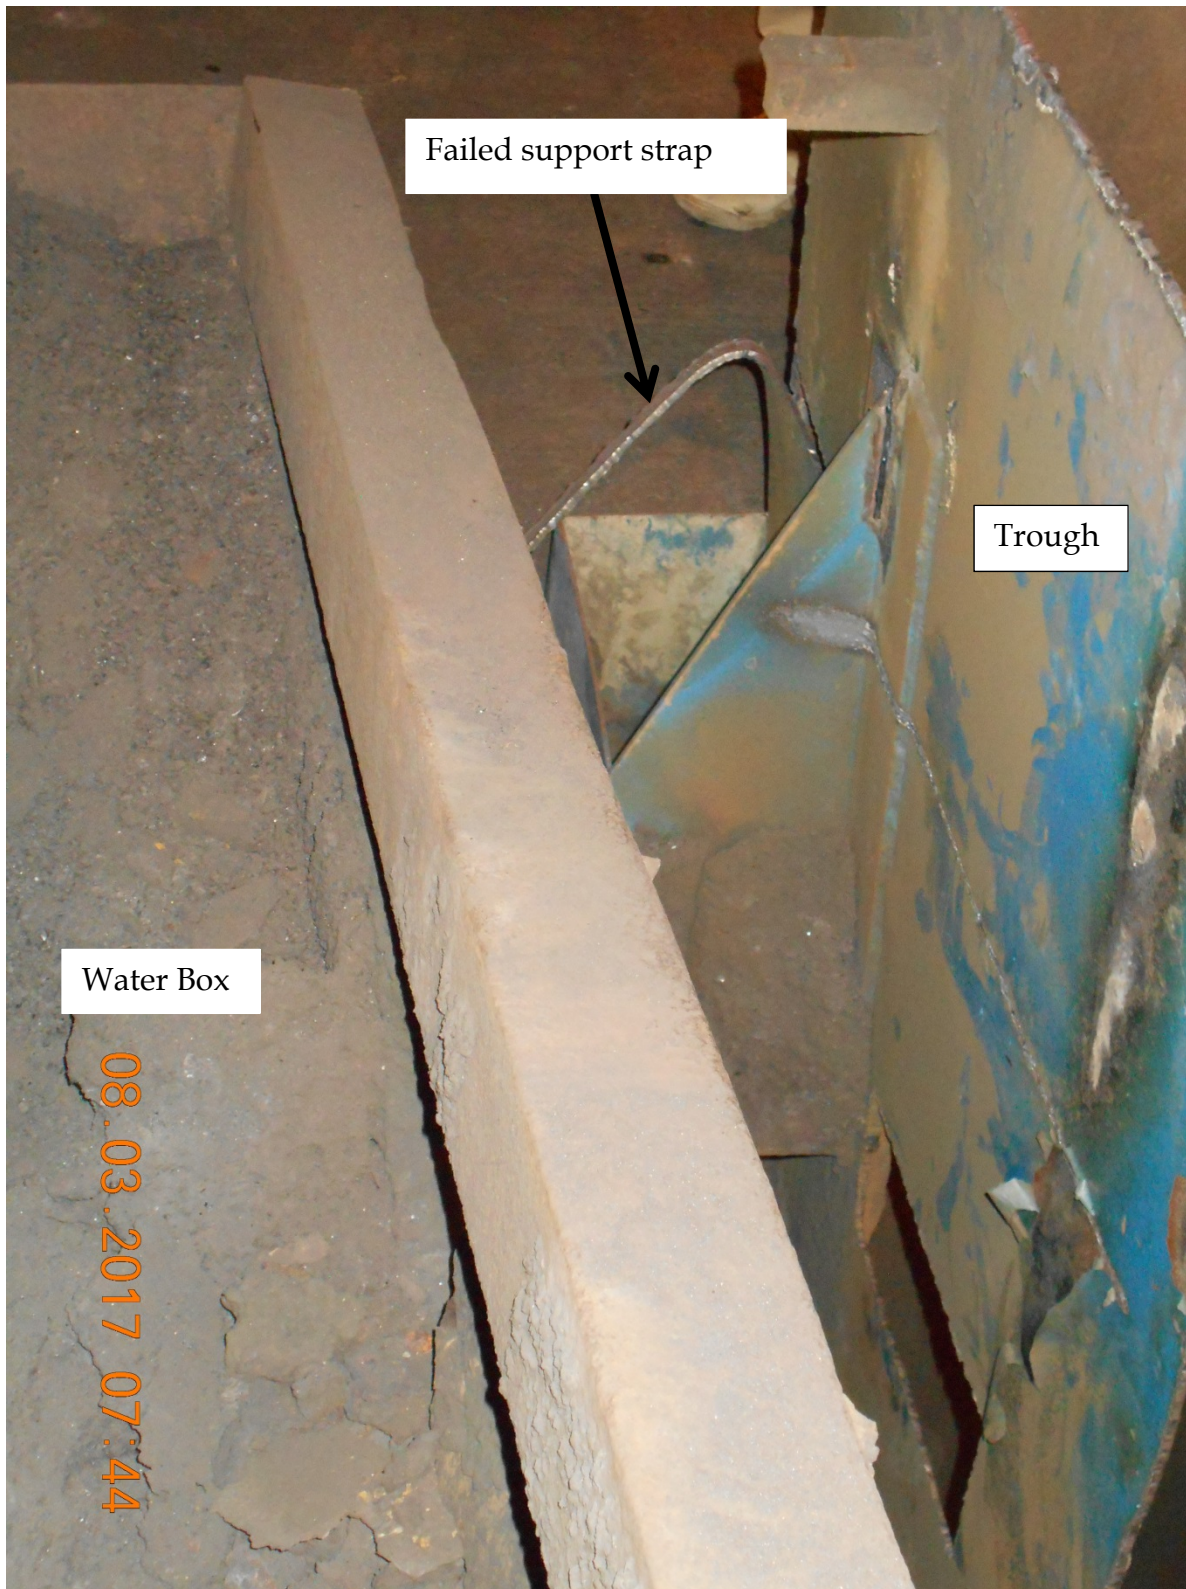
Photo #1 East end of water box

On the day of the accident, Stevens was planning to continue dismantling the filter. He had previously removed the filter assembly but the water box still needed to be dismantled. He used a plasma cutter to cut the metal water box into smaller manageable pieces, and then lowered them from the 3rd floor to the 2nd floor. Stevens had made cuts along the trough underneath the filter housing to allow the water box to separate. He left 1-inch wide strips of metal on both ends in an apparent attempt to hold the water box in place as it was being dismantled. The east end of the water box was attached to the filter tub. Stevens had made a cut in this area to separate the water box from the filter tub. After the cuts were made, the box was only supported on the east end by a 1-inch wide strip of metal that tapered down to $\frac{3}{4}$ inches wide. The accident occurred when the water box shifted and fell on top of Stevens (see Appendix B). Adequate blocking material had not been installed to support the water box.

Investigators determined from the location of Stevens' body that he had positioned himself under the water box. The east end of the water box fell approximately 29 inches, pinning Stevens' upper body to the floor. The mine's engineering department estimated that the water box weighed about 1,400 pounds.

When performing work under machinery or equipment that has been raised, the machinery or equipment is required to be securely blocked against motion. Instead of properly blocking the water box against motion prior to beginning to take it apart, Stevens depended on the 1-inch wide strip of metal he cut on the east end and the 3-inch wide strip on the west end to support the water box.

1. Root Cause: Mine management did not ensure that machinery or materials being worked on were securely blocked against motion prior to work being performed. The water box was cut loose from the trough and was not secured against motion. The metal strip that was left to hold the water box in place on the east end was not sufficient. This support allowed the water box to shift and fall on the victim

Corrective Action: Mine management developed a plan for the remaining dismantling of the preparation plant trough and trained all employees to ensure safe completion of the project. Management will continue to review plans with miners to ensure blocking against motion of all material and equipment in future projects.
