REPORT OF INVESTIGATION

Fatal Powered Haulage Accident
October 23, 2017

Marfork Coal Company, LLC
Horse Creek Eagle Mine
Whitesville, Raleigh County, WV
I.D. No. 46-09091

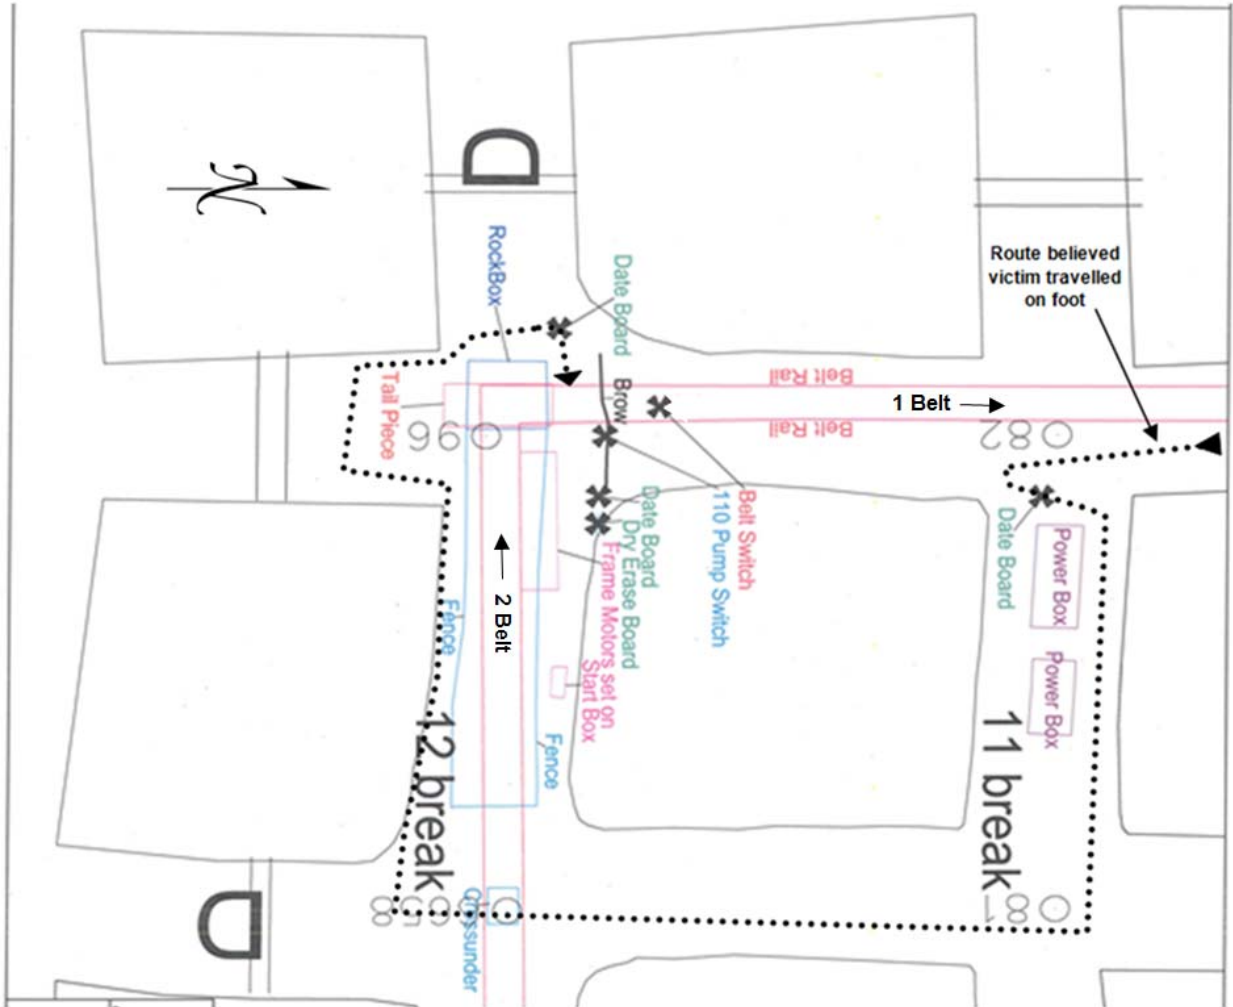
Appendix B
Drawing of No. 2 Belt Transfer
(Not to scale)

The mine tracking system shows that at 4:10 a.m., Adkins recorded the date, time, and his initials (DTIs) at the date board located at the No. 1 belt drive outside the mine belt portal. He then entered the mine and traveled along the conveyor belt, recording his DTIs at successive date boards. At 4:26 a.m., his final DTIs were recorded at the off-side of the No. 1 belt across from the No. 2 belt junction point. His DTIs were not recorded on the next date board, which was directly across the belt on the walkway side (see Appendix B).

Adkins parked his personnel carrier at the No. 9 crosscut on the No. 1 conveyor belt and traveled on foot to conduct the rest of his examinations. He traveled along the No. 1 conveyor belt from the No. 9 crosscut to the No. 11 crosscut, where he placed his DTI on the date board and checked the two power centers. He then used the crossunder at surveyor spad 6658 and walked behind the guard at the No. 2 belt drive and take-up unit, where he examined the offside of the No. 2 belt drive (see Appendix B).

After Adkins placed his DTI on the offside date board, he attempted to cross the No. 1 conveyor belt at the No. 1 conveyor belt tailpiece rather than returning to the crossunder, which was 95 feet away. As he attempted to cross, he fell onto the No. 1 belt at approximately the same time that the conveyor belt was started up. Adkins was then transported on the No. 1 conveyor belt out of the mine.

The No. 2 belt transfer, near where Adkins fell, was constructed with four-foot by eight-foot sheets of metal plating welded together to form a steel chute with angled deflector walls. This steel chute, called a "rock box," funneled mined material onto the No. 1 conveyor belt to minimize spillage. At this location, there were 37 ½ inches of clearance between the belt and the roof.

Investigators found smudges and chalk marks on the roof bolt plates above the belt directly in front of the rock box. This indicated that the plates had been used as handholds while the examiners crossed the belt. The tracks indicated that the

examiners stepped up on a water line lying beside the belt structure, stood on the belt structure, reached over to the roof bolt plates, and stepped across the conveyor belt onto the opposite belt structure and the ground. This crossing was apparently used as a shortcut instead of the nearest crossunder, which was 95 feet away (see Appendix B).

The belt was suspended from the roof by chains spaced every ten feet for the entire length of the belt. The clearance between the roof and the belt was as small as twenty inches, making it extremely difficult for a miner to exit the fast-moving belt after falling.

Corrective Action: The mine operator installed belt crossovers at all belt transfer points. These crossovers are located at the belt tailpieces and prevent the use of belt tailpieces as a means to cross the belts. All crossovers, mid-belt crossovers, and crossunders were evaluated and modified, relocated, added or removed as appropriate. All miners were trained to use these suitable belt crossing facilities.
