REPORT OF INVESTIGATION

Fatal Machinery Accident
December 29, 2017

Black Jewell, LLC
S-7 Surface Mine
Fayette County West Virginia
I.D. No. 46-07491

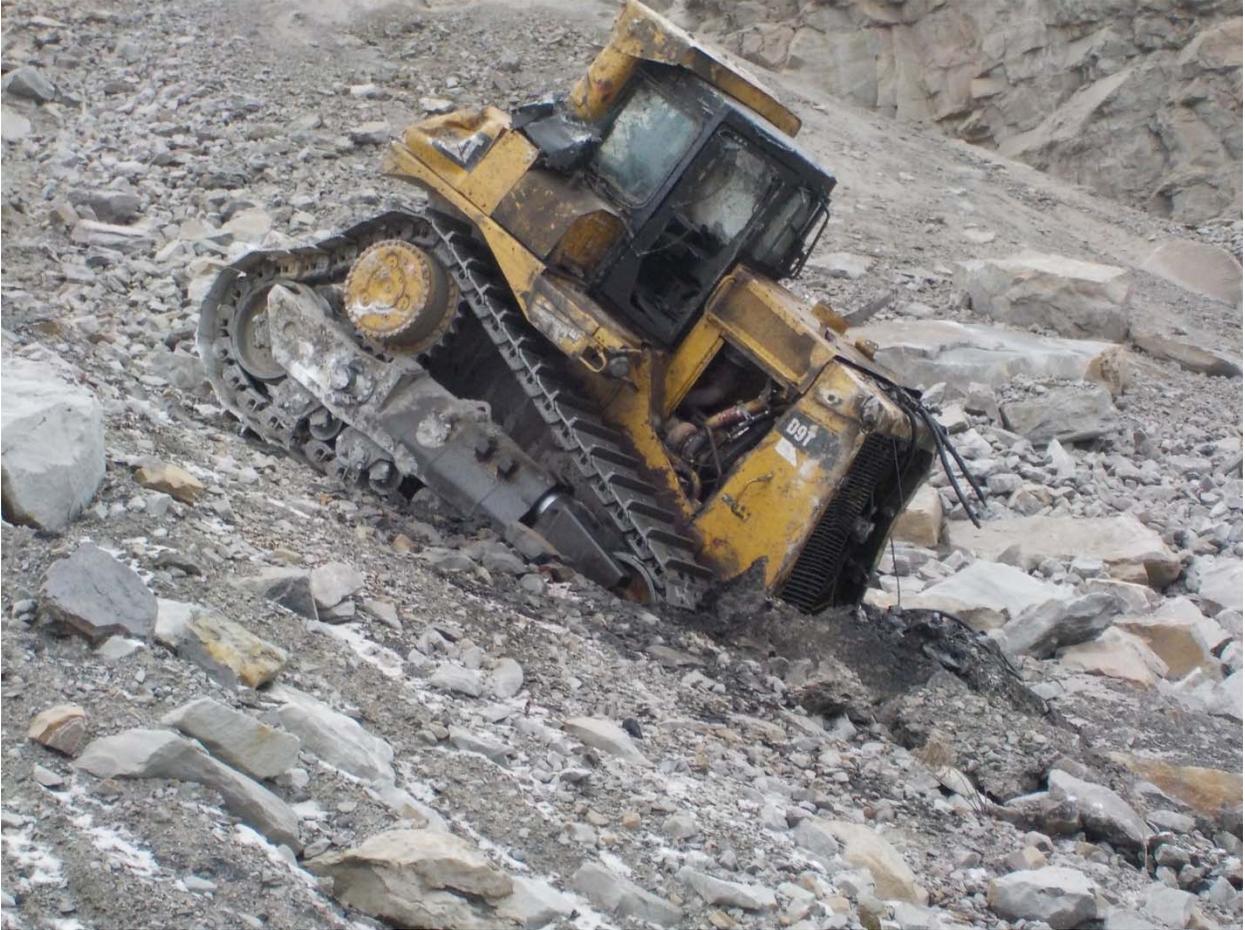
The Caterpillar D-9T bulldozer operated by Thurman Watts was working in the Winifrede Ryder Pit, pushing shot material over a crest of the highwall. After traveling over the highwall, the bulldozer dropped approximately 100 feet and continued down the spoil bank, coming to rest approximately 400 feet from the top of the highwall (see Appendix B).

Bulldozer after it fell

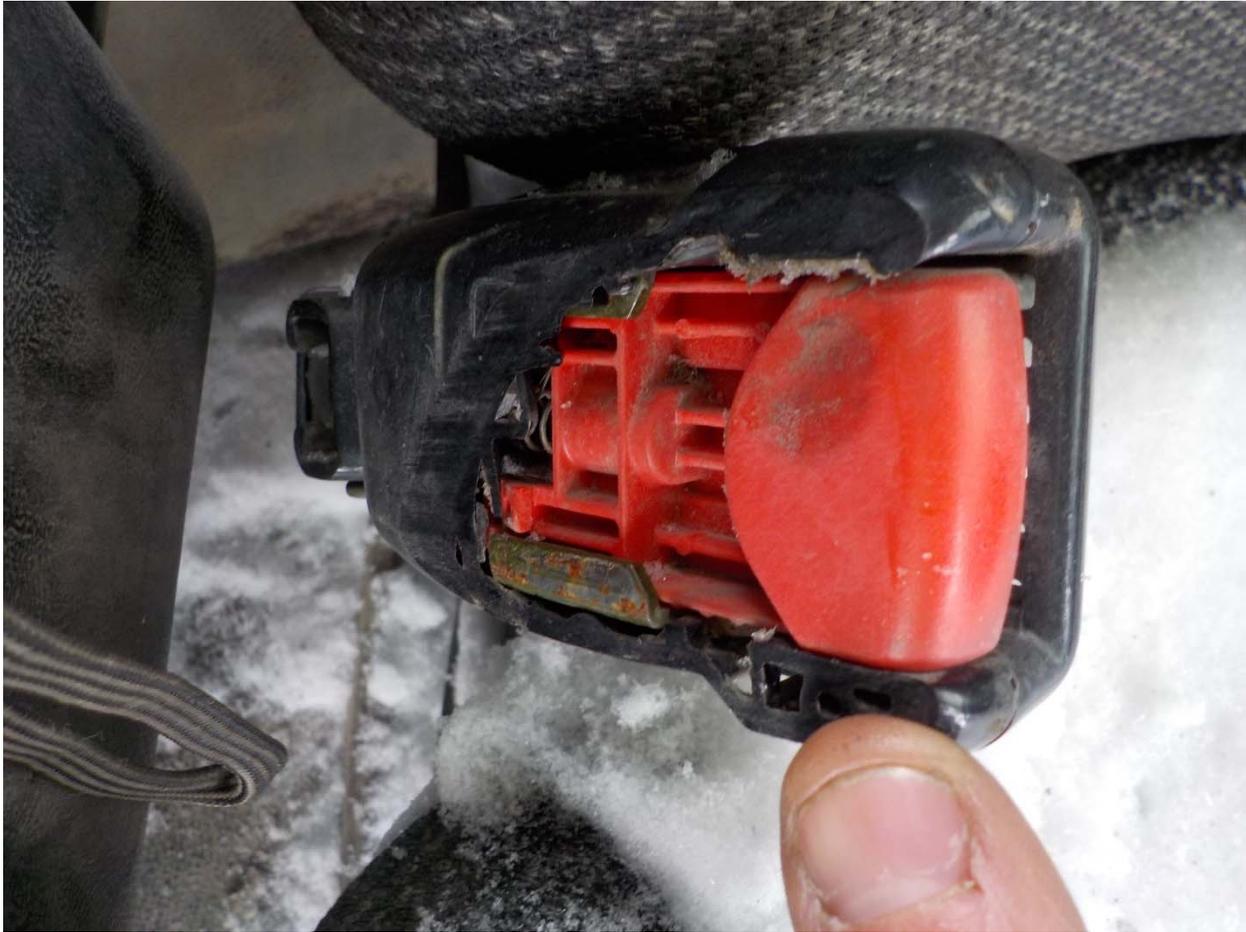
The rollover protective structure (ROPS) was not altered or damaged and the confines of the cab interior maintained its integrity. The outer plastic of the seat belt buckle or latch had broken off, exposing the seat belt inner mechanism (see Appendix B). The seat belt was tested and found to be functioning properly. Investigators found the seat belt unbuckled, however, they were not able to determine if the victim was wearing the seat belt at the time of the accident.

Broken Seat Belt Latch
