REPORT OF INVESTIGATION

Fatal Powered Haulage Accident
May 6, 2017

Rosebud Mine & Crusher/Conveyor
Western Energy Company
Colstrip, Rosebud County, Montana
ID No. 24-01747

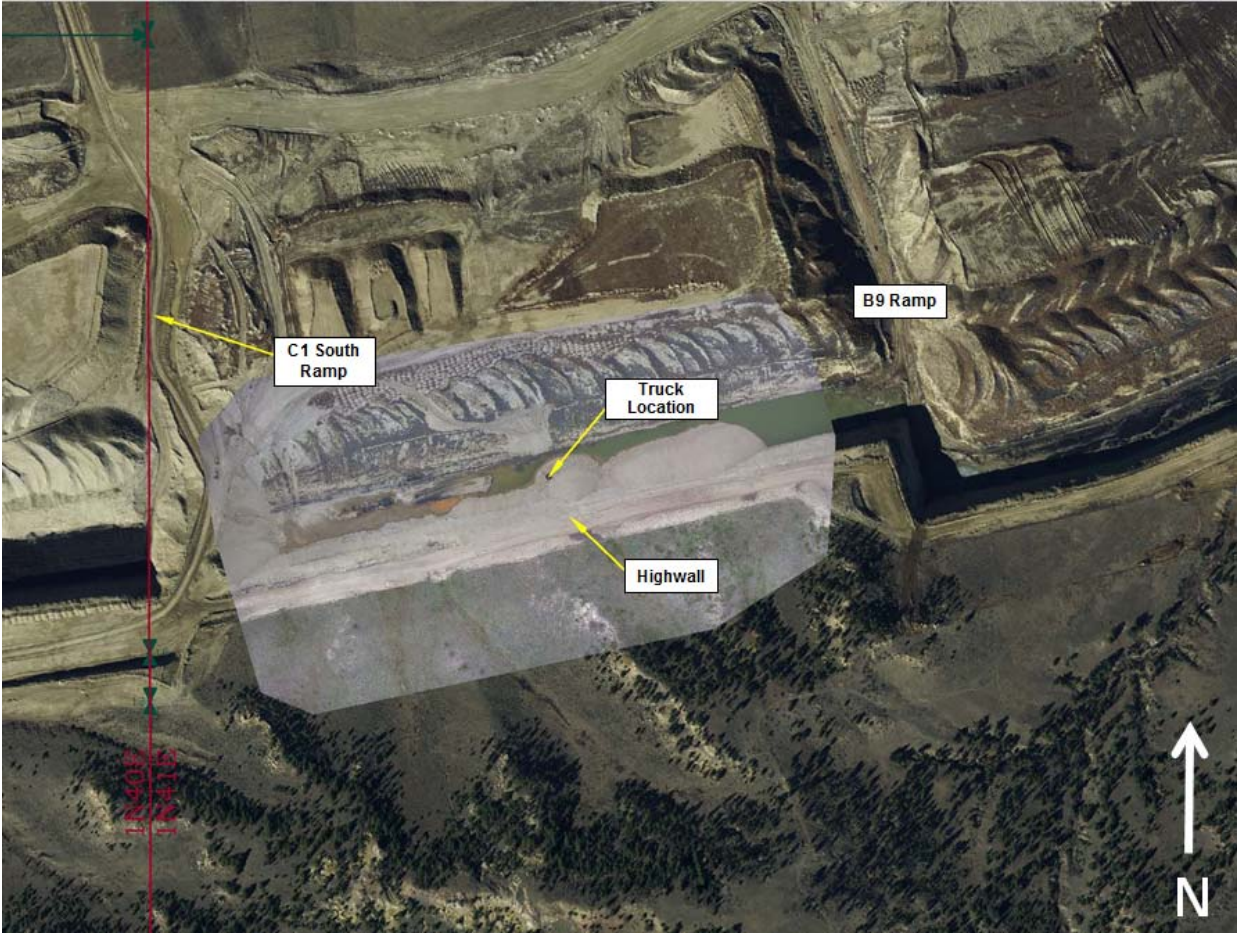
Appendix B
Map of Accident Site

The truck went over the highwall in Area B between the C-1 south ramp and B-9 ramp (see Appendix B). The highwall is at the boundary line of the mine permit. The haul road on top of the highwall is 50 feet wide. The haul trucks were using a right hand traffic pattern traveling east to west along the highwall edge. When the trucks reached the dump location they would turn left, backup to the edge, and dump over a berm. The berm, which consisted of soil and clay, was located at the edge of the highwall and measured four foot eight inches high by five foot six inches wide.

The ground where the truck was dumping failed, creating an opening at the edge of the highwall causing the truck to fall. The opening was approximately 24 feet wide and extended up to 10 feet back from the edge of the highwall. The operating width of a Cat 777 truck is 21 feet 4 inches.

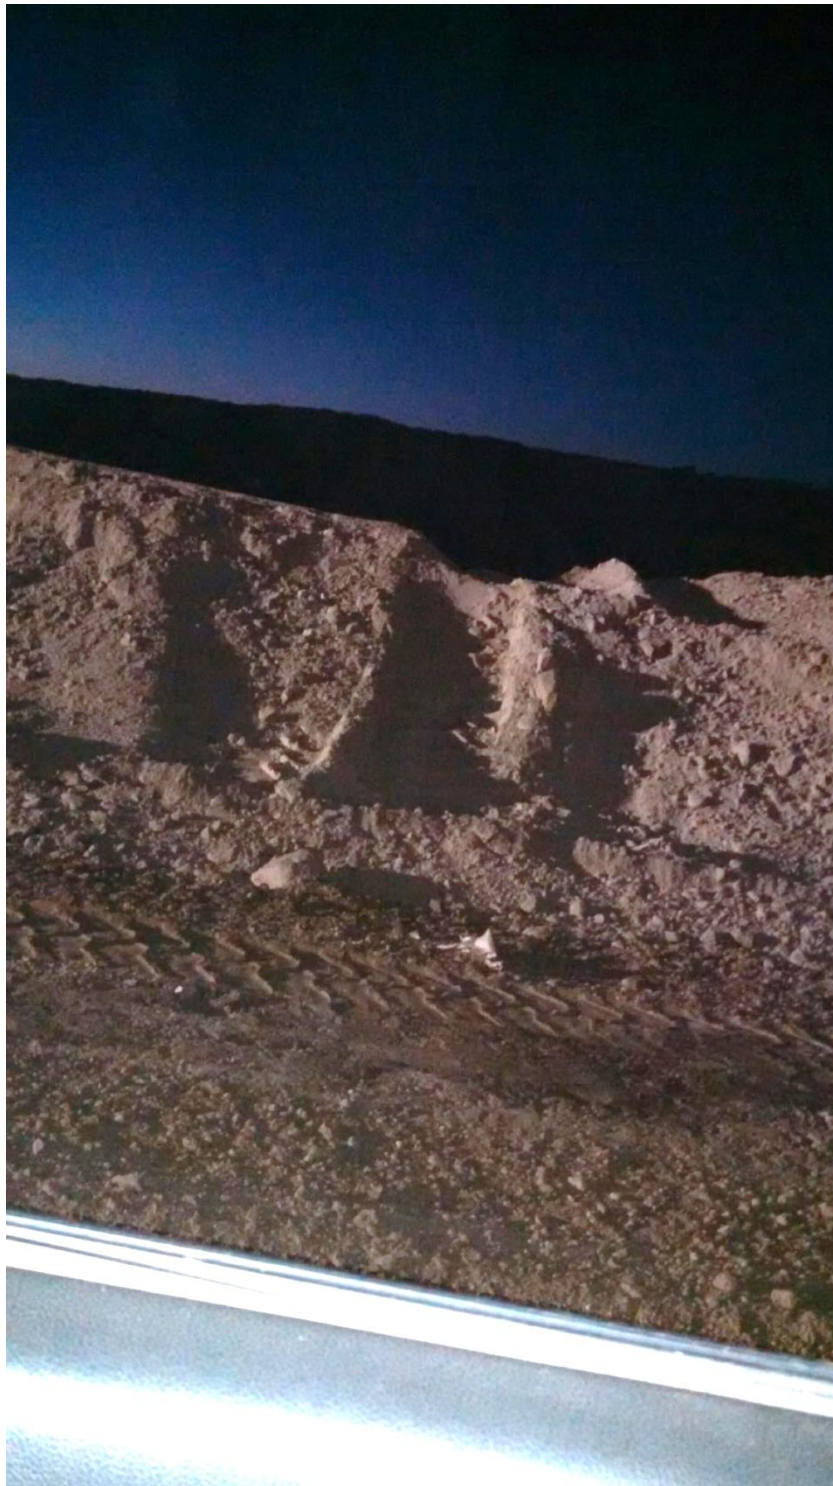
Appendix C
Photo of Tire Marks

On Thursday, May 4, 2017, two days before the accident, Alan Raymond, Motor Grader Operator and Miners' Representative, observed tire marks in a berm at the highwall 200 feet from the accident scene. This indicated to him that unsafe dumping practices were occurring at this location. He believed trucks were repeatedly pounding into the berms when dumping, causing the berms to be pushed back toward the edge of the highwall, to the point where the berms were in danger of giving way or failing. Raymond believed a miner would get hurt or die if this practice continued. He immediately exercised the mine operator's "stop work authority" provision and informed E. Buchholz, the Crew 4 Supervisor, of his concerns regarding the unsafe practice and the potential injury or death to a miner. Western Energy Company's safety manual states the following regarding stop work authority:

During the night shift on May 4, 2017, E. Buchholz traveled to the berm area and took a photograph of the tire tracks (see Appendix C). His intention was to show the photo to Richard Sheridan, the supervisor of the previous shift (Thursday day shift), so that Sheridan could discuss it with his crew. However, E. Buchholz told investigators he did not have a chance to show the photograph to anyone prior to the accident.

Investigators were not able to determine if, prior to the accident, trucks impacted the berm at the location where the victim's truck went over the highwall. However, it was clear that the company's dump short and 25 foot policies were not followed at either location.
