COAL MINE SAFETY AND HEALTH
REPORT OF INVESTIGATION
Underground Coal Mine

Fatal Powered Haulage Accident

June 19, 2017
Oak Grove Mine
Oak Grove Resources, LLC
Jefferson County, Alabama
I.D. No. 01-00851

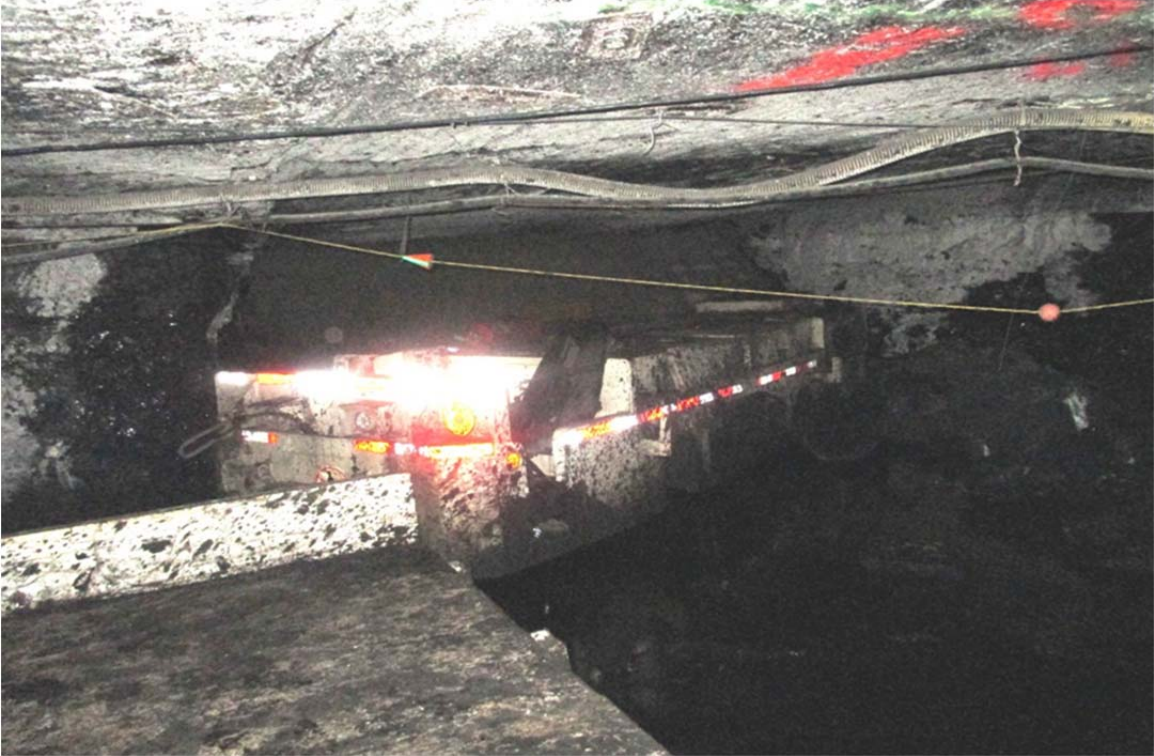
Photo of Derailed Train

Traveling at an excessive speed, the train continued about 175 feet to the curve at crosscut No. 17, where the East Main track turns into the Main North 4 track, and it derailed. The lead locomotive came to rest completely off the track and in a crosscut. The ballast car and the No. 12 trailing locomotive remained on the track (see Appendix B).

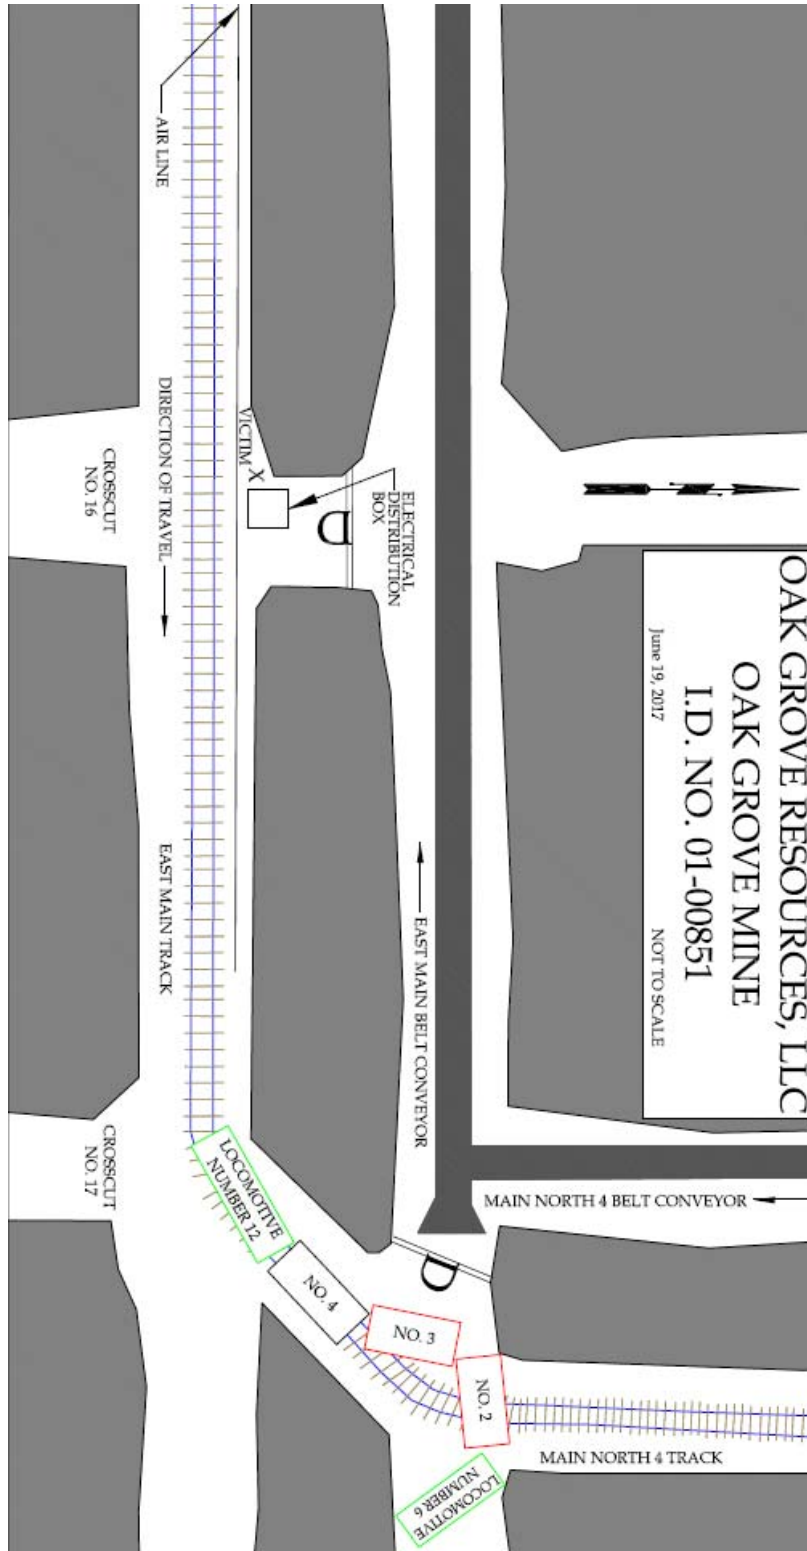
APPENDIX B - Map of the Accident Area

Oak Grove Resources, LLC conducted a vertical profile survey of the East Main track grade. It found the grade averaged approximately 2.8% along the track where the operators noted problems in controlling the speed of the train. The steepest length of the track is on a 6.74% grade for a distance of approximately 80 feet. The flattest area along the track has a grade of 0.56% (see Appendix B).

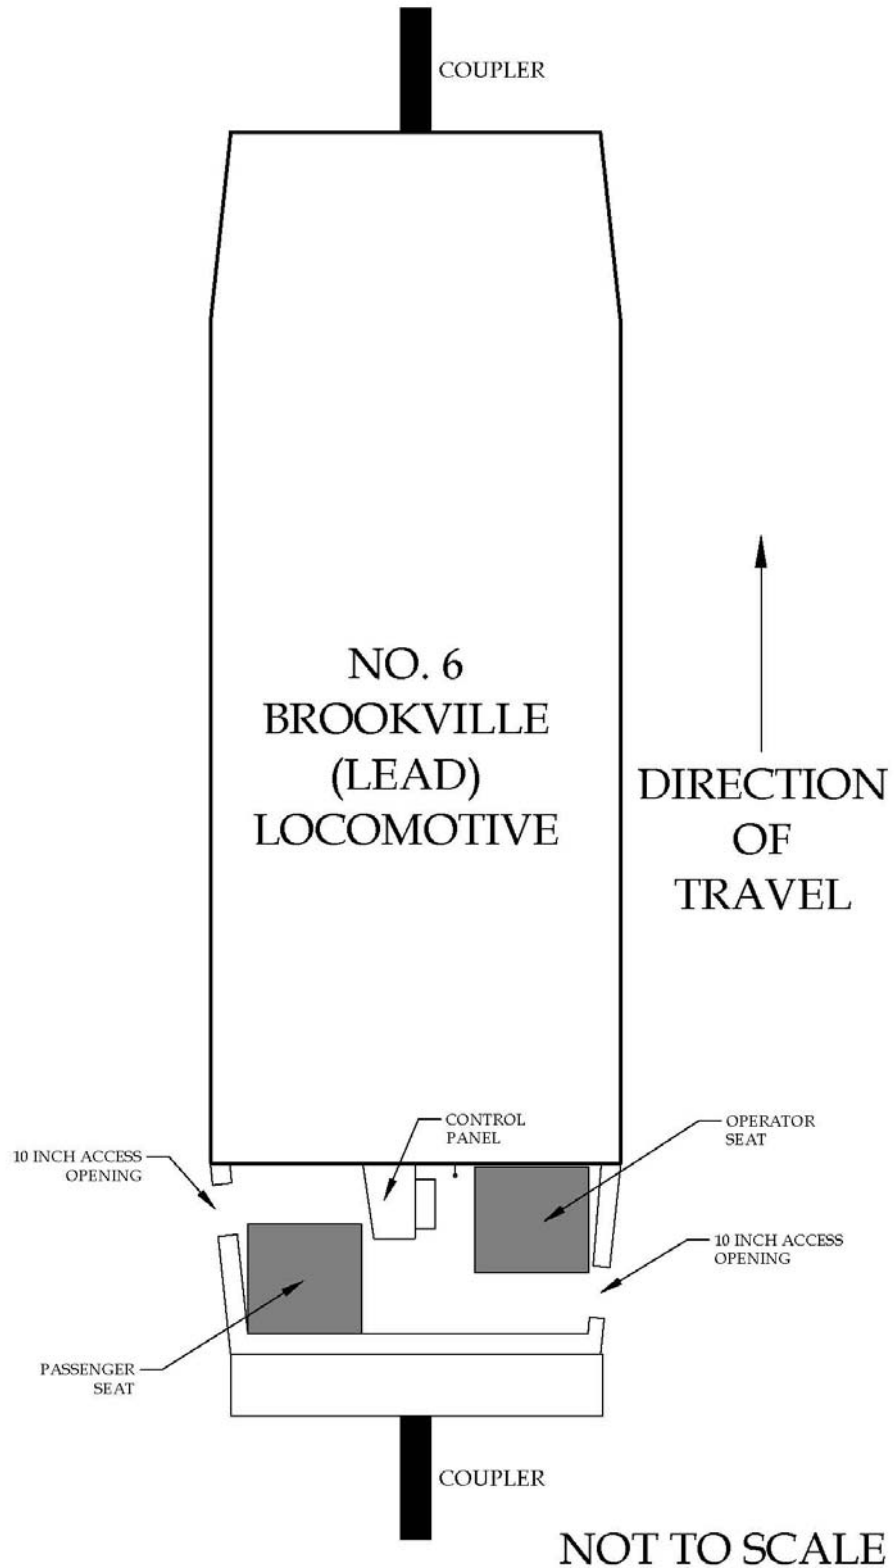
APPENDIX C
Sketch of Lead Locomotive

The front No. 6 locomotive was a Brookville Model BDC-20UP, serial number 7929, 20 ton, manufactured in 1996. The operator and passenger seat were inspected and no deficiencies were observed (see Appendix C). A seatbelt or other restraint was not required and was not installed in the locomotive. The weight is listed as 40,575 pounds and it is 19 feet long and 7 feet wide.

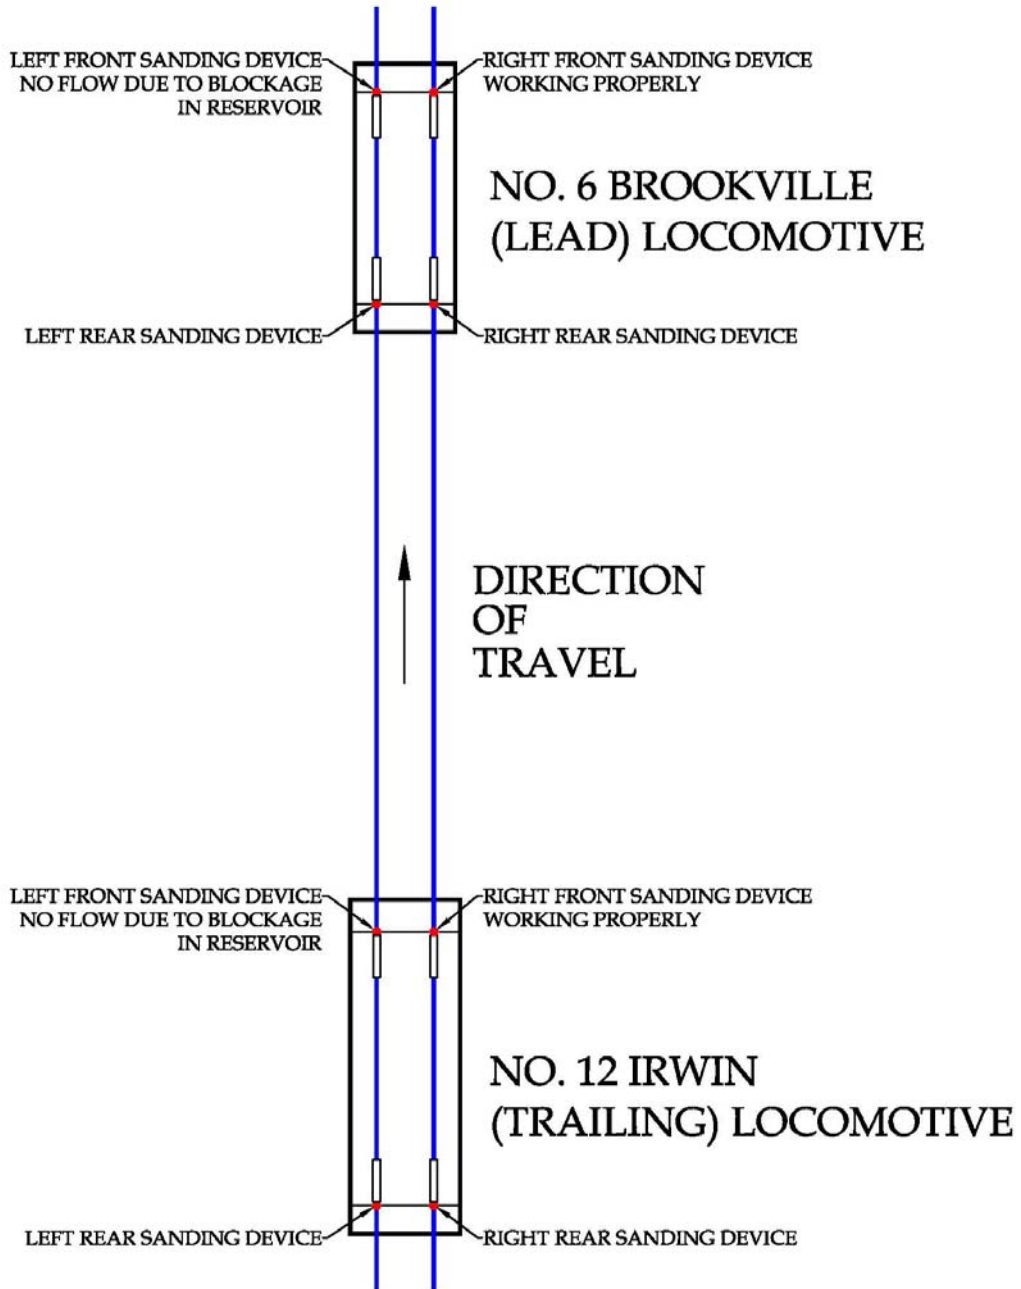
APPENDIX D
Sketch of Locomotive Sanders

Each locomotive is equipped with four sand reservoirs to deposit sand on the rails. Two are located on the front, one on each side and two on the rear (see Appendix D). Track sanders are designed to apply sand to the rails only in the direction of travel. These sanders are referred to as the 'front' sanders. For both the lead No. 6 locomotive, and the rear No. 12 locomotive investigators found that the left front sanders were inoperative due to blockages in the reservoirs. MSHA could not determine when these sanders became inoperative.

The two right front sanders on each locomotive were working as required. With only two of the front four sanders functioning as intended, there was insufficient frictional force between the locomotive's wheels and the track rails to help slow the speed of the supply train.
