REPORT OF INVESTIGATION

Fatal Powered Haulage Accident
August 25, 2017

Pleasant Hill Mine
Carter Roag Coal Company
Mill Creek, Randolph County, West Virginia
ID No. 46-08194

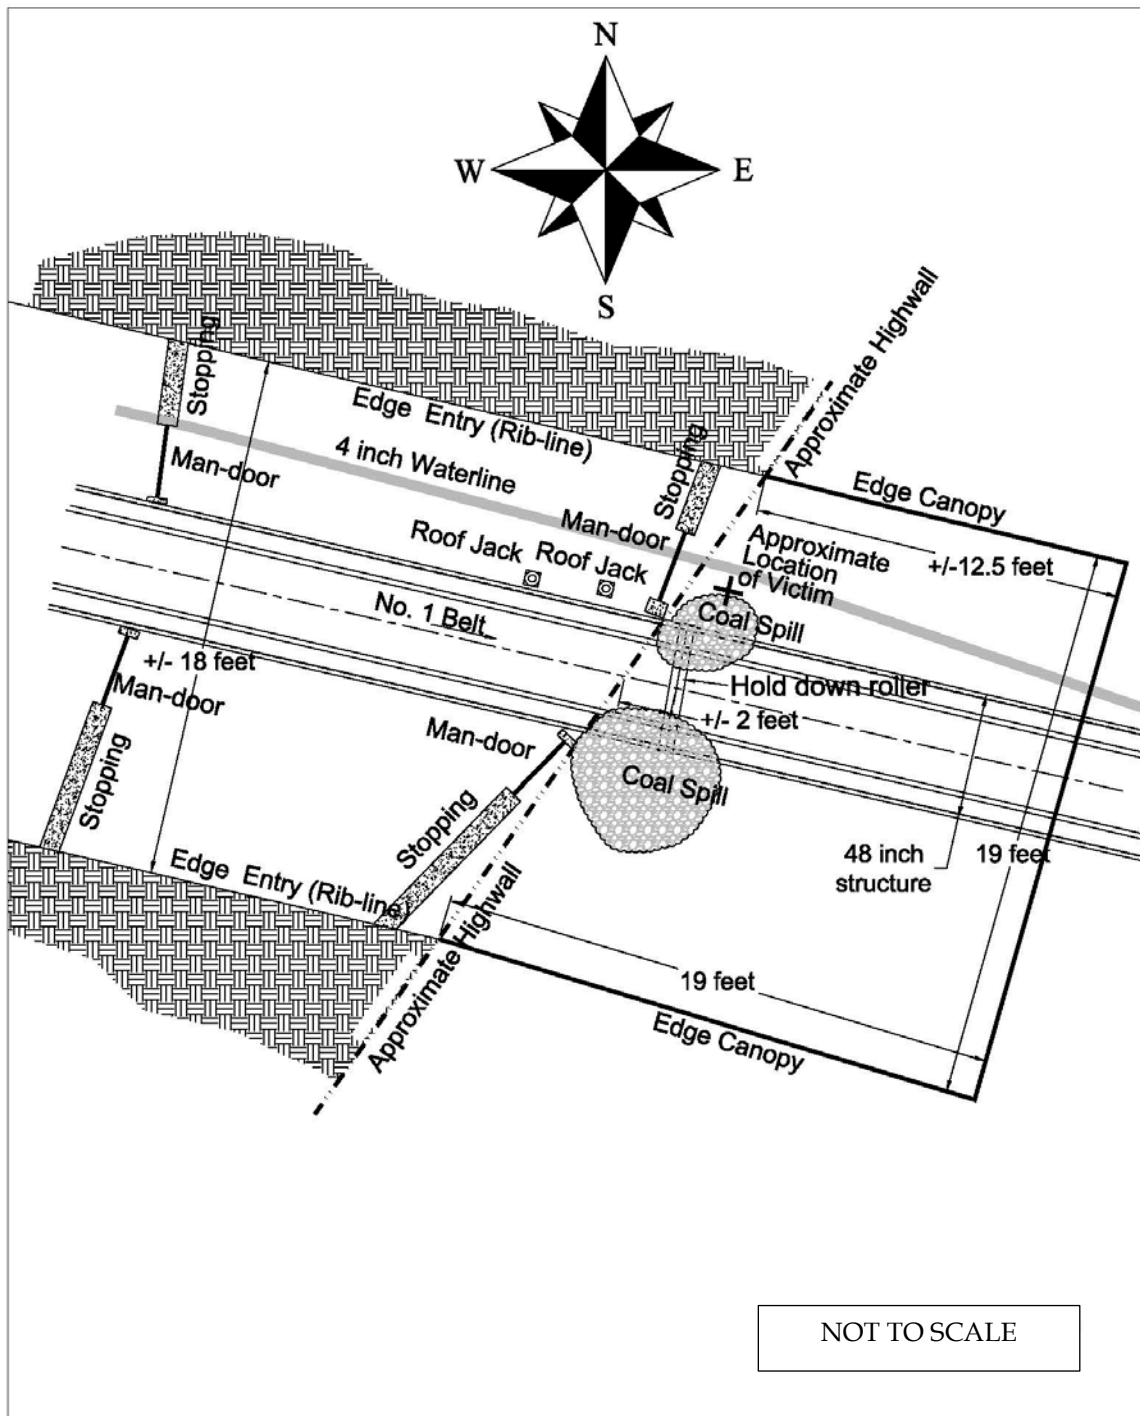
Appendix A Drawing Showing Victim

The distance from the coal on the conveyor belt to the bottom of the crossover was approximately six inches. Investigators identified locations along the No. 1 conveyor belt where Jones contacted the crossover and mine roof while he was on the conveyor belt. Jones was found lying face down under the canopy at the pit mouth. A hold down roller installed near this location may have expelled Jones from the conveyor belt.

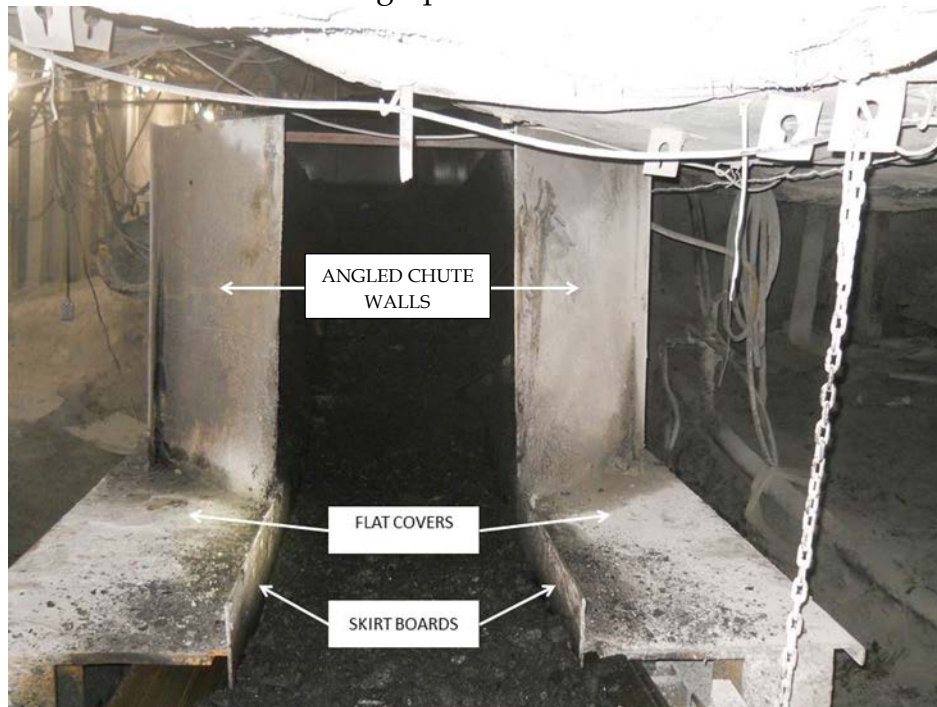
The No. 2 belt transfer was constructed with flat steel covers over both sides of the conveyor belt (see photos in Appendix B). The covers are approximately 32 inches above the mine floor. The opening between the covers, where the conveyor belt is exposed, measures 29 inches. Steel skirt boards extend vertically four and a half inches above both covers along the opening. The average clearance between the flat covers

and the mine roof is 58 inches. Mined material leaves the No. 2 conveyor belt at a belt discharge roller located inside a steel chute with angled deflector walls. This steel chute, called a "rock box," funnels the material onto the No. 1 conveyor belt.

Footprints were detected in the rock dust on the flat covers at the No. 2 transfer point. Handprints were found on the angled deflector on the tight side of the rock box. Vertical streaking marks were in the dust on the inside and outside of this angled deflector measuring 25 inches in length. The evidence indicates Jones was utilizing the outby side of the No. 2 transfer to cross over the moving No. 1 conveyor belt to travel to the tight side of the conveyor belt. Investigators believe the streaking marks were made by Jones as he fell onto the conveyor belt.

Photo of No. 1 transfer flat covers and rock box wings.

Corrective Action: The mine operator installed guards at certain belt transfer locations to prevent miners from using them as a means to cross a moving conveyor belt.

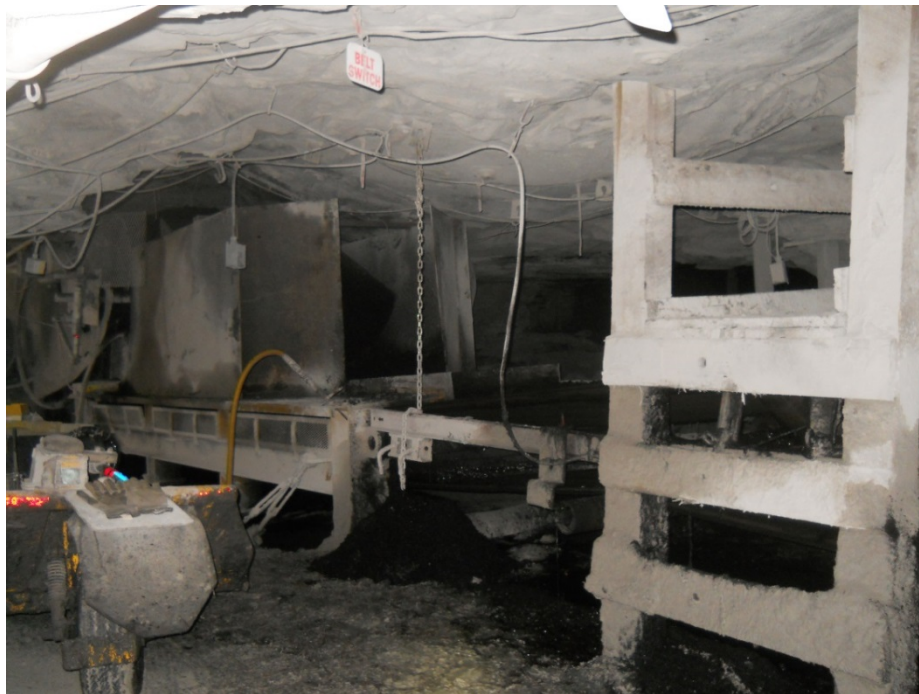
The crossover located 10 feet from where Jones fell onto the belt was constructed approximately 6 months before the fatal accident. The vertical support members were six inch by six inch timbers wedged to the mine roof. The floor and sides were one inch thick boards. The crossover was 27 inches wide and 74 inches across the conveyor belt. The floor boards were an average of 46.5 inches above the mine floor, leaving only 34 inches to 37 inches of clearance to the mine roof.

The dimensions of the crossover made it difficult to use. A miner would not have enough width to turn on top of the crossover and climb down feet first. Evidence gathered by investigators showed that it was not being used by miners, including mine examiners. Thick rock dust was evenly deposited and undisturbed on the crossover. If miners had used the crossover, the rock dust would have been disturbed.

Photo of No. 2 transfer including the mantrip and the cross over.

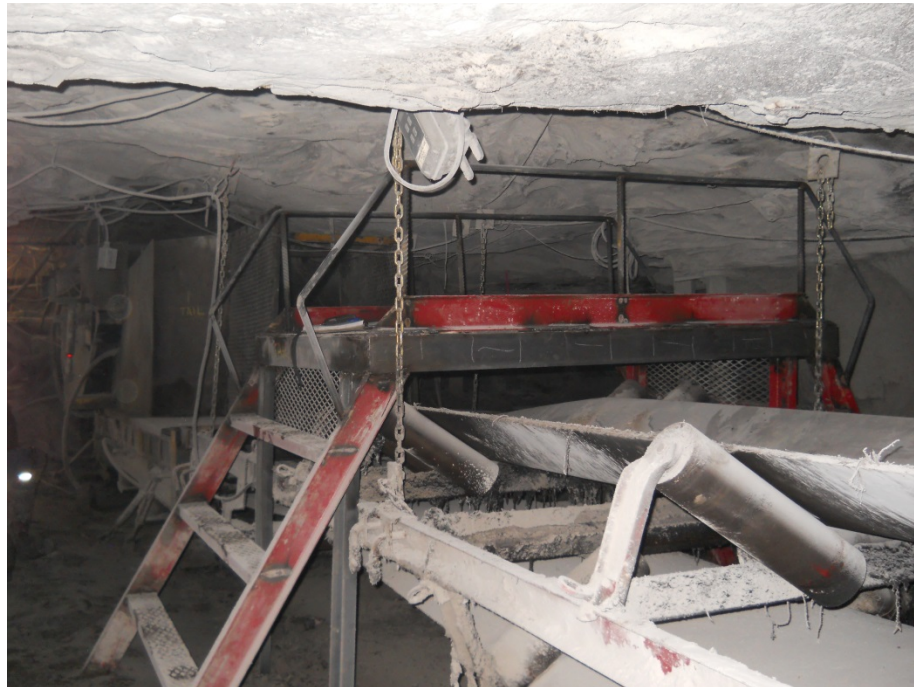
1. Root Cause: The mine operator did not provide an adequate crossover outby the No. 2 belt drive for miners to safely cross the moving No. 1 conveyor belt.

Replacement steel crossover at accident scene.

Corrective Action: The mine operator removed the crossover and constructed an adequate crossover for miners to use (see Appendix F).

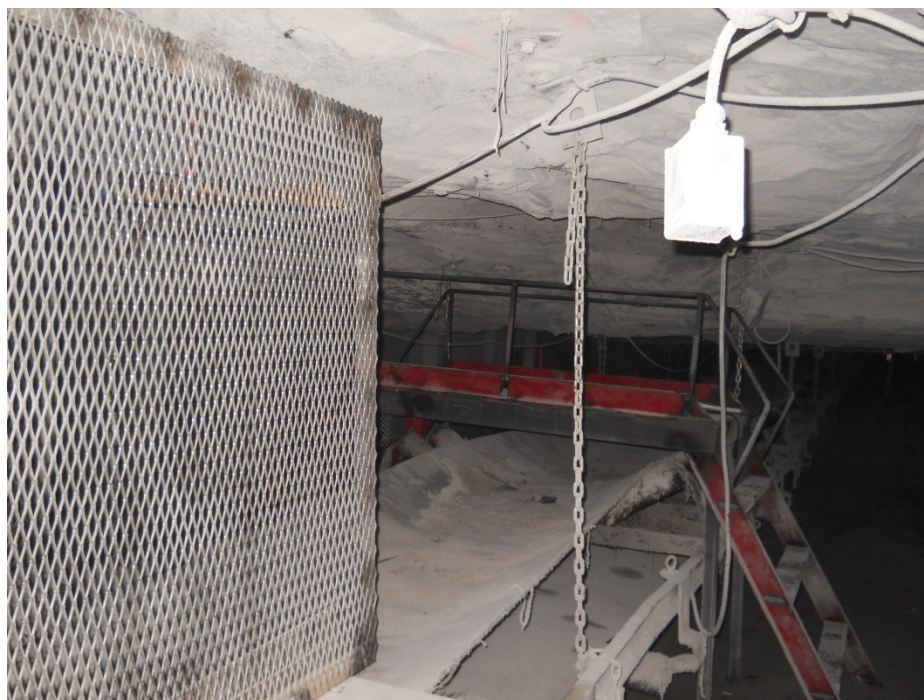
2. Root Cause: The configuration of the drive on the outby side of the rock box was not constructed to prevent a miner from using it as means to cross the moving conveyor belt.

Metal barrier installed on the No. 2 transfer.
