REPORT OF INVESTIGATION

Fatal Fall of Face Accident
September 28, 2017

Bridger Underground Coal Mine
Bridger Coal Company
Point of Rocks, Sweetwater County, Wyoming
ID No. 48-01646

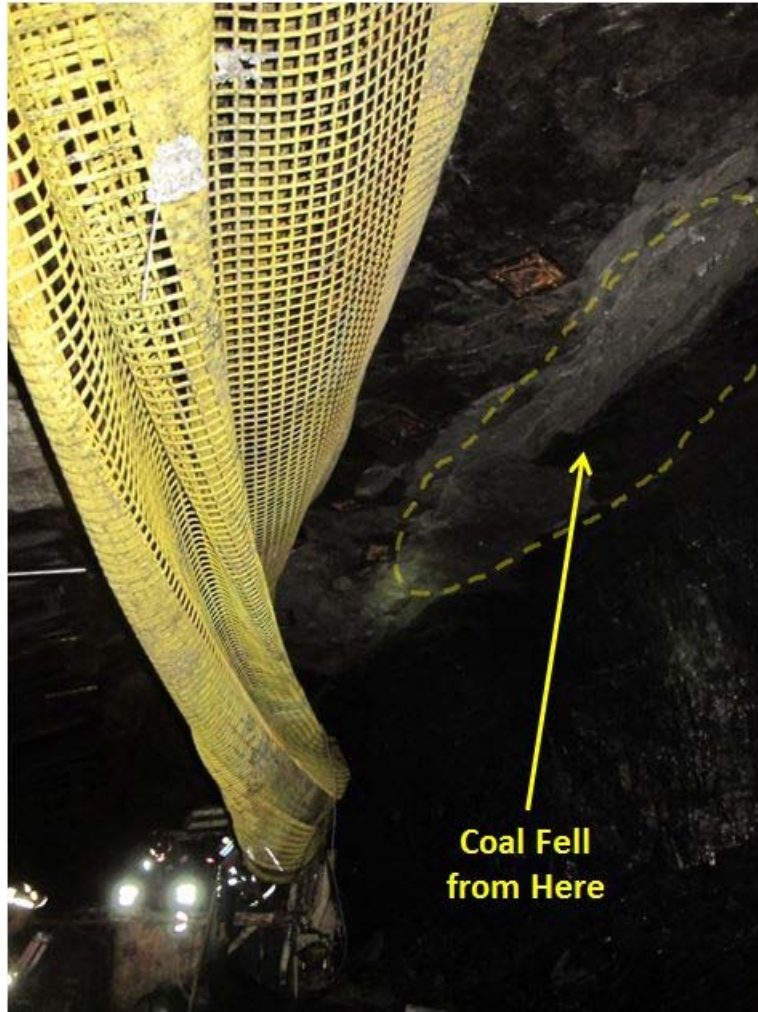
Appendix B
Longwall Face and Roof

The average mining height was approximately 9.5 feet along the face, however, from shield 47 to shield 59, the face and roof had been falling and the shearer had left a brow (coal left attached to the mine roof extending out from the mined face) of about 24 inches. The longwall face was abnormally high in the area from shield 47 to shield 59 measuring over 13 feet high at shield 53, where the accident occurred (see Appendix B).

The picture above shows the longwall face and roof in the area of the accident with mesh rolled up.

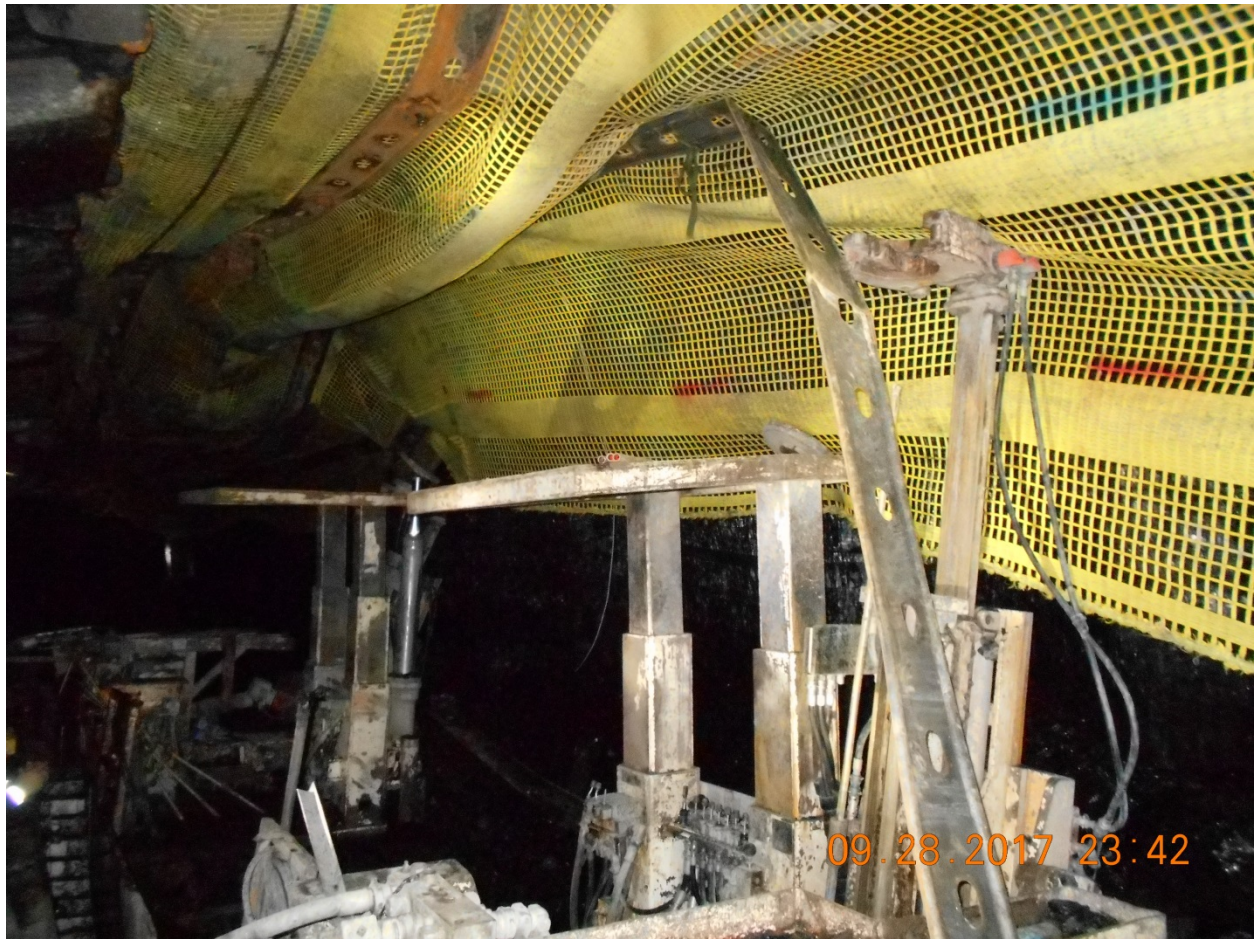
Appendix C
Longwall Face and Mesh

Bridger's approved roof control plan for the longwall recovery (extraction) area called for the installation of yellow synthetic fabric Huesker mesh (mesh). (See Appendix C) As per the plan, the mesh was to be installed over the longwall shields as the face approached the final position. It would drape over the top and back of the shields and keeps the collapsed roof (gob) behind the shields from falling into the face area as the shields are removed. The plan also required, in part, that at a minimum 12 feet, tension cable bolts be installed from the headgate to within 100 feet of the tailgate. Within 100 feet of the tailgate, the plan provided that tension cable bolts could be replaced with 96" fully grouted bolts. Metal beams with at least a four inch wide flange were to be installed from the shield tips toward the face. The mine was in compliance with the plan. The plan did not require face or rib bolting.

Looking towards the tailgate from shield 54 at panline bolting machine

Corrective Action: The mine operator submitted a roof control plan addendum to address safety measures in the area where the accident occurred. The approved plan required mesh to be placed on the face from shields 50 to 61 and secured with roof bolts. At no time could anyone be in the face conveyor. All roof and rib bolting were required to be performed from the panline bolting machines. Adequate support, including face bolting, was also required from shield 50 to the headgate. All future longwall recovery plans will require a site specific roof control plan and will incorporate longwall face support.
