REPORT OF INVESTIGATION

Fatal Powered Haulage Accident
January 26, 2017

#2
R & C Coal, LLC
Stone Coal, Pike County, Kentucky
ID No. 15-16855

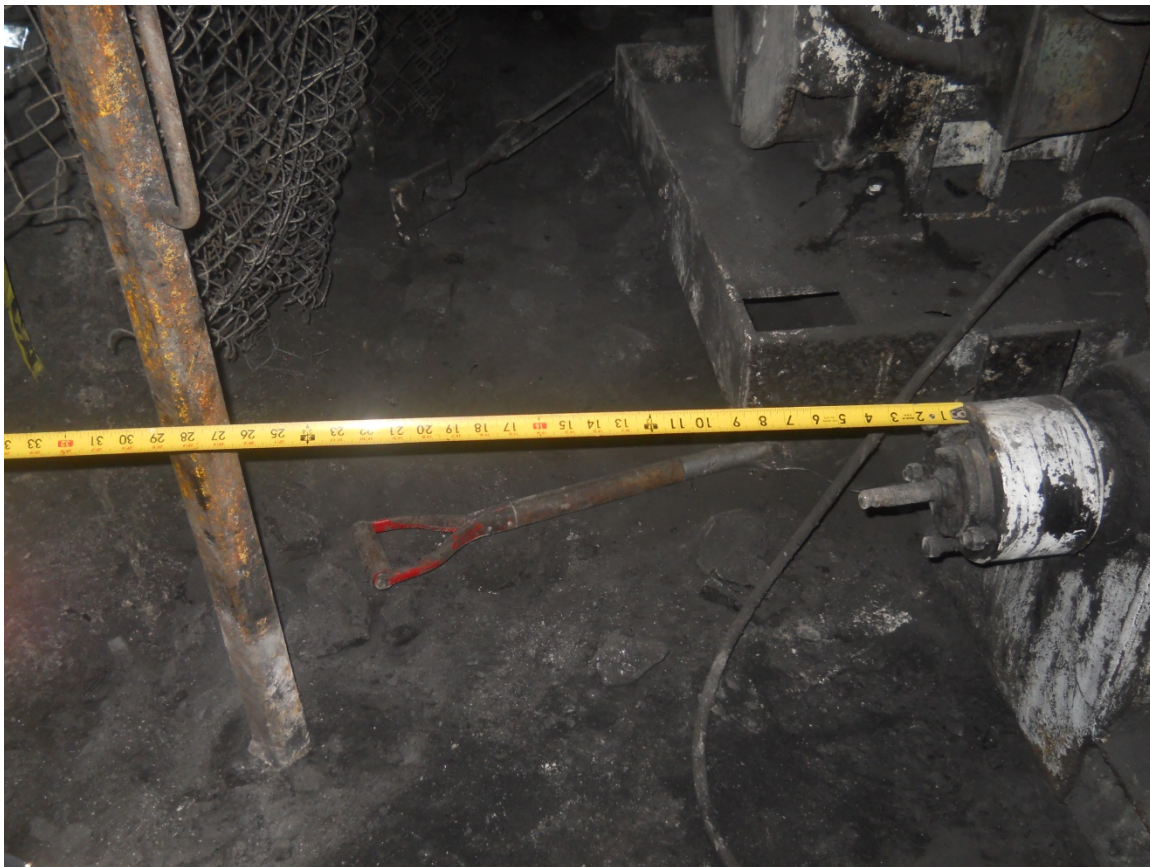
This photo shows the space that existed between the guard and the roller at the time of the accident. It also shows the stud bolts extending from the inby tandem roller shaft. These bolts are similar to the bolts that extended from the outby roller shaft where the accident occurred.

where the clearance between the outby tandem roller shaft and the guard was 24 inches to 28 inches wide. His clothing became entangled in the rotating stud bolts that were extending from the outby tandem roller shaft. Hatfield was pulled into the shaft of the roller, resulting in fatal injuries.

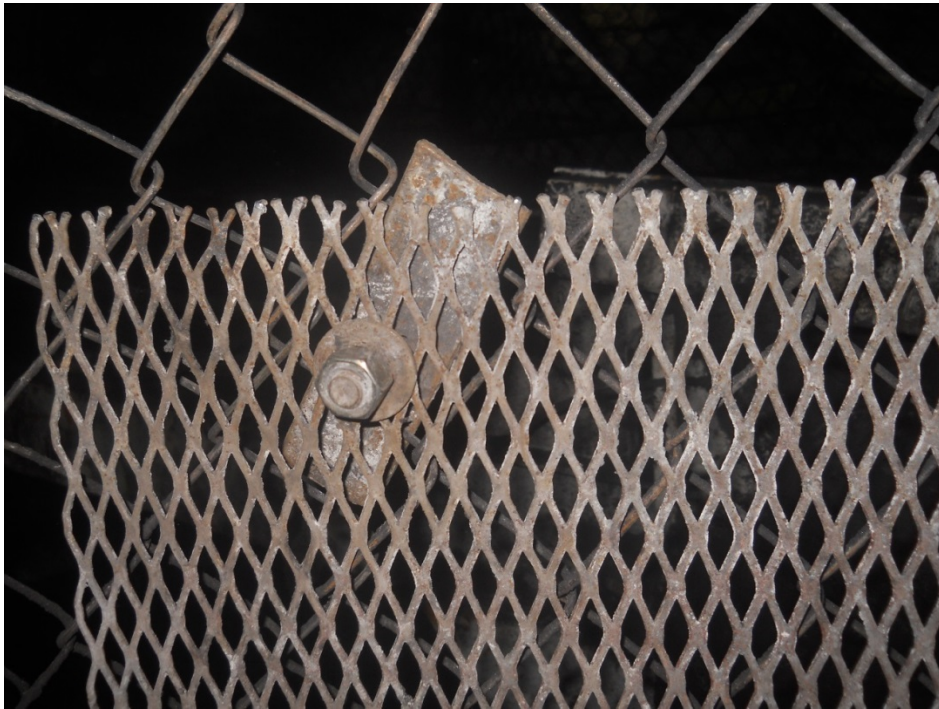
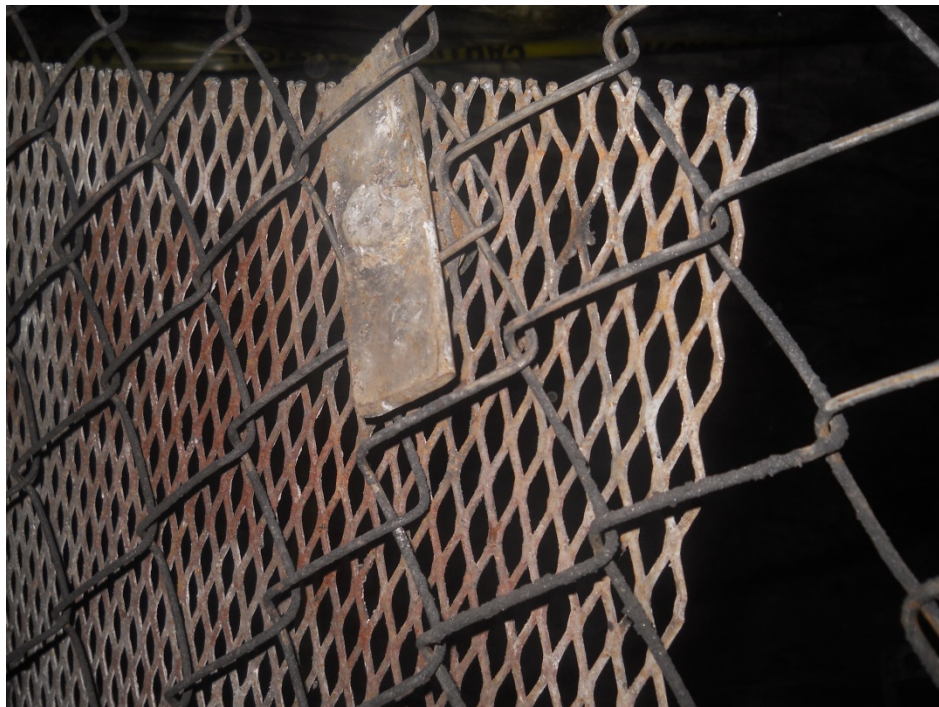
Appendix B Guard Installation

A 25-inch by 48-inch piece of expanded metal covered an opening in the chain link fence near the boom of the belt drive but had been removed from the fence and was lying on the ground at the time of the investigation. During his interview, Hall referred to this section of guard as a “door.” This type of guard was insufficient to ensure safety because it was not substantially constructed and firmly bolted. While the guard had the appearance of being bolted to the chain link fence, upon further investigation, it was discovered that it was not bolted onto the fence, but rather, hung on the fence and could be removed easily. A photo depicting the manner in which this guard was installed has been included in Appendix B. Hall stated that he commonly de-energized the belt drive and entered the “door” to shovel in the area.

Guarding provided at the No. 3 belt drive is not adequate to prevent persons from coming in contact with moving machine parts which may cause injury. The area around the belt drive is primarily guarded by chain link fencing that is not securely fastened. It is attached to posts with clamps and the posts are wedged against the mine roof with screw jacks which can easily become dislodged. Another piece of expanded metal guarding that measures 25 inches by 48 inches is provided in an area near the boom of the belt drive. This guard is not firmly bolted to the fencing and

can be easily installed and removed by simply hanging it onto the chain link fence. This guard was referred to as a "door" when interviewing miners and was frequently being removed to gain access into a restricted area to perform clean up duties around the belt drive. This guarding was installed in such manner that it could be easily defeated. This condition also resulted in a violation of 30 CFR 75.1722(c) because the "door" was not securely in place and could be easily removed.

The guards for the three belt drives at this mine were redesigned following the accident. The area guards and “door” no longer exist and the new guards are securely fastened and installed in a manner that allows the belt drives to be shoveled without having to remove the guards.

Corrective Action: All belt drive guards were redesigned to remove the "door" and/or area guarding and are now adequate. The mine operator has implemented written procedures that will ensure that belt drives are de-energized and blocked against motion prior to removing guards and performing work. All employees have been trained in these procedures and a lock and tag have been provided at belt power centers. The mine operator has trained all employees in hazard recognition and avoidance while working around moving conveyor belts and their associated components.

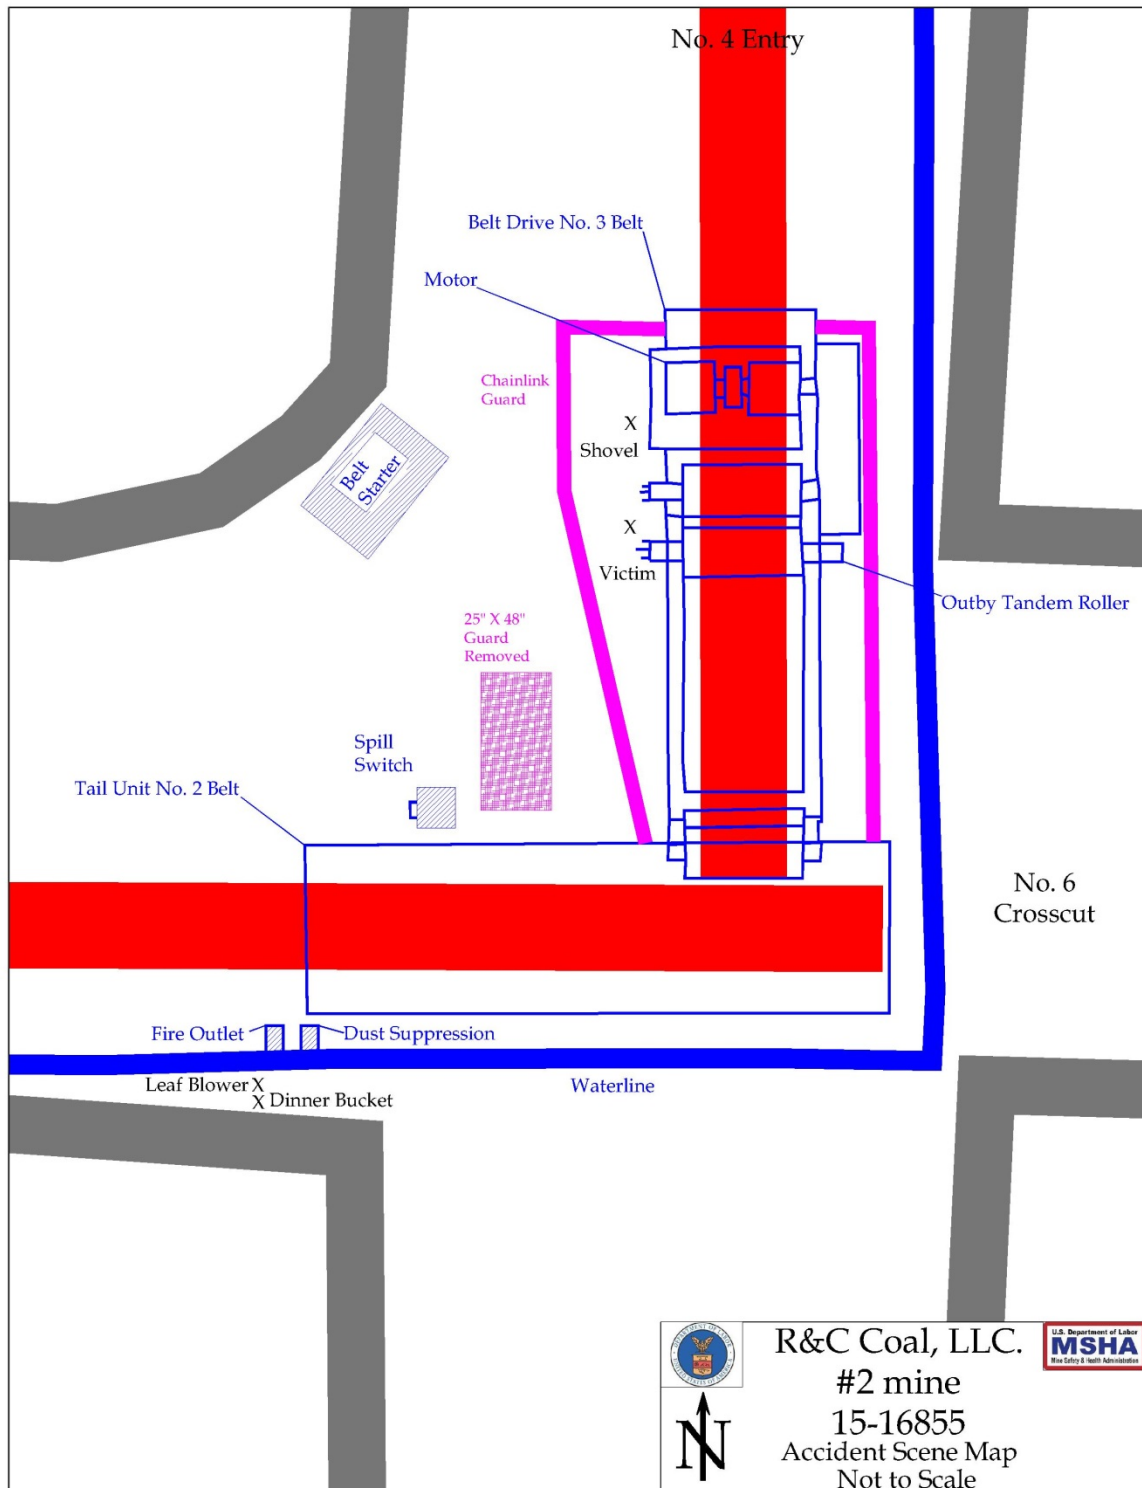
Appendix C Location of the Accident

shafts, there were no wheels on the shaft. Both shafts with hub adapters were protruding from the belt drive toward the fencing. There is a ¾ inch diameter stud bolt welded to the center of each shaft that extends outward 3 inches. Each of the hub adapters has ½ inch diameter studs with nuts that extend 1¼ inches from the end of the shafts. There are 3 of these studs on the outby shaft and 4 on the inby shaft (see Appendix C).
