REPORT OF INVESTIGATION

Powered Haulage Accident  
February 3, 2017

Stacy Equipment and Repairs, Inc. (K306)  
Gilbert, West Virginia

Elk Lick Tipple  
Greenbrier Minerals, LLC  
Lorado, Logan County, West Virginia  
ID No. 46-04315

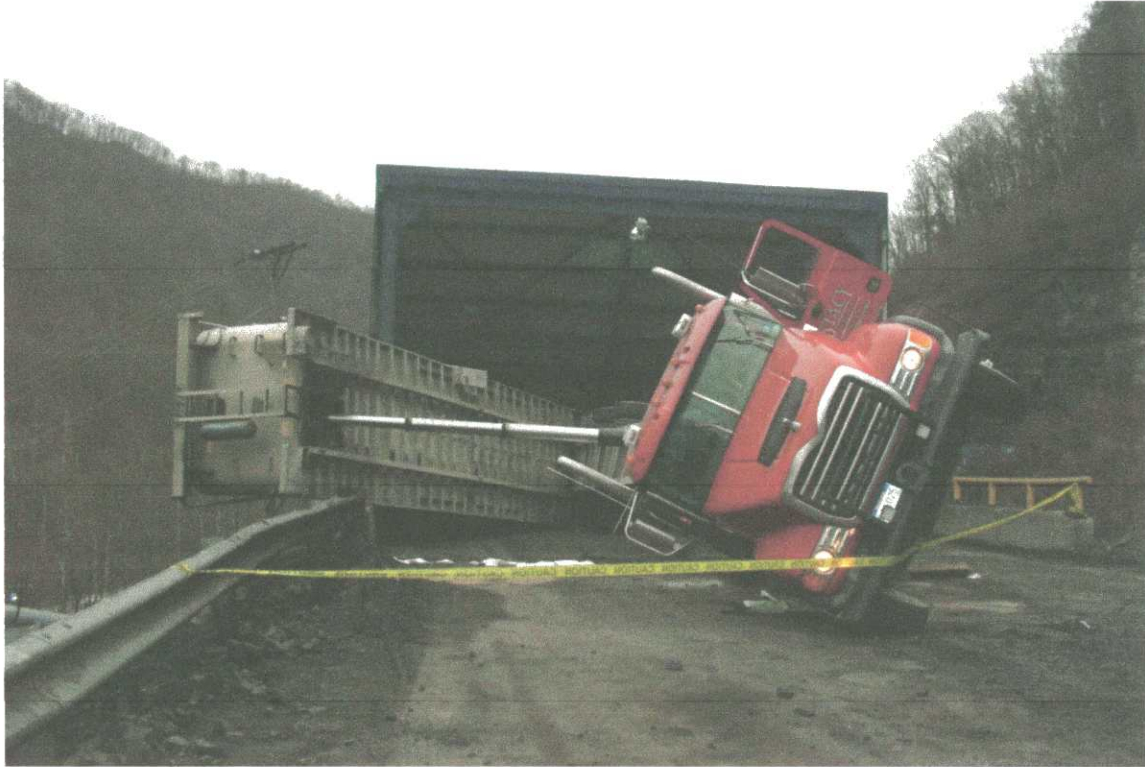
## PHOTO OF ACCIDENT SCENE

On February 3, 2017, at 7:25 a.m., Franklin L. Vannoy, Coal Truck Driver, sustained serious injuries while operating the 2005 Mack TT tractor and the 2000 East TL trailer to dump coal at the truck dump. Vannoy jumped from the tractor as the tractor and trailer overturned. On February 10, 2017, Mr. Vannoy passed away due to the injuries received during the accident.

After the accident, coal was found in the trailer and over the side of the mountain where the truck dump was located. Because the trailer had been fully extended, the entire load should have fallen out of the trailer. However the material had stuck (hung load) to the trailer truck bed. The manufacturer’s procedures for a hung load include: (1) fully lower the trailer to not keep the hung load elevated, (2) do not fully extend the trailer (i.e. do not raise the trailer to the lifting limit of the hoist cylinder), and (3) only raise the trailer to the lowest height for dumping. These procedures were not followed.

Investigators determined that the hung load caused the trailer to be overweighted on one side and unbalanced. As the hoist cylinder was raised to its fully extended position, the unbalanced weight of the hung load caused the truck to fall over.

They also found the hoist cylinder fully extended indicating that the manufacturer’s warning against fully extending the hoist cylinder was not heeded. Investigators also found hoist control in the “lift” position as opposed to the “hold” position as stated in the manufacturer’s warning.
