REPORT OF INVESTIGATION

Fatal Slip or Fall of Person Accident
February 27, 2017

Bishop Impoundment Area
Chestnut Land Holdings, LLC
Squire, McDowell County, West Virginia
ID No. 46-02380

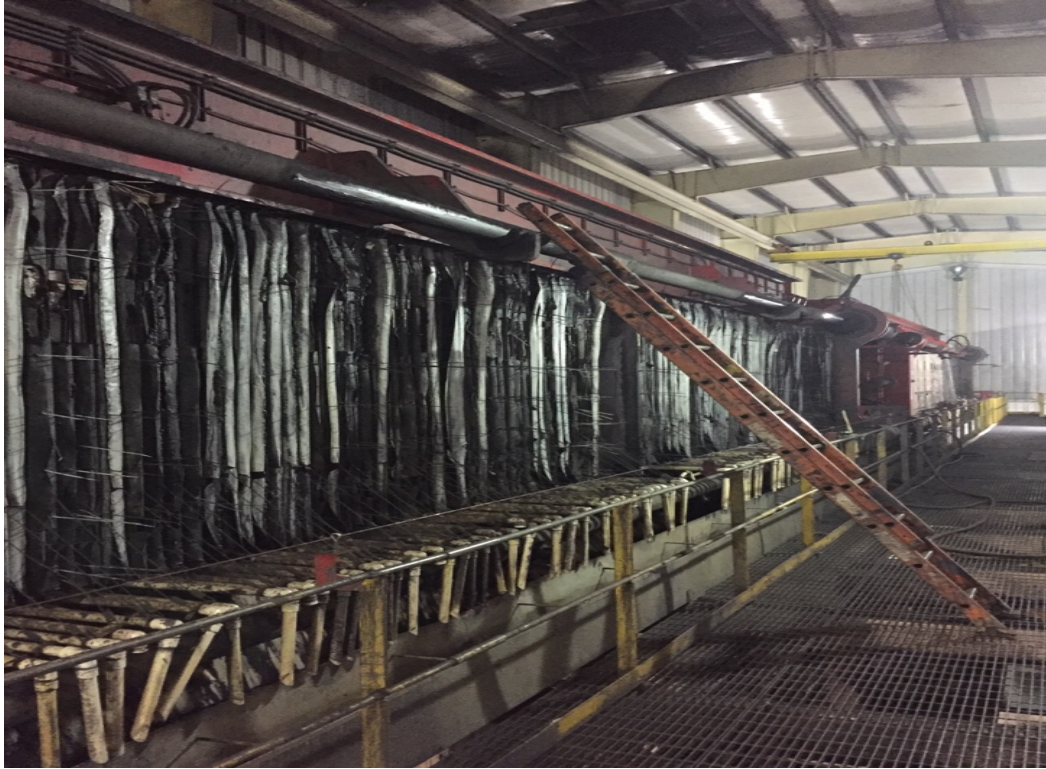
PHOTO OF ACCIDENT SCENE

On February 27, 2017, at approximately 10:00 p.m., Jason Kenneth Matthews, a 43-year-old plant attendant with 13 years of mining experience, received fatal injuries when he fell through an opening in a plate press. The victim was preparing to make repairs to the plate press when he fell onto a moving conveyor belt, which moved the victim to a transfer chute 55 feet from where he fell.

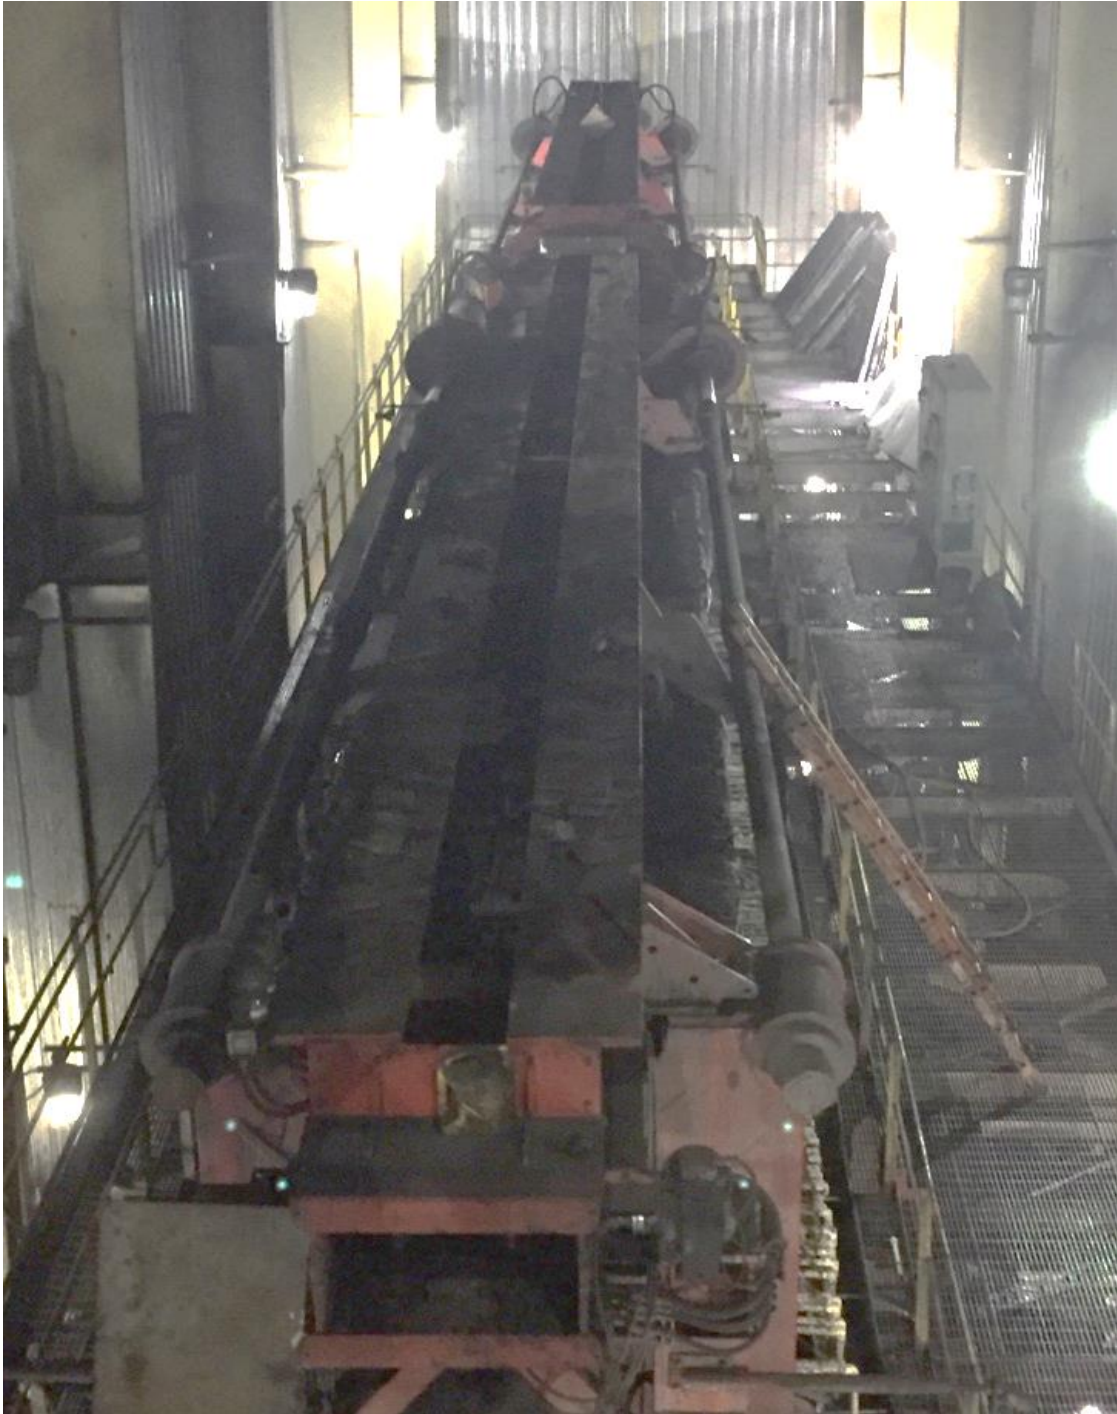
Overhead View of Plate Press

Caster type rollers are attached to the top of the plates allowing them to move along an "I" beam track. Each plate locks into a chain, which is located on top of the plate press, and extends from end to end (see Appendix B). In order to slide the plates manually, the locking mechanism on the chain must be released. This work can only be performed from the top of the plate press, which is 7 feet 7 inches above the floor of the preparation plant and 18 feet 7 inches above the FCC conveyor belt.

The width of an I-beam is 16 ½ inches. The accident investigation could not verify whether the victim was on the top of an I-beam or on top of the plates when he fell. Investigators saw boot prints in both areas.

Corrective Action: The operator installed 8 tag lines, 2 on each side of both plate presses; the lower of the tag lines is utilized while travelling up a ladder or walking on top of the plates and the upper tag line is utilized when working on top of the plate press. The operator has provided a dual lanyard system (100% tie-off) in which miners are always tied off overhead to prevent falling. Also, the operator revised the ground control plan to address examinations, maintenance, and required use of the tag lines.

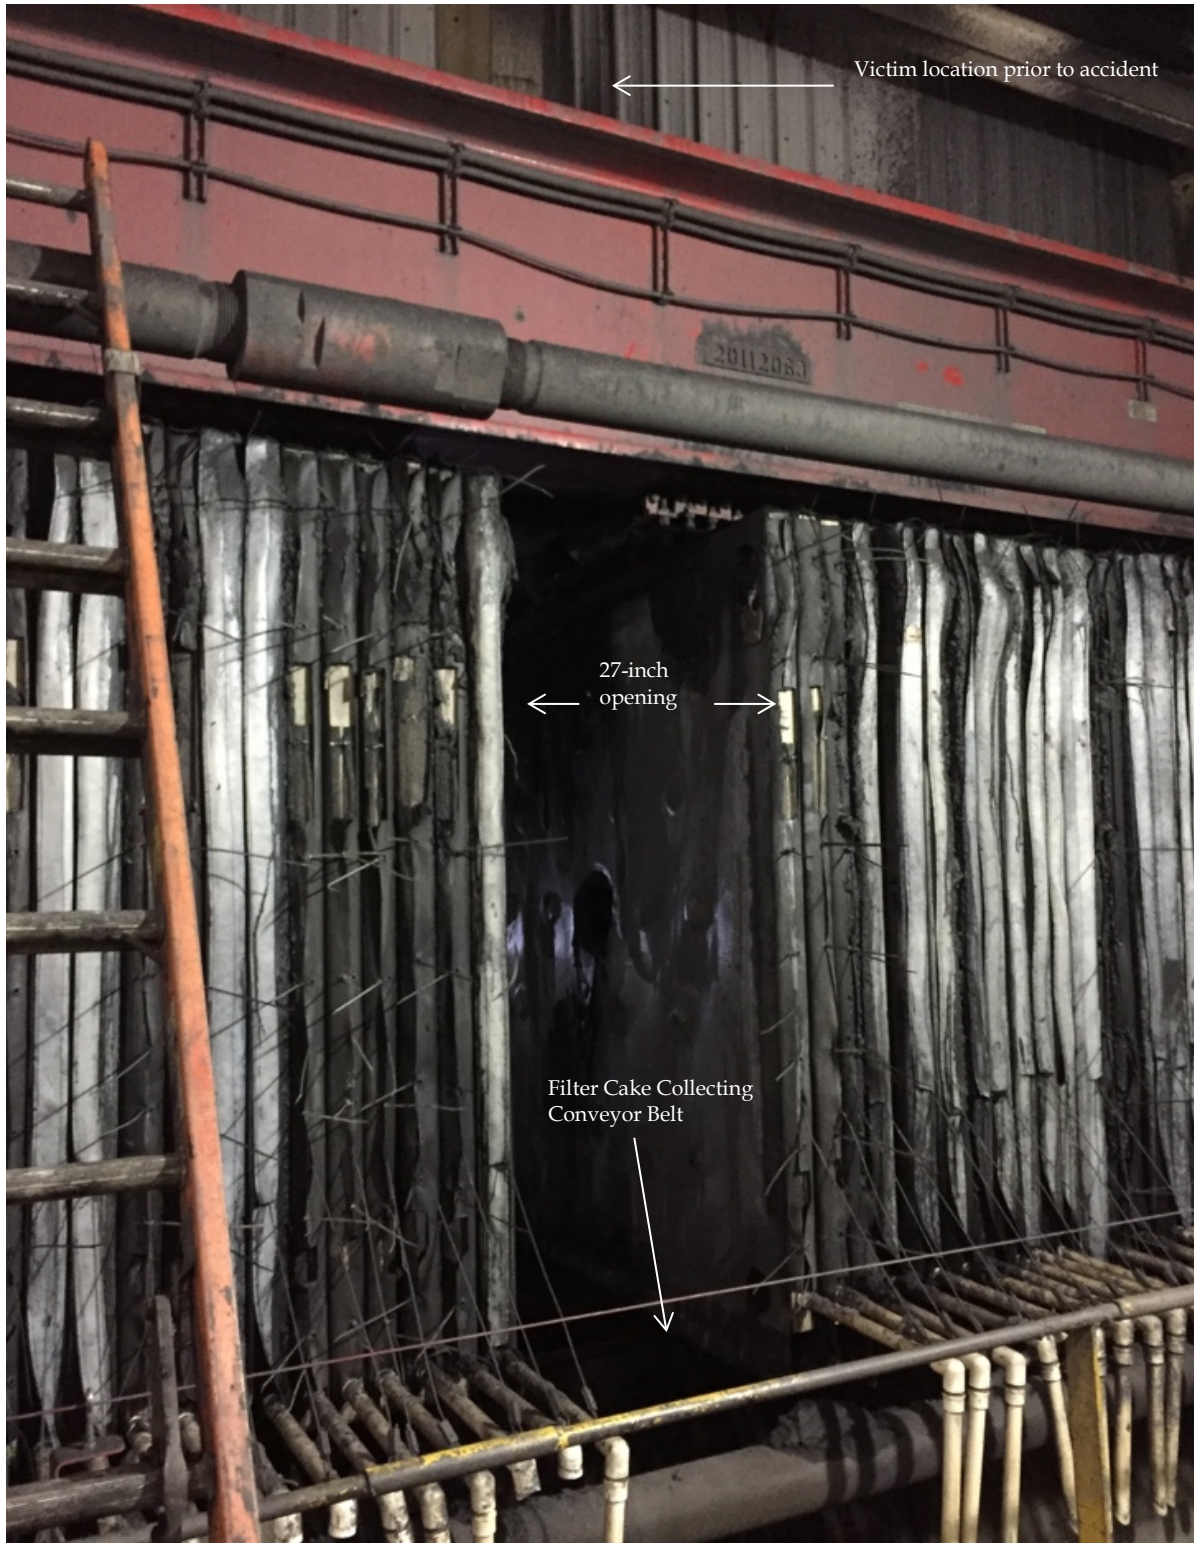
The accident occurred because fall protection was not used during work in an area where a risk of falling existed. Also, a safe means of access to this area was not provided.

2. Root Cause: The mine operator failed to provide a safe means of access to all areas where miners are required to work and travel, as required by 30 CFR § 77.205(a). An effective means was not provided for miners to tie off when working on top of the plate press.

Opening between plates where victim fell

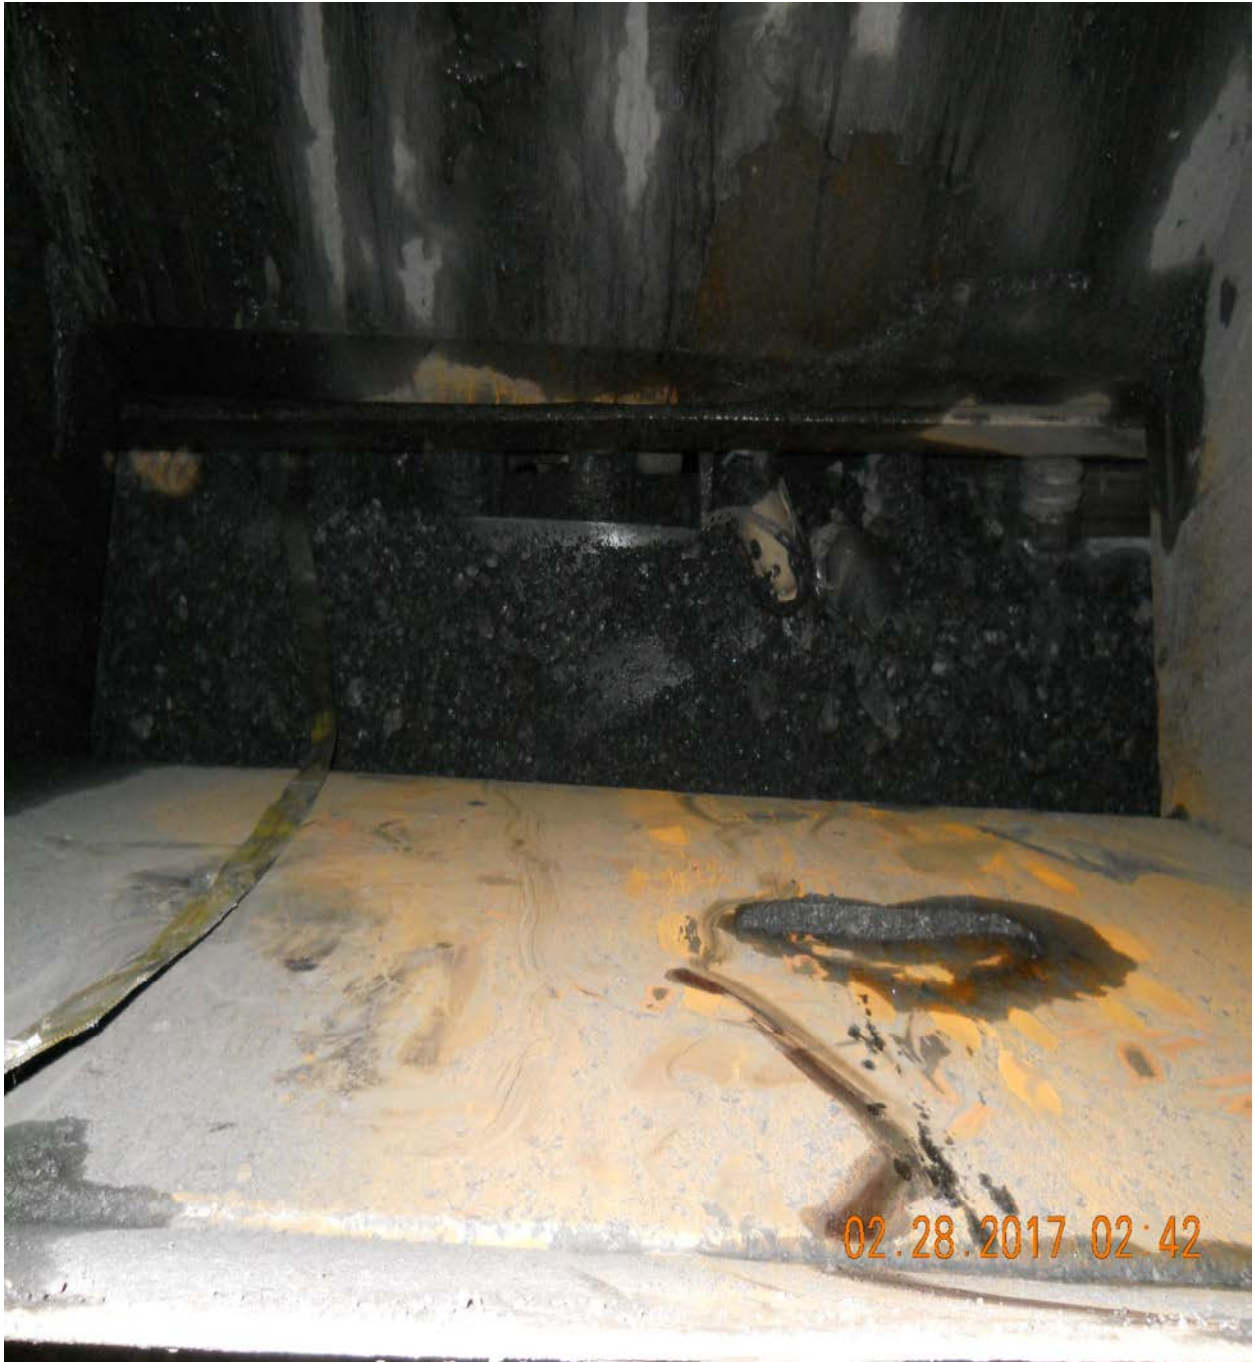
At approximately 10:05 p.m., Sparks and Music located the victim inside the transfer chute between the FCC conveyor belt and the refuse collecting (RC) conveyor belt. Matthews was sitting upright with refuse material piled up around him to his chest and was unresponsive. At 10:06 p.m., Music returned to the control room to call Orick and request emergency medical technicians (EMTs) and to call 911.

Transfer Chute where victim was located
