REPORT OF INVESTIGATION

Surface Coal Mine
(Auger Operation)

Fatal Fall of Face, Rib, Pillar or Highwall Accident
March 30, 2017

GHM #51
Green Hill Mining, Inc.
Rockholds, Whitley County, Kentucky
ID No. 44-07079

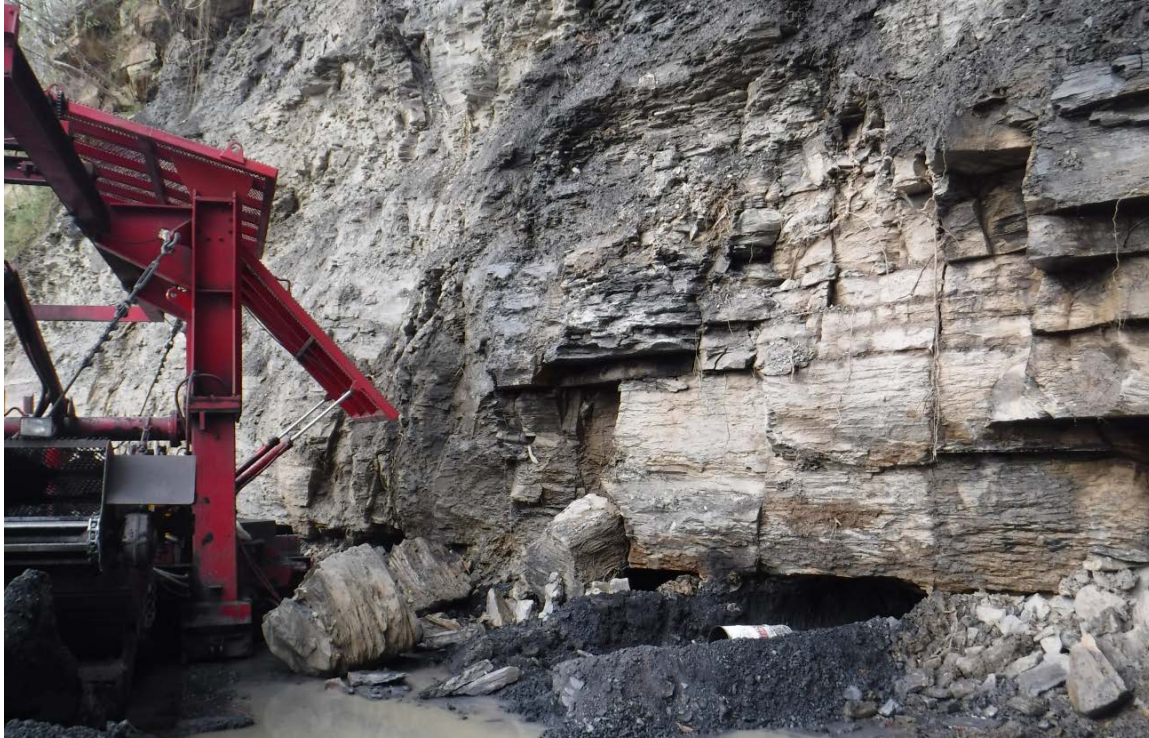
PHOTOGRAPH OF ACCIDENT SCENE

The accident occurred while Partin was standing between the auger machine and highwall under the extended highwall guard. Kidwell was positioned on the auger machine to assist Partin and to observe the highwall. Partin had changed three worn cutter head bits when a triangular shaped rock measuring approximately 4 feet by 5 feet and 30 inches in thickness fell from the bottom section of the highwall, immediately above the coal seam and struck Partin from behind. The rock weighed about two tons.

At the time of the accident, the highwall measured 54 feet in height in front of the auger machine. The rock strata in the pit area consisted of sandstone, shale, and siltstone bands. Deteriorated sandstone ledges and new growth trees existed along the top section of the highwall. Two sets of strata joints intersected throughout the siltstone layer above the coal seam, creating a triangular-shaped rock that became separated at the top through a weak and weathered bedding plane.

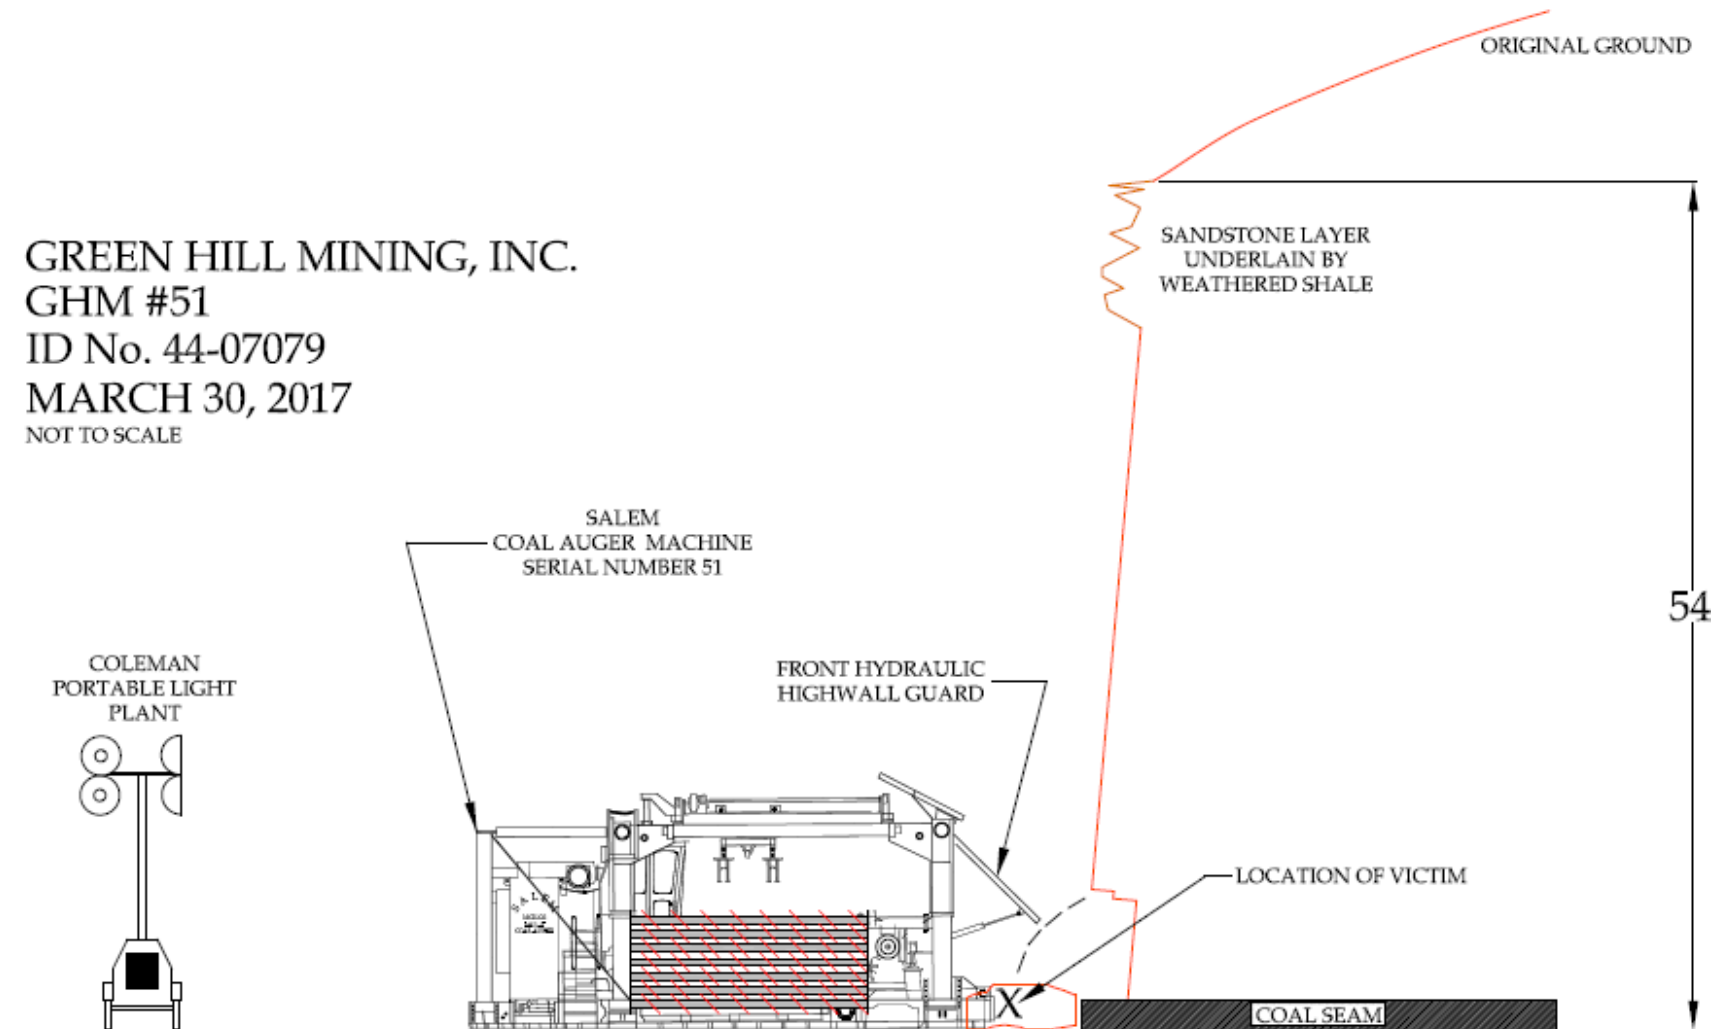
APPENDIX B
Sketch of Accident Scene

The auger machine was a Salem MUL-T (Triple Head) coal auger machine equipped with three 16-inch cutter heads that create an auger entry 18 inches in height and 56 inches in width. The machine also had 28 sets of 16 foot triple auger flights capable of mining an auger entry approximately 450 feet in depth and a front mounted heavy gauge screen highwall guard that could extend and retract with two 30 inch hydraulic cylinders (see Appendix B).

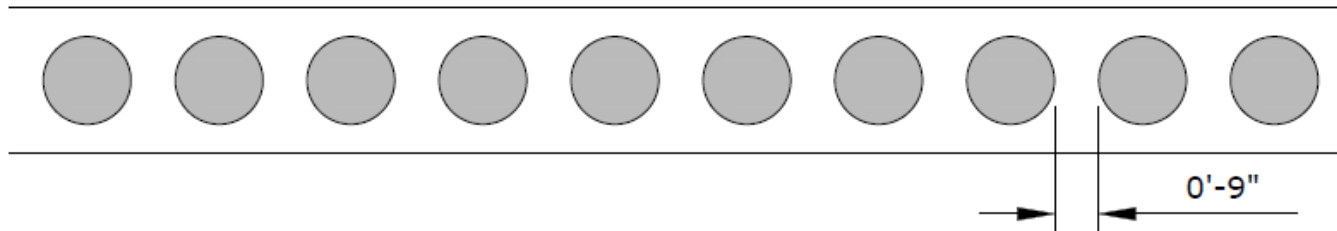
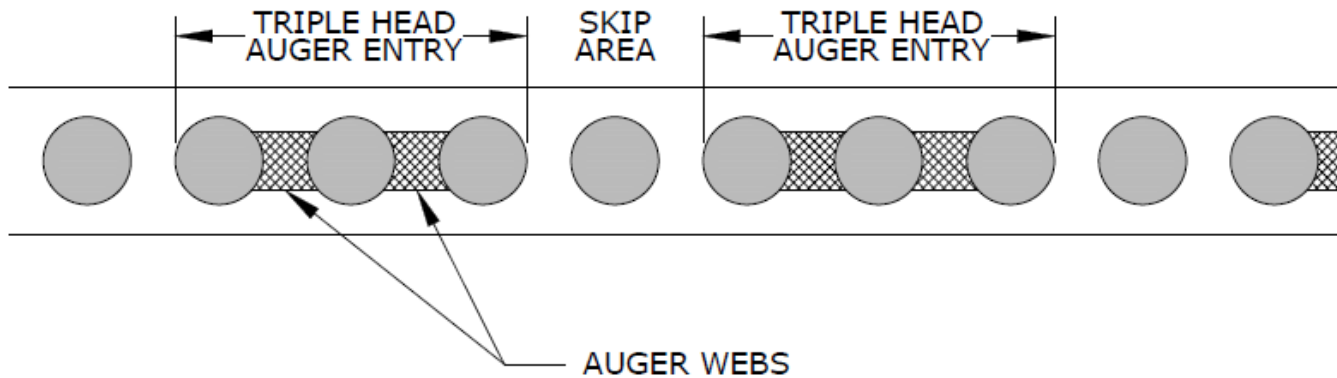
APPENDIX C
Sketch of Auger Mining History

The mining of the Jellico coal seam at this location in Pit #1 was conducted in a right to left mining sequence (looking toward the highwall). One pre-existing single 18-inch diameter auger entry and two spacing webs (approximately 9 inches in width) between each 18-inch auger entry, were skipped in order to support the highwall. The pre-existing single auger entries were estimated to be a maximum depth of 300 feet. The triple head auger machine penetrated three single entries, removing two webs and surpassing the depth of the single auger entries to an approximate depth of 450 feet (see Appendix C and Appendix D for the complete mining sequence).
