REPORT OF INVESTIGATION

Fatal Fall of Roof Accident  
February 23, 2017

Mine No. 5  
C K Coal Corporation  
Delbarton, Mingo County, WV  
ID No. 46-09362

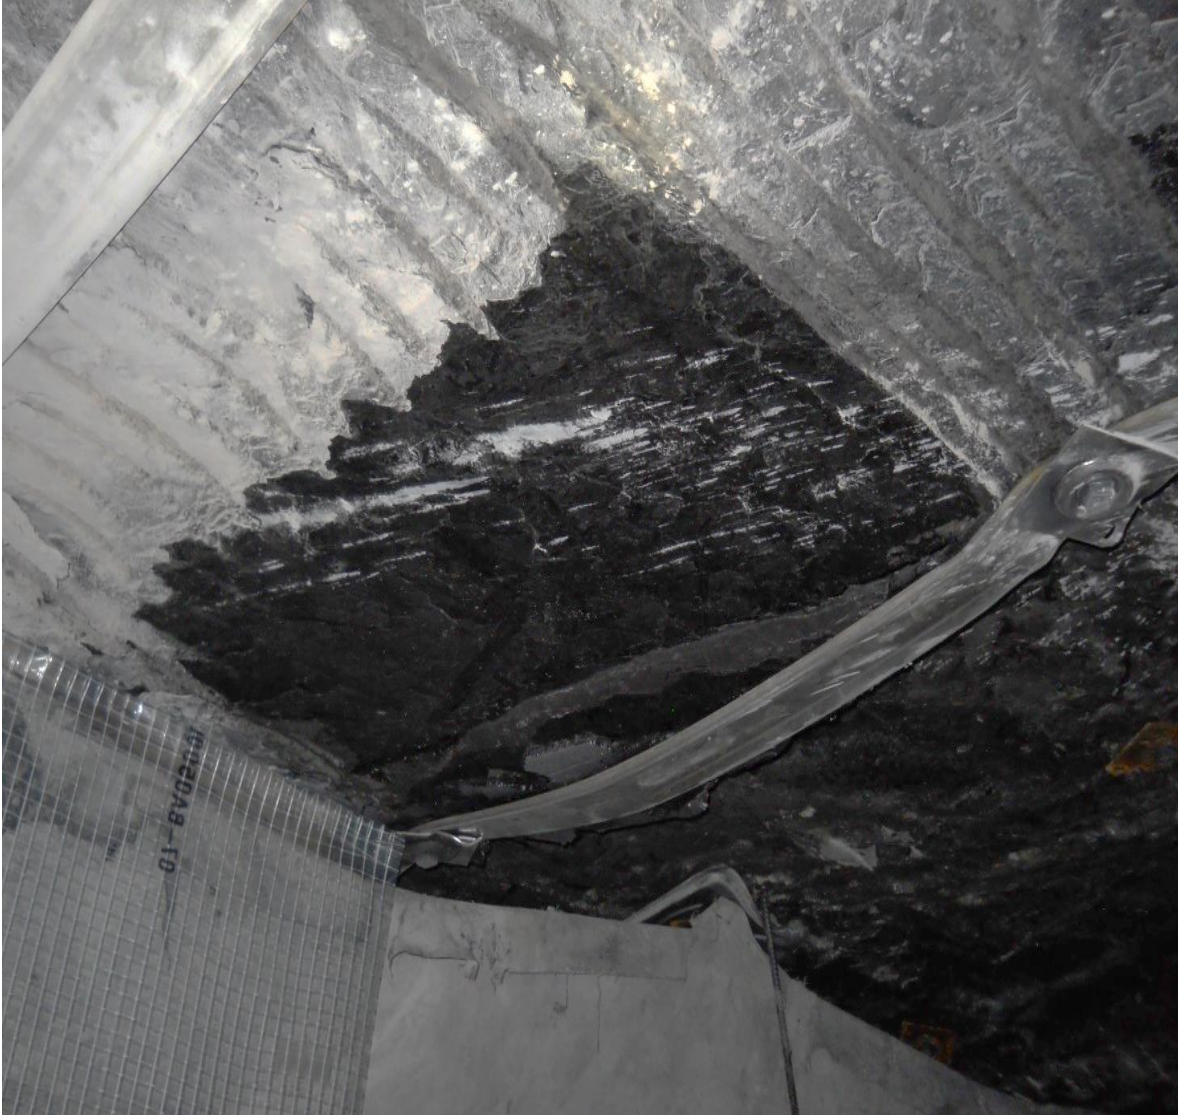
PHOTO OF ROOF AT ACCIDENT SCENE

In the working place where the accident occurred, the roof contained portions of shale rock in sporadic locations along its horizon. The shale rock ranged from less than 1 inch to 8 inches in thickness. In addition to the portions of draw rock, which fell during the accident, other portions of the shale had loosened and become draw rock, which was identified and pulled down during the investigation. The mine roof in this area was also severely fossilized, with numerous large fossils where the thin layers of shale had separated and fallen away from the sandstone bed. These fossils contained thin coal streaks and thin unconsolidated layers of shale rock at the transitioning point where they joined the sandstone.

As a result, the immediate mine roof contained portions of firm sandstone along with portions of thin, loose, and unconsolidated layers of shale, intermixed at the roof horizon. The thin shale layers had broken edges, which terminated at varying positions across the working place, and did not continue into the intersecting point of the coal pillar. This created a condition that reduced the self-supporting abilities of the shale roof rock. Without bearing plates to provide surface support, thin and incomplete layers of shale rock can become loose and fall from the roof, injuring miners who work and travel under it.

During the investigation, numerous areas of shale rock (draw rock) were visually identified by the broken and unconsolidated edges present on the horizon of the mine roof. A slate bar was used to confirm these portions of draw rock were loose and improperly supported. As each of the portions of loose rock was identified, the company representatives were alerted, the rock was scaled down, and the conditions were discussed. The portions of rock identified and scaled down varied in size measuring up to 3 to 5 feet in length and width, with thickness ranging from 1 to 6 inches.

Corrective Actions: The operator implemented a corrective action plan, which included installing additional roof supports on the active working section to provide the appropriate level of support and control; revising the approved roof control plan to include minimum support systems for future developments; requiring mine examiners to perform sound and vibration tests when evaluating the roof and removing loose unsupported mine roof from safe locations; and training all miners and examiners on the corrective action plan, roof control plan revisions, and adequate examinations.

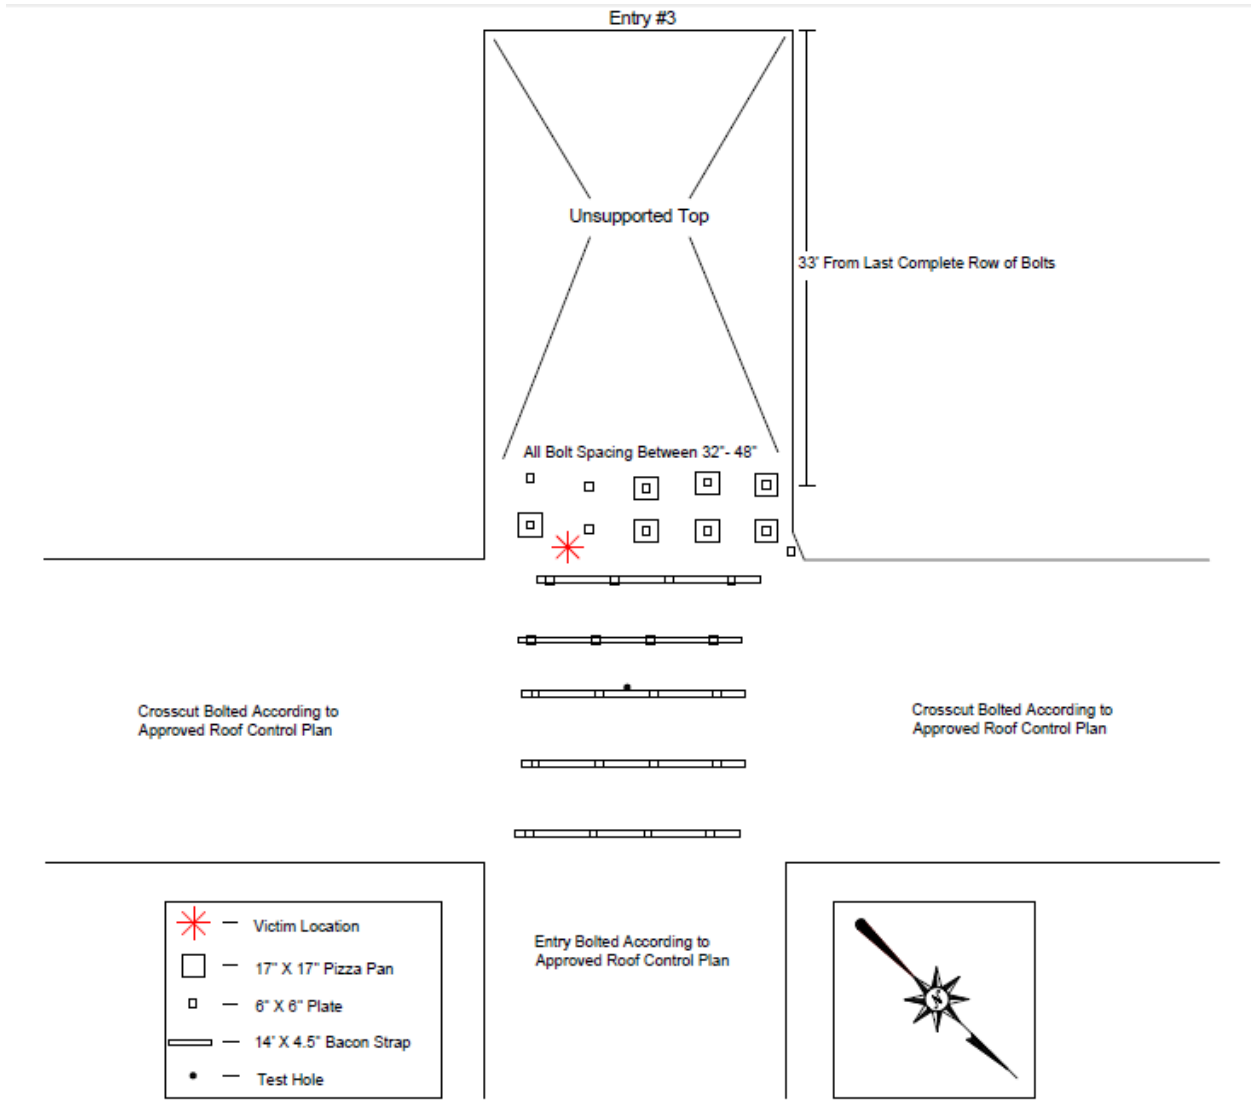
## Sketch of Accident Scene

For supplemental support, some primary roof bolts were provided with a 17-inch by 17-inch roof mat known as a "pizza pan" in addition to the 6-inch bearing plates. The mine operator also installed bolt-to-bolt straps as supplemental supports across various portions of the mine entries. These straps are 4.5 inches wide by 14 feet in length and were installed with the 6-inch bearing plates. The roof where the accident occurred was supported in the manner shown in Appendix B.

The roof bolts in front of Fillinger and to his right did not have supplemental support. It was from this area of the mine roof from which the rock fell onto Fillinger.
