REPORT OF INVESTIGATION

Fatal Machinery Accident  
October 17, 2018

No. 1 Surface Mine  
Princess Polly Anna Coal, Inc.  
Rupert, Greenbrier County, West Virginia  
ID No. 46-09473

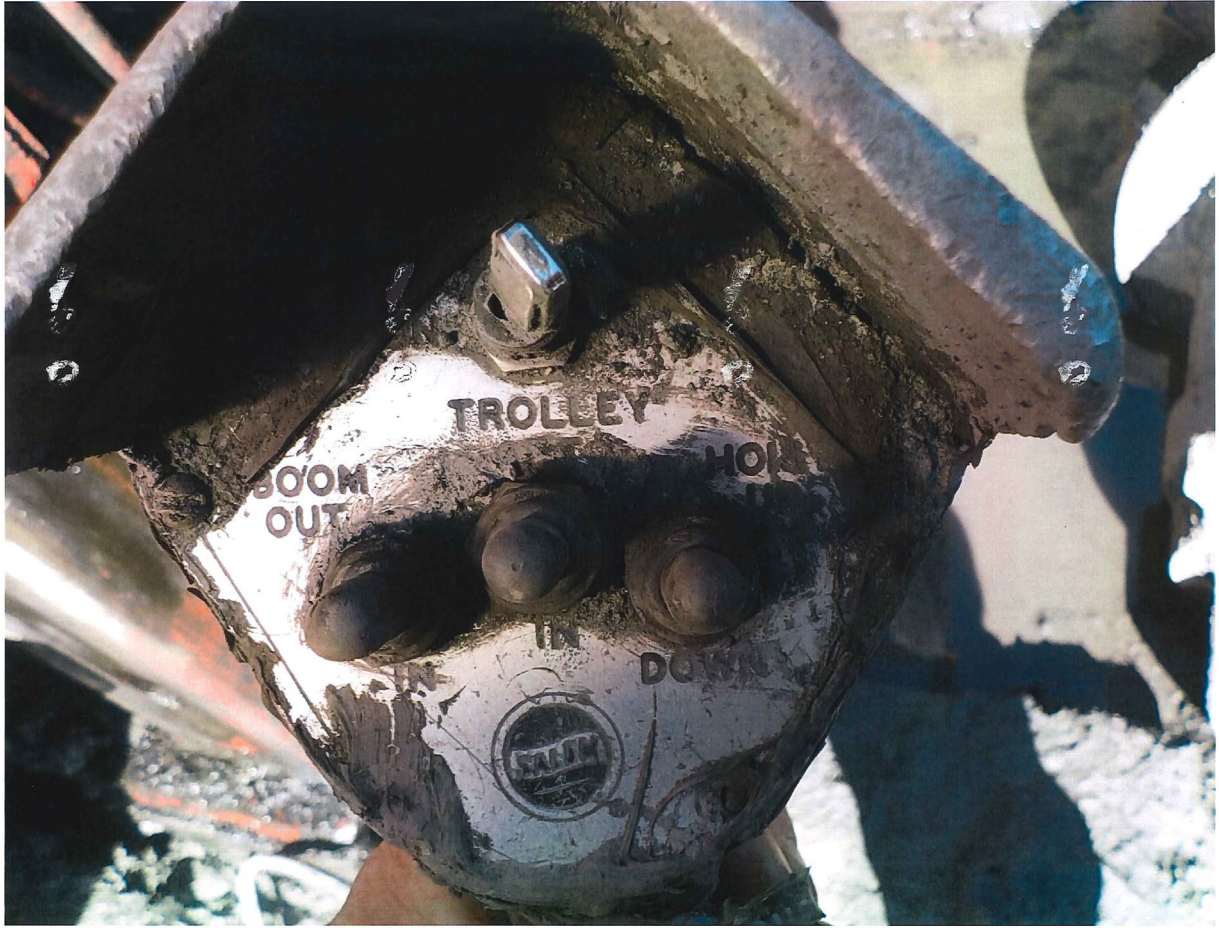
### Crane Boom Hand Held Control Picture

Investigators determined there was a defect in the crane boom swing toggle switch on the crane control handset. See "boom out" and "in" in Appendix C. When tested, in several instances this switch was placed in the swing out position, but the crane boom did not swing. For it to work, the switch had to be moved back and forth a few times.

Investigators found a brass alloy water-oil-gas gate valve, not a part of the original design, on the crane boom jack that was not rated for the operating pressure of the machine. Also, an extra, unused switch marked "Trolley" was installed on the crane control (see Appendix C). This "Trolley" control served no purpose since this machine did not have an extendable boom.

Investigators determined that the remote was equipped with a crane boom in-out "Trolley" switch that was not connected because the boom did not have this capability to extend and retract the length of the boom. The investigation team inspected the controls of the auger machine and conducted tests on the auger's crane boom hydraulic functions. Investigators determined that the on/off switch on the remote control was reversed (see Appendix D). When the switch was in the "off" position, the system was actually on. Also, the crane boom would slowly swing outward without operator input. Testing showed that when the crane boom toggle switch was placed in the neutral (stopped) position, the crane boom would swing out slowly away from the machine instead of staying still. The drift rate was 70 degrees per minute when there was no load on the crane boom and 45 degrees per minute when the crane boom was carrying an auger steel.
