REPORT OF INVESTIGATION

Fatal Rib Fall Accident  
February 6, 2018

Sentinel Mine  
Wolf Run Mining LLC  
Philippi, Barbour County, West Virginia  
ID No. 46-04168

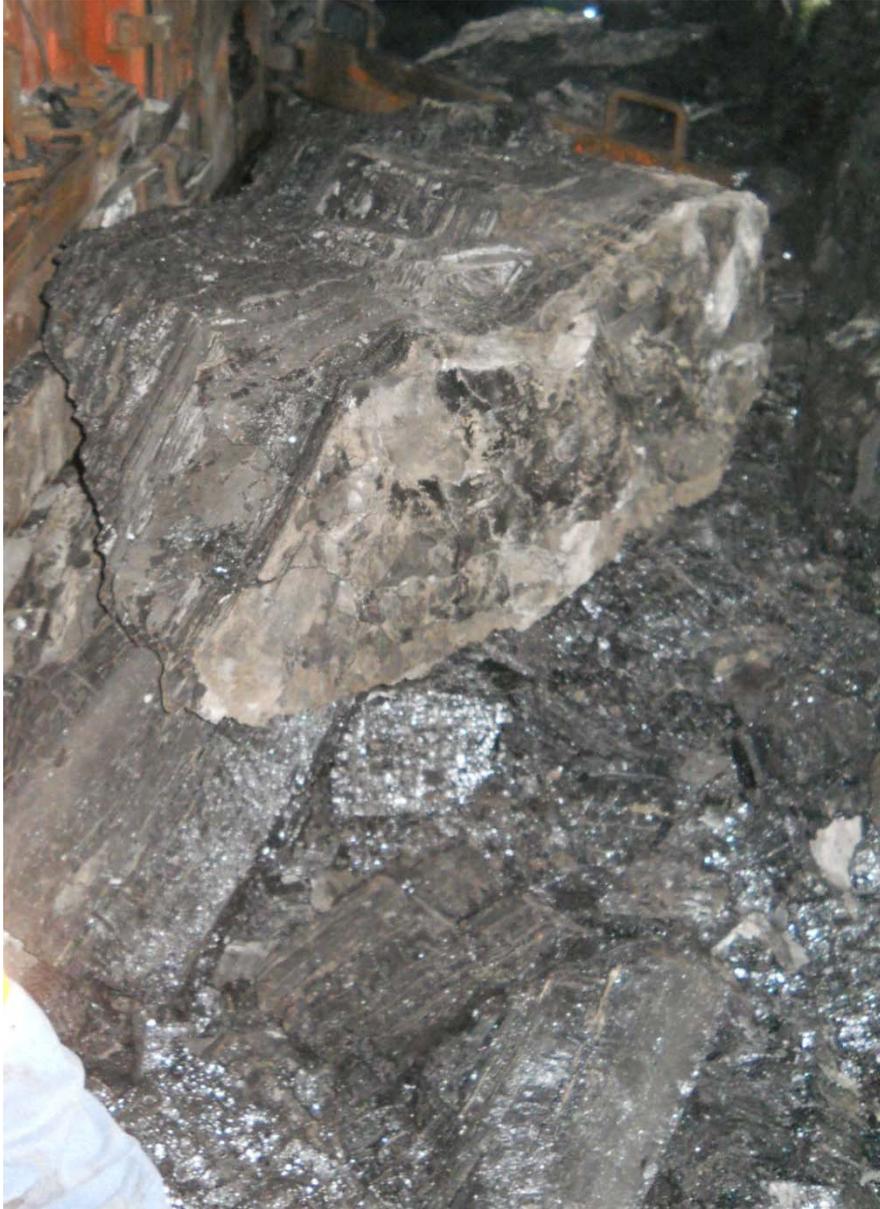
APPENDIX A  
Photograph of Piece of Fallen Rib

The fallen rib measured approximately 18 feet long by 7 feet high and up to 14 inches thick. The fallen rib material had a fragmented texture with slabs and blocks of varying sizes. The large portion of the rib removed from on top of Griffith was 36 to 42 inches long by 28 inches high and up to 14 inches thick.

The rib roll occurred because of geologic features that were difficult to see. These features became apparent during the investigation. The rib was weakened by the interaction of coal cleats, inconsistent rock partings scattered within the seam, and barely perceptible small discontinuous slickenside structures, along with the normal pillar surface yielding after an area has been mined.

36 to 42 inches long by 28 inches high and up to 14 inches thick.

Corrective Action: The mine operator revised the roof control plan to require the installation of rib bolts in all entries on development.

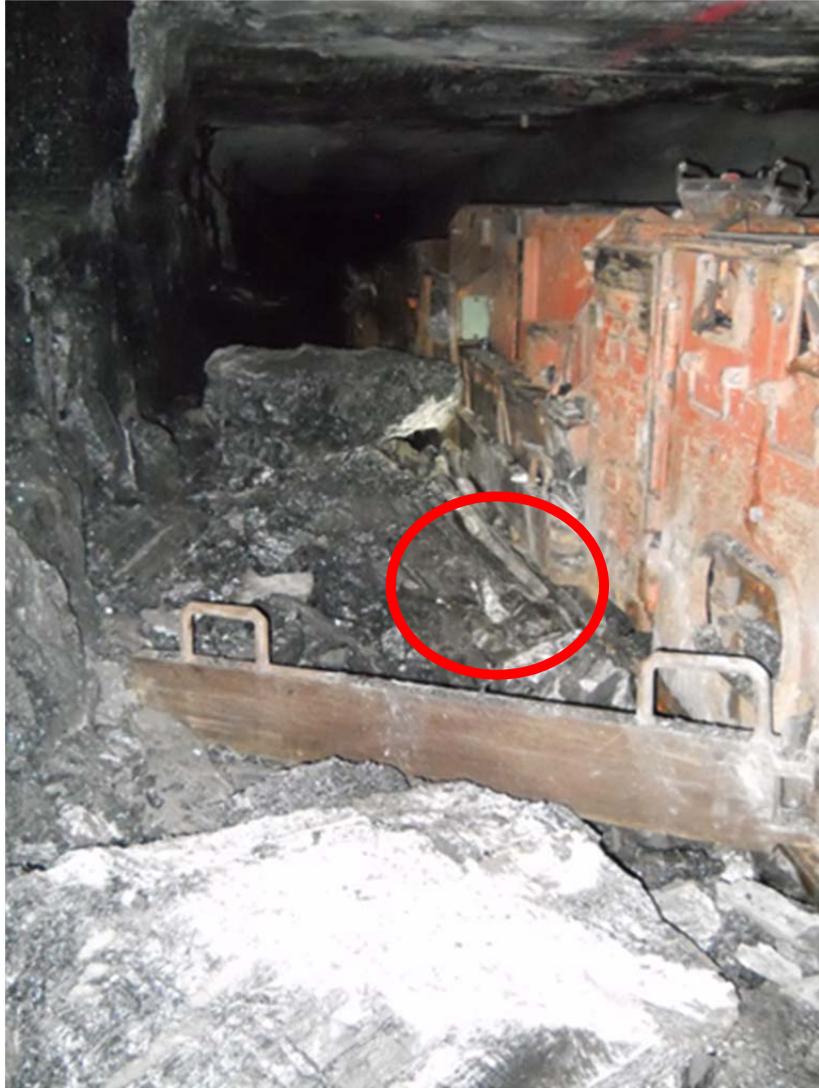
APPENDIX B  
Photograph at Accident Scene

The accident took place in the No. 1 entry just outby the No. 16 crosscut on 3-Section. The entry was mined uphill at a 15 percent grade from the No. 15 crosscut to follow a change in the orientation of the coal seam. The original mine entry at the accident site was approximately 7 feet high by 18 feet wide. The average width at the accident site after the rib roll occurred was 18.9 feet. The depth of cover was approximately 700 feet with no overmining or undermining in the vicinity.

Approximate Location of Victim
