REPORT OF INVESTIGATION

Fatal Rib Fall Accident  
February 6, 2018

Sentinel Mine  
Wolf Run Mining LLC  
Philippi, Barbour County, West Virginia  
ID No. 46-04168

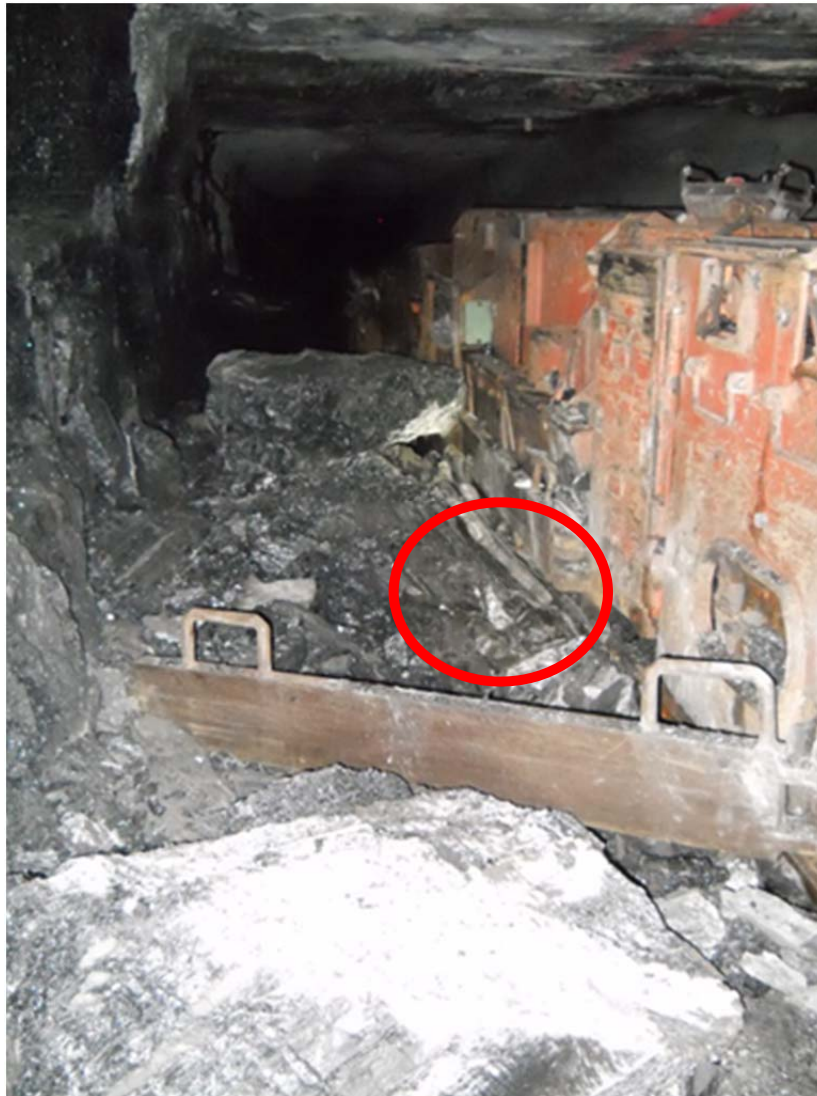
APPENDIX B  
Photograph at Accident Scene

The accident took place in the No. 1 entry just outby the No. 16 crosscut on 3-Section. The entry was mined uphill at a 15 percent grade from the No. 15 crosscut to follow a change in the orientation of the coal seam. The original mine entry at the accident site was approximately 7 feet high by 18 feet wide. The average width at the accident site after the rib roll occurred was 18.9 feet. The depth of cover was approximately 700 feet with no overmining or undermining in the vicinity.

The rib roll occurred because of geologic features that were difficult to see. These features became apparent during the investigation. The rib was weakened by the interaction of coal cleats, inconsistent rock partings scattered within the seam, and barely perceptible small discontinuous slickenside structures, along with the normal pillar surface yielding after an area has been mined.

Approximate Location of Victim

Corrective Action: The mine operator revised the roof control plan to require the installation of rib bolts in all entries on development.
