REPORT OF INVESTIGATION

Fatal Powered Haulage Accident
December 20, 2018

North Fork
AK Coal Resources, Inc.
Acosta, Somerset County, Pennsylvania
ID No. 36-10041

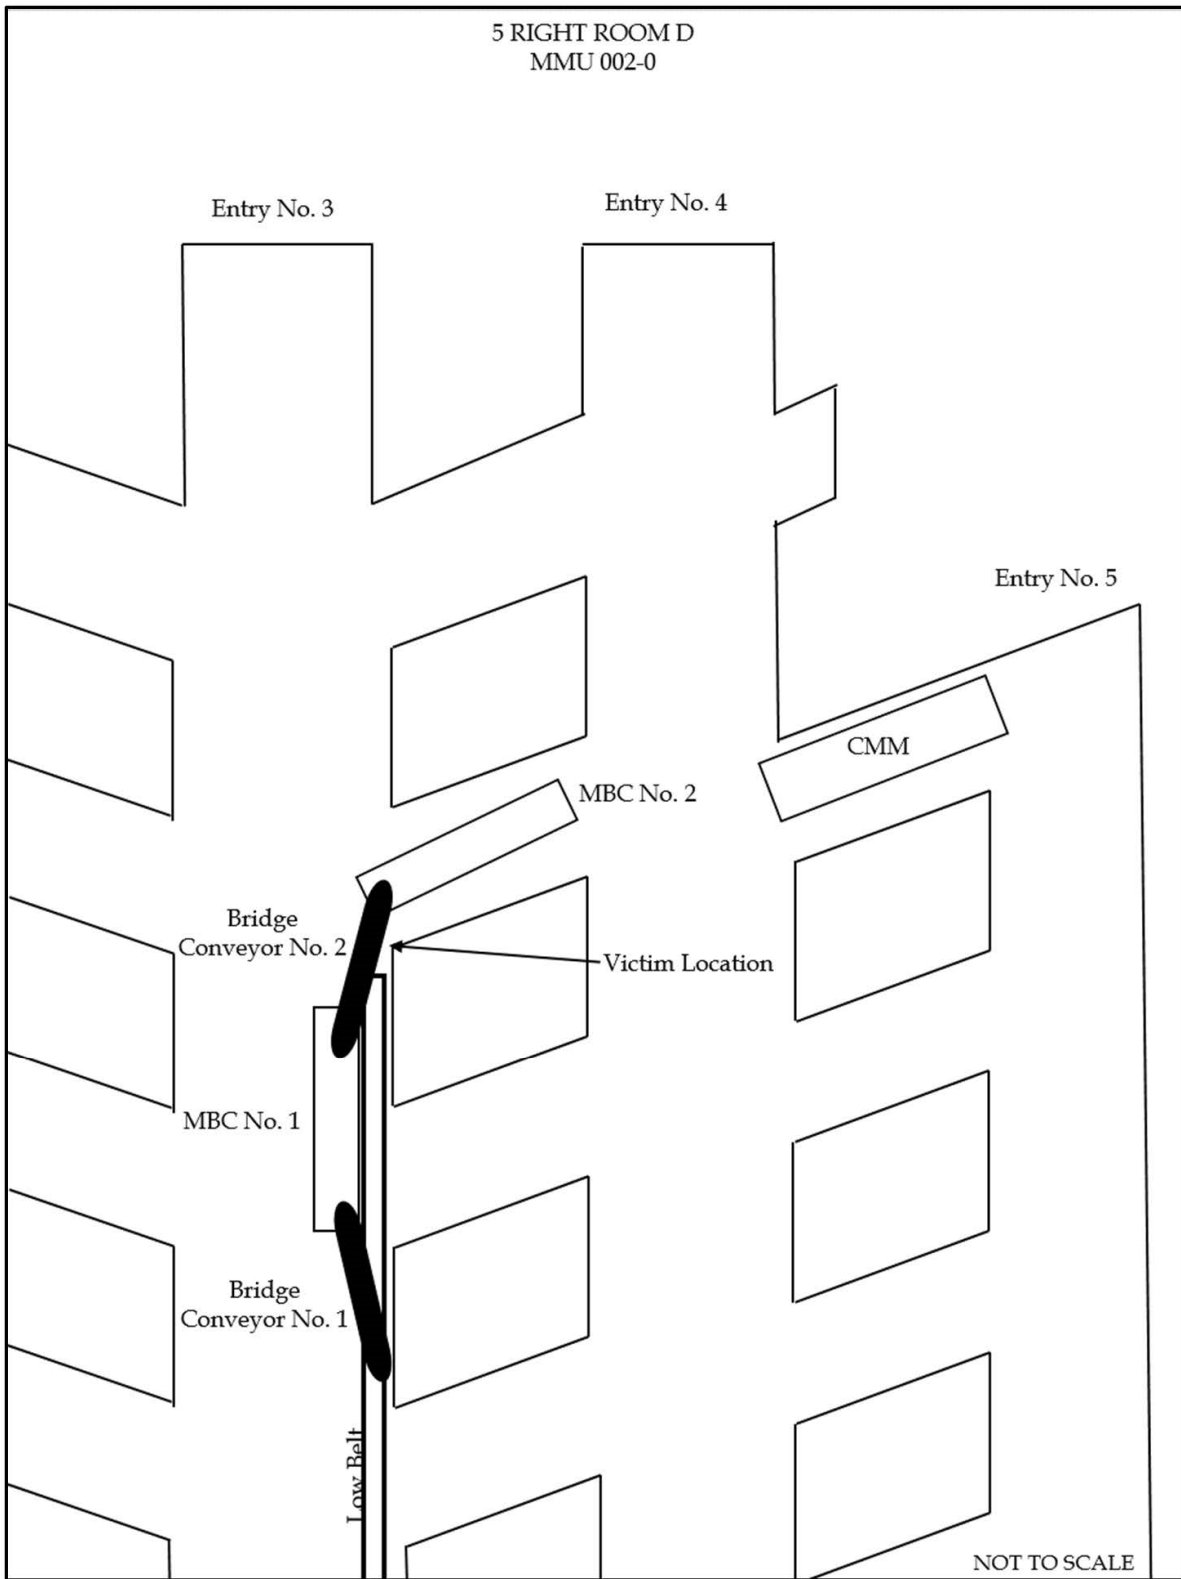
Appendix A
Victim Location

The accident occurred 5 feet inby station spad 8487, in the No. 3 entry intersection of the 5 Right Room D section. The victim was on the right outby corner of the intersection in the No. 3 entry and the No. 1 MBC was outby the corner of the intersection in the No. 3 entry, between the conveyor belt and the left coal rib (see Appendix A). The area was mined 47 inches high. The roof had permanent roof support installed, and no hazardous conditions were observed in the roof and ribs in the area. The mine roof, ribs, and bottom were dry.

The continuous haulage mining system involved in the accident was a “detached system,” meaning that the MBCs and bridge conveyors were not physically attached to the CMM. In addition, the MBCs did not have operator compartments and were remotely controlled. The continuous haulage system was a Fairchild¹, Model - Hi-Cap XL, Serial Number (SN) MBC 13-182, MSHA approval number 2G-3326A-7. The No. 2 (inby) MBC collects the mined coal from the rear of the CMM. A bridge conveyor connects the No. 2 MBC to the No. 1 (outby) MBC and another bridge conveyor connects the No. 1 MBC to the section conveyor belt (see Appendix A).
