REPORT OF INVESTIGATION

Surface Coal Mine Facility

Fatal Machinery Accident  
November 29, 2018

WMPI  
Waste Management & Processors Inc.  
Gilberton, Schuylkill County, Pennsylvania  
ID No. 36-07805

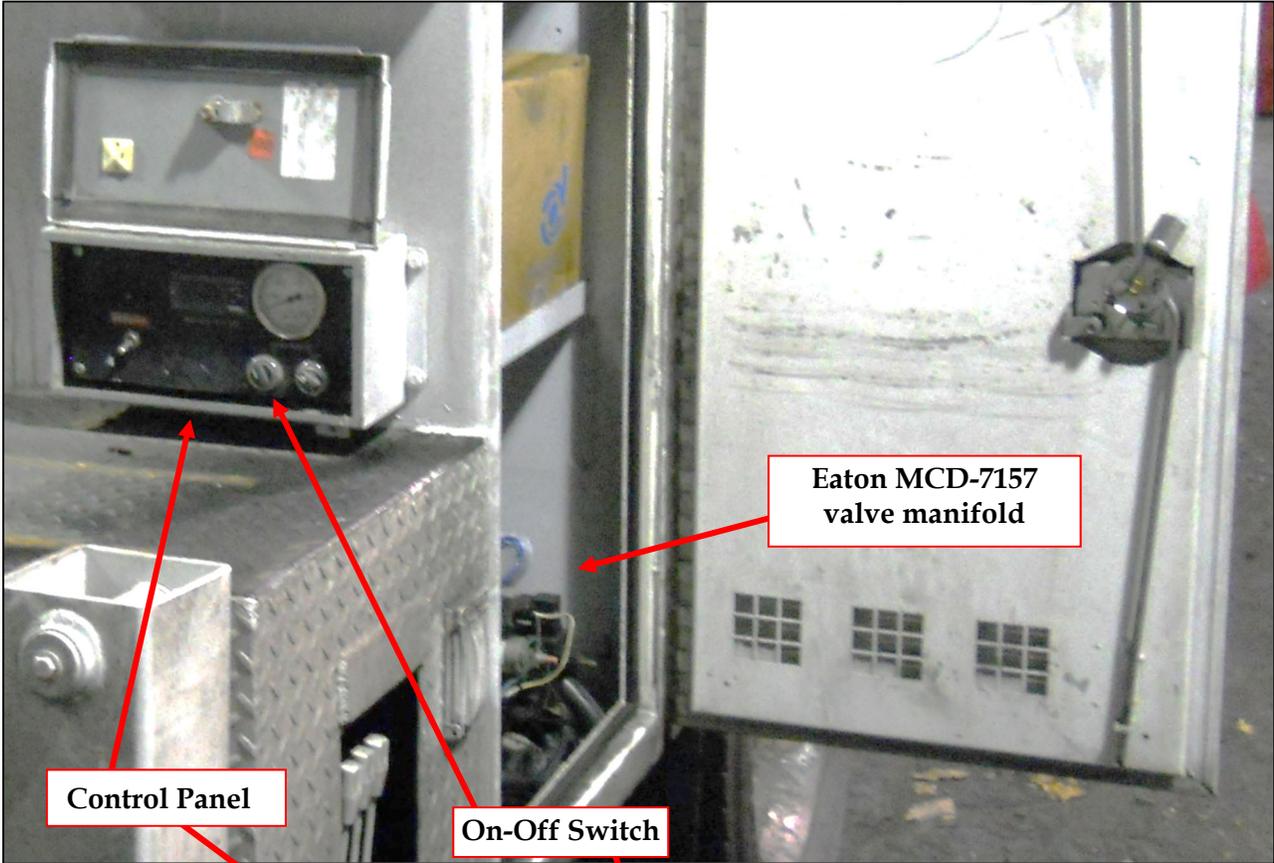
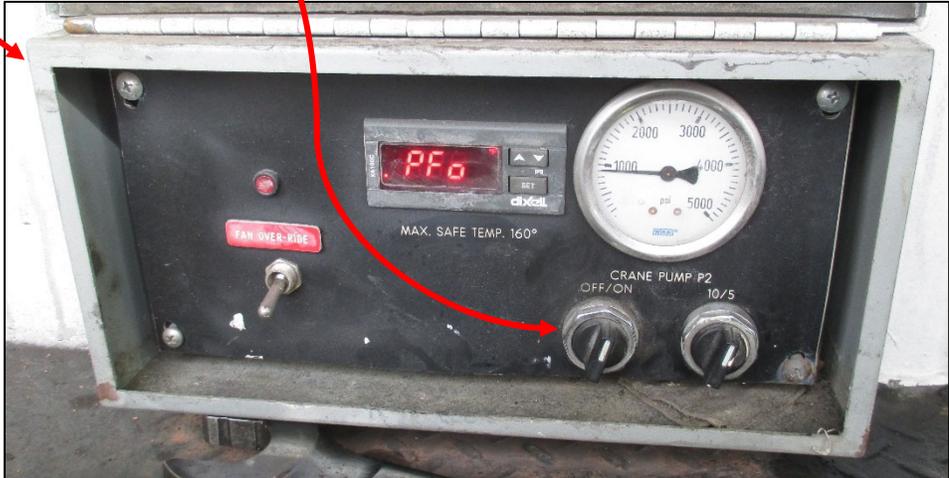
Appendix B  
Control Panel and On-Off Switch

An “on-off” switch on a panel near the rear of the truck controlled whether hydraulic pressure was directed to the hose reel or the crane. The “on” position typically sent up to 200 psi to the reel while the “off” position sent up to 3,000 psi to the crane (see Appendix B). On the day of the accident, Morgan had modified the hydraulic system to direct 3,000 psi to the reel instead of the typical 200 psi when the switch was in the “on” position. He told investigators that he modified the hydraulic system to remove components that were not needed for operation of the crane.

Based on a review of the evidence, inspectors believe it is most likely that Ney turned the on-off switch partially to the “on” position while examining the hydraulic system at close range. This would have directed excessive pressure to the hydraulic reel, causing the temperature sensor to burst from the fitting and strike the victim in the head.

Once the victim was struck, the switch was released, causing it to move back to the “off” position. A small amount of hydraulic fluid was found after the accident. If the

switch remained in the “on” position after the victim was struck, hydraulic fluid would have continued to be pumped out of the fitting.

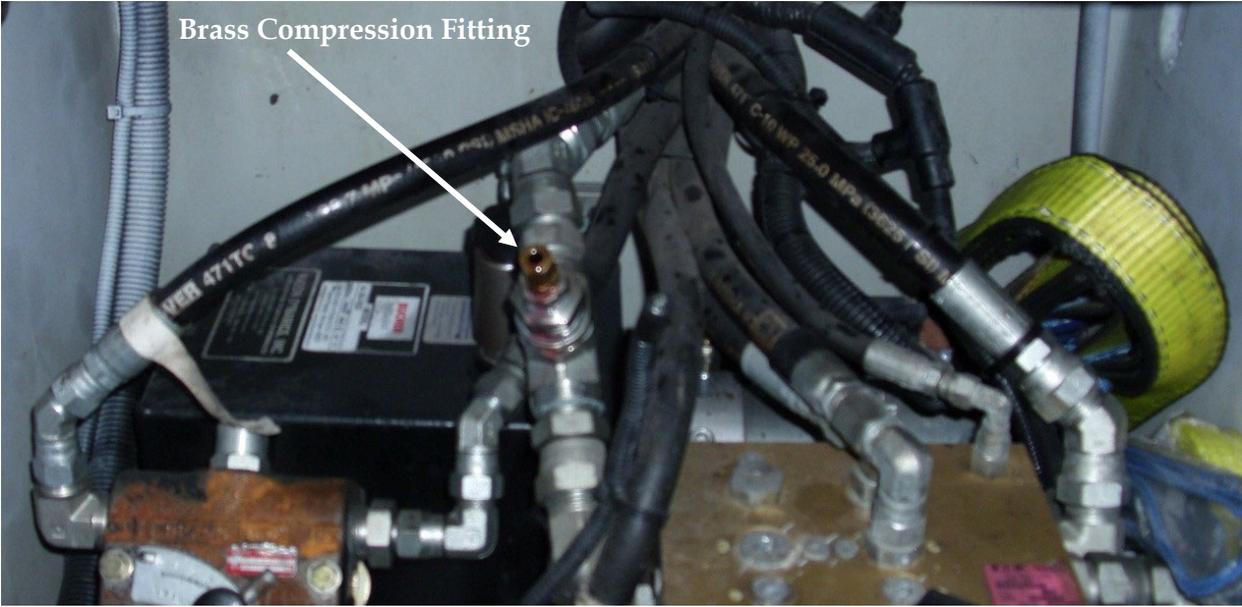
Appendix C  
Brass Compression Fitting

The hydraulic reel circuit included a brass compression fitting that held a temperature sensor (see Appendix C). The fitting had a maximum rating of 800 psi which is significantly less than the 3,000 psi it was subjected to after Morgan modified the hydraulic system. Ney was examining this area at the time of the accident (see Appendix D).

Corrective Action: The mine operator developed new task training incorporating best practices. The operator provided new task training to miners who maintain and/or repair hydraulic systems. This training included safe work procedures when working on hydraulic systems, with instruction to not pressurize hydraulic systems prior to the completion of repairs.
