REPORT OF INVESTIGATION

Fatal Electrical Accident
February 21, 2018

SHM52 Highwall Miner
Bundy Auger Mining, Inc.
Rhodell, Raleigh County, West Virginia
ID No. 46-09531

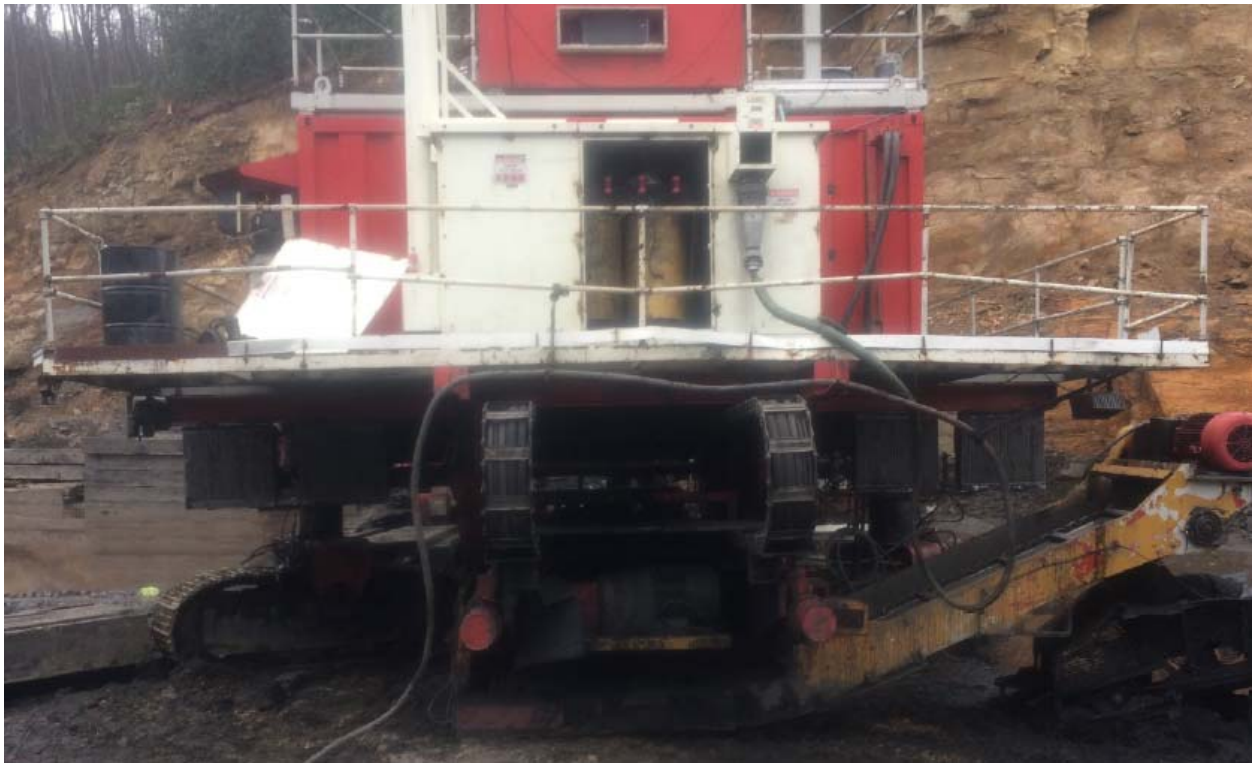
PHOTO OF ACCIDENT SCENE

The accident occurred in the transformer compartment located on the rear of the mining machine. The victim was found lying on the floor of the compartment with the upper portion of his body positioned behind three high voltage transformers. An access panel adjacent to the transformer bank had been removed to gain entry into the compartment. This provided a 12 inch wide opening between the transformer bank and the incoming 7,200 VAC cable connections/load break switch (see Appendix B).

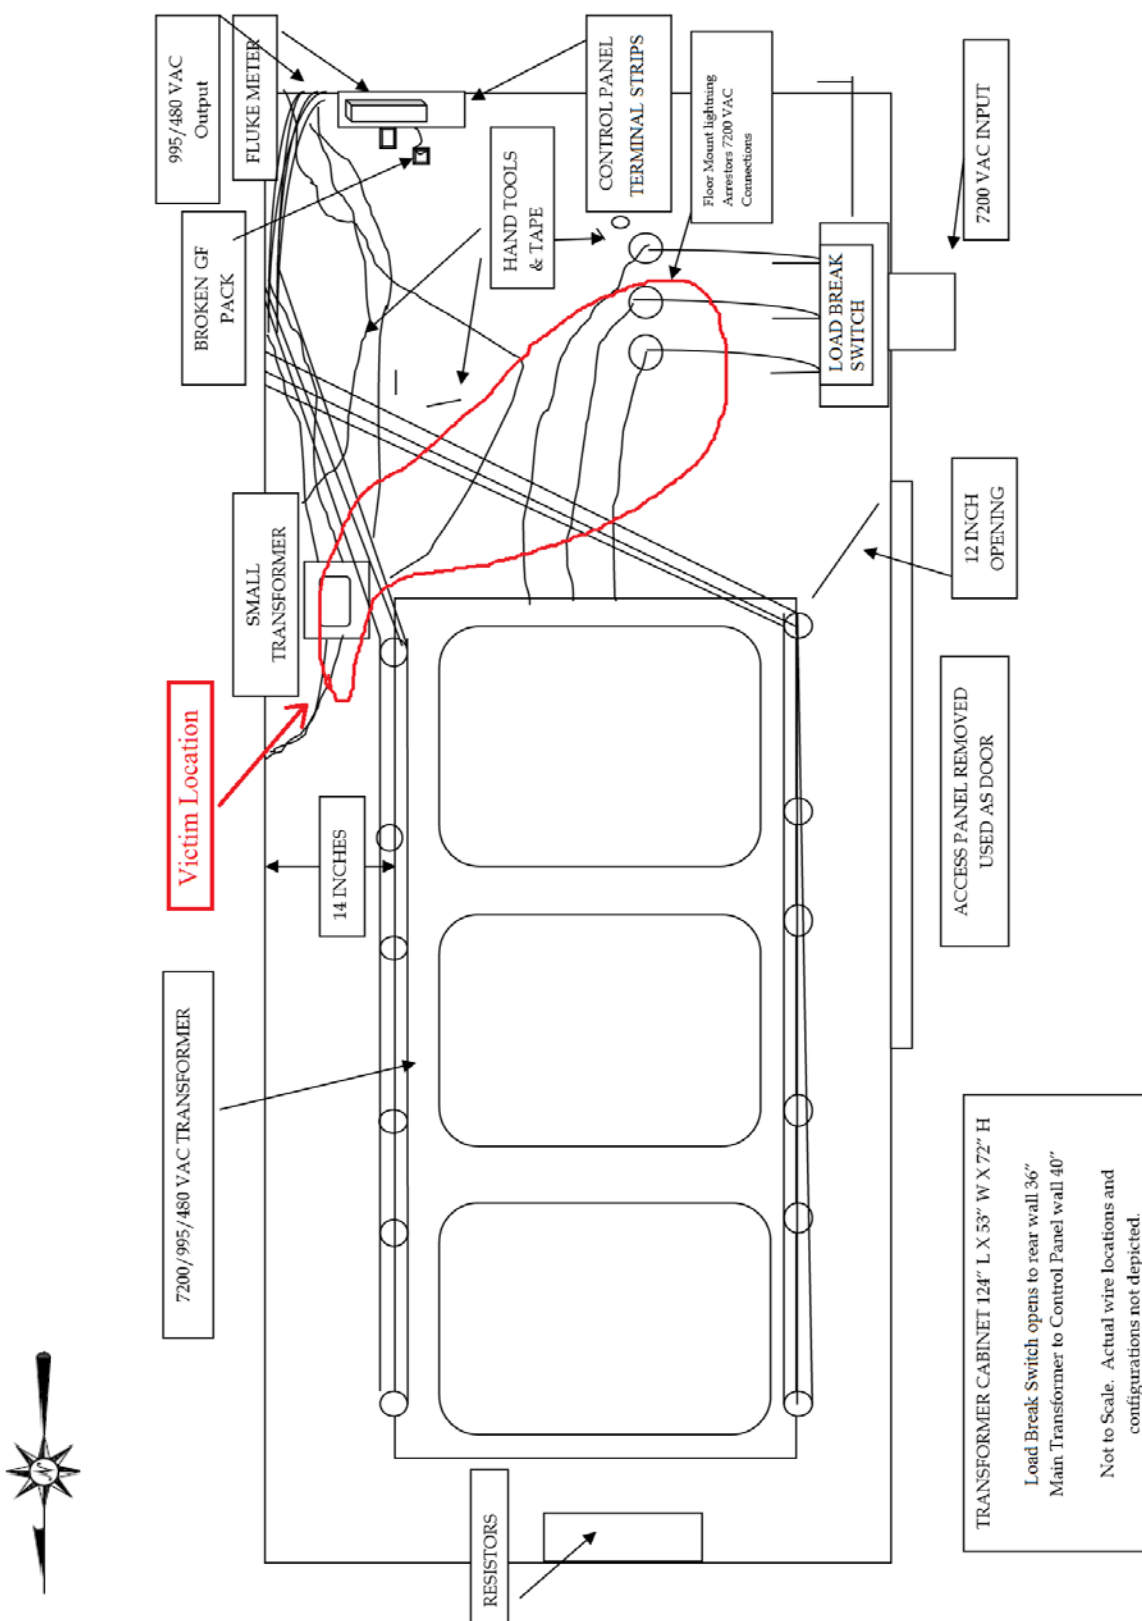
Sketch of Transformer Compartment

The victim came in contact with one phase of the energized portion of the switch, which caused him to experience 4,160 VAC phase-to-ground. The grounding resistor, at the substation, was 261.3 ohms and the grounding circuit from the transformer compartment to the substation was 1.98 ohms. The maximum possible ground fault current was 15.8 amperes.

Hand tools and repair materials (i.e. electrical tape, pliers, screwdrivers, plastic zip ties, and a Fluke® multimeter) were found lying on the floor and on top of the back-up ground fault system access panel inside the onboard transformer compartment (see Appendix B). The meter was turned off but had the test leads deployed. One of the back-up ground fault transformers had a broken mounting bracket and was hanging by the wiring. Investigators could not determine if this condition was present before the accident or was caused by the accident.

1. Only qualified personnel perform electrical work;
2. Miners receive additional training on electrical testing and repair;
3. The installation of safety features on electrical equipment. The safety features include lid switches wired into the ground monitor circuit, a grounding bar on the load break switch for the three phases of the high voltage transformers, and an additional external visible vacuum disconnect, which will also interrupt the ground monitor circuit causing the substation to remove power on the trailing cable; and
4. Proper lock /tag out procedures.
