REPORT OF INVESTIGATION

Fatal Electrical Accident
February 21, 2018

SHM52 Highwall Miner
Bundy Auger Mining, Inc.
Rhodell, Raleigh County, West Virginia
ID No. 46-09531

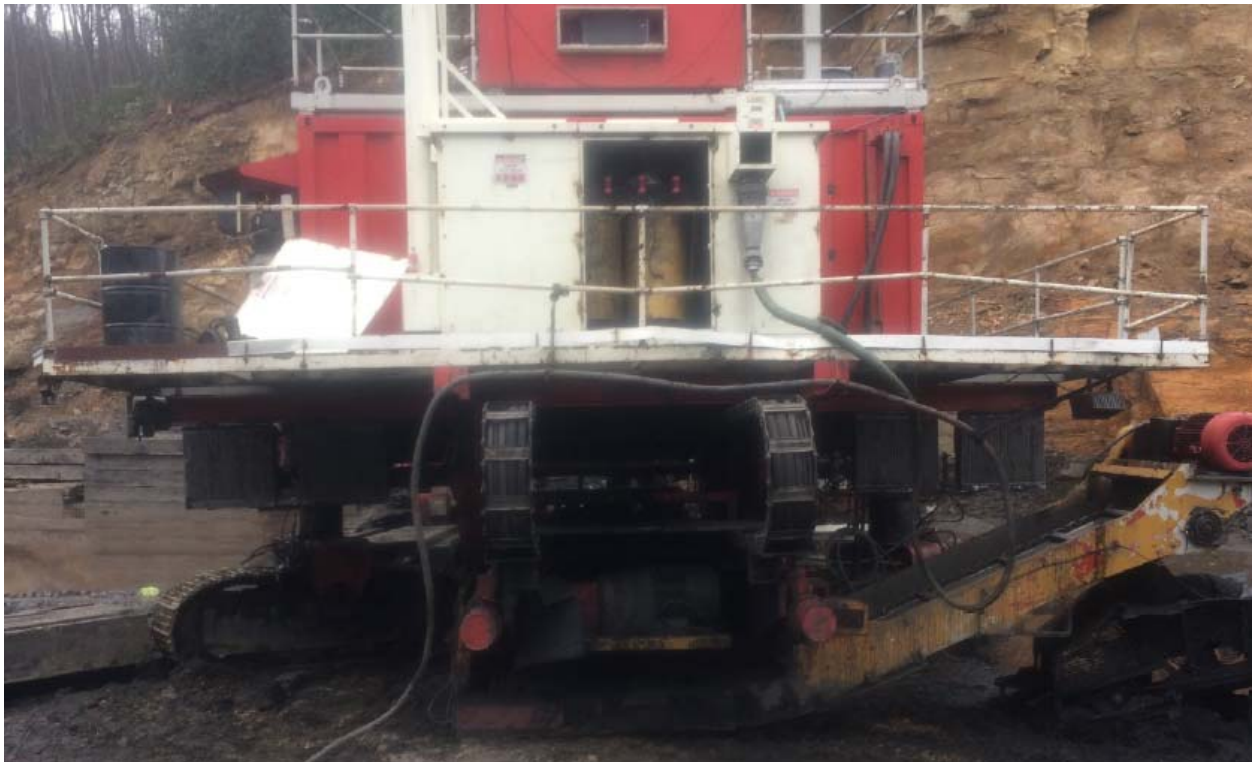
PHOTO OF ACCIDENT SCENE

The accident occurred in the transformer compartment located on the rear of the mining machine. The victim was found lying on the floor of the compartment with the upper portion of his body positioned behind three high voltage transformers. An access panel adjacent to the transformer bank had been removed to gain entry into the compartment. This provided a 12 inch wide opening between the transformer bank and the incoming 7,200 VAC cable connections/load break switch (see Appendix B).

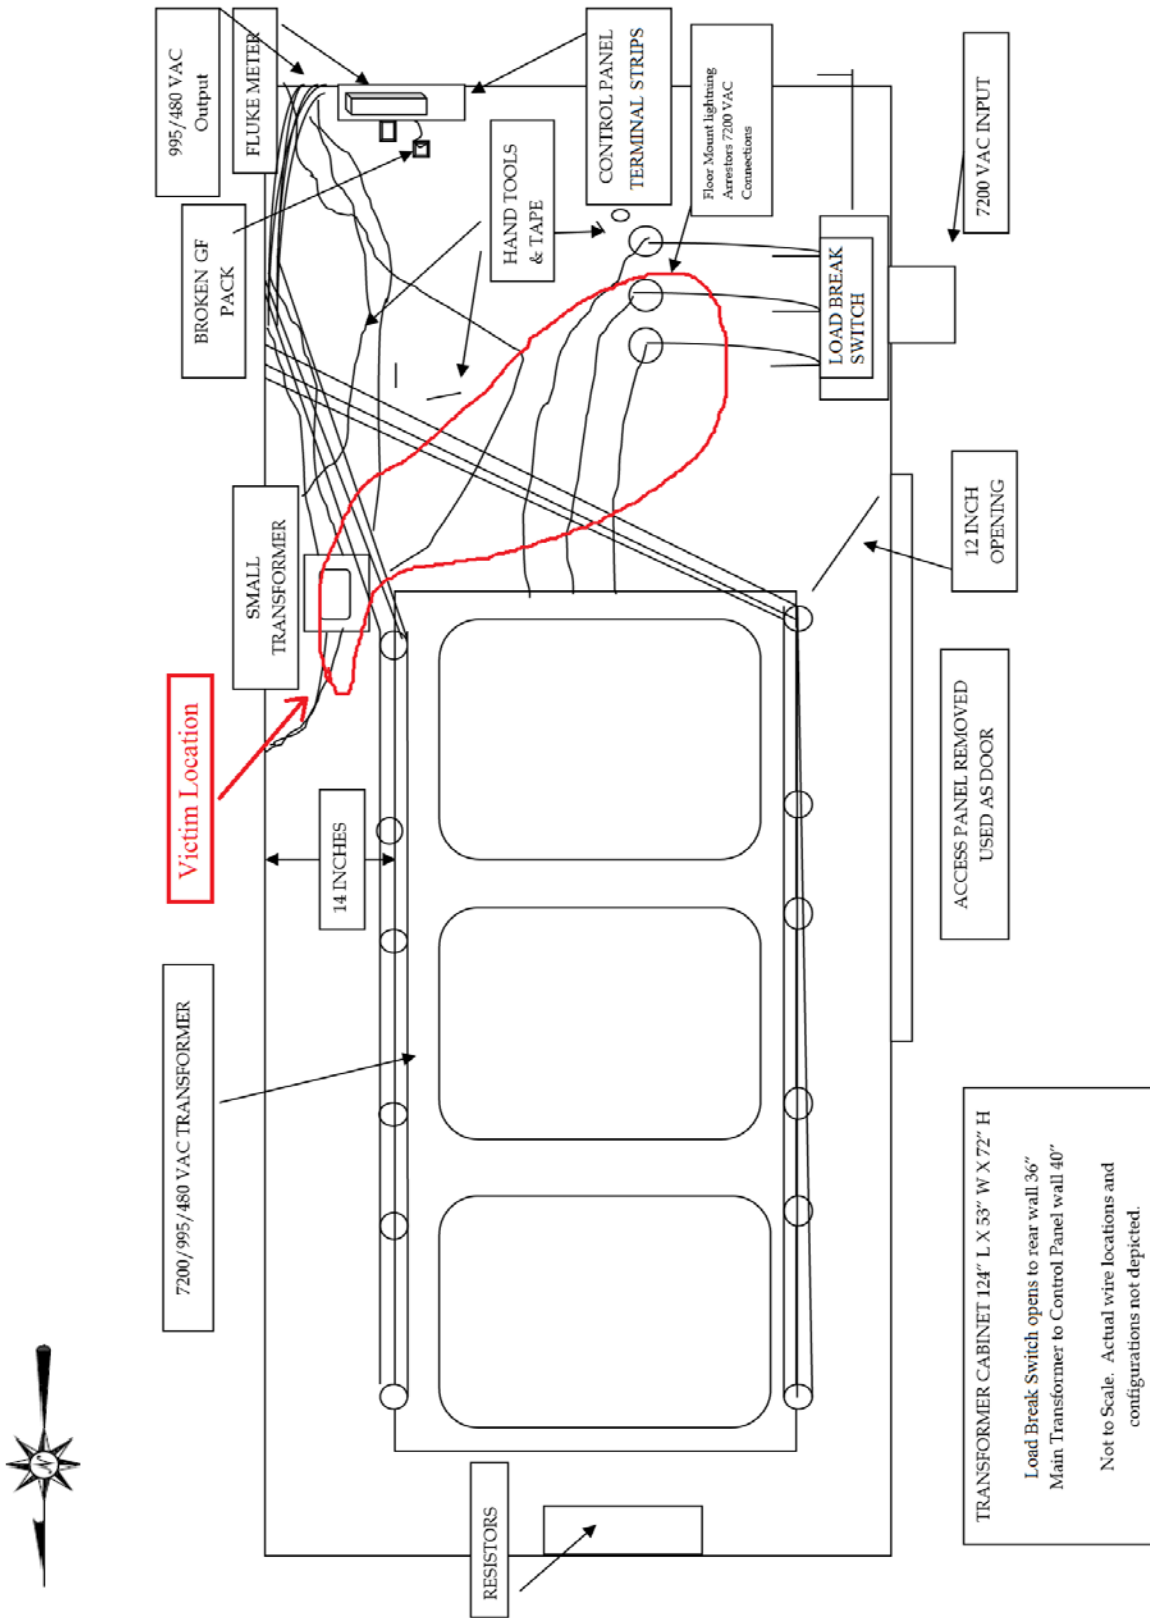
Sketch of Transformer Compartment

The transformer compartment measures 124 inches long, 53 inches wide, and 72 inches high and contains a three phase high voltage transformer bank, which transforms the incoming 7,200 VAC to 995 VAC and 480 VAC for the motors used to operate the highwall mining machine system. The compartment also contains another 480 VAC transformer, ventilating fans, high voltage lightning arrestors, and ground fault/ground monitor components for the 995 VAC and 480 VAC circuitry, along with a manually operated high voltage load break switch. The load break switch is a gang-operated (one action opens or closes three connections, one for each phase, at the same time) visual disconnect switch; it was found in the open position. When in the open position, the switch provides visual evidence that the circuitry in the transformer compartment is deenergized, except the line side of the switch, which remains energized with 7,200 VAC.

The victim came in contact with one phase of the energized portion of the switch, which caused him to experience 4,160 VAC phase-to-ground. The grounding resistor, at the substation, was 261.3 ohms and the grounding circuit from the transformer compartment to the substation was 1.98 ohms. The maximum possible ground fault current was 15.8 amperes.

Hand tools and repair materials (i.e. electrical tape, pliers, screwdrivers, plastic zip ties, and a Fluke® multimeter) were found lying on the floor and on top of the back-up ground fault system access panel inside the onboard transformer compartment (see Appendix B). The meter was turned off but had the test leads deployed. One of the back-up ground fault transformers had a broken mounting bracket and was hanging by the wiring. Investigators could not determine if this condition was present before the accident or was caused by the accident.

1. Only qualified personnel perform electrical work;
2. Miners receive additional training on electrical testing and repair;
3. The installation of safety features on electrical equipment. The safety features include lid switches wired into the ground monitor circuit, a grounding bar on the load break switch for the three phases of the high voltage transformers, and an additional external visible vacuum disconnect, which will also interrupt the ground monitor circuit causing the substation to remove power on the trailing cable; and
4. Proper lock /tag out procedures.
