REPORT OF INVESTIGATION

Fatal Powered Haulage Accident  
January 14, 2019

Toms Fork Mine  
TENNCO INC.  
Balkan, Bell County, Kentucky  
I.D. No. 15-19844

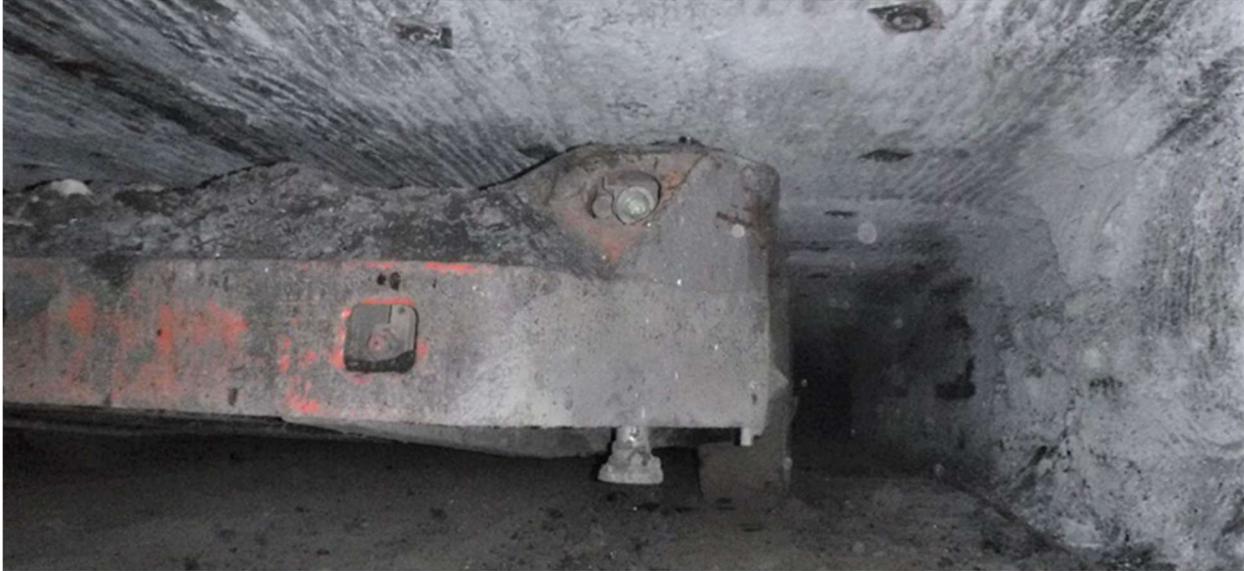
## PHOTOGRAPH OF ACCIDENT SCENE

Investigators believe the accident occurred at approximately 11:10 a.m., when Lane turned the No. 4 shuttle car into the No. 3 entry at the switch-out location. The No. 4 shuttle car is 28 feet long and Slone's map was found about 30 feet from the inby corner of the pillar (see Appendix C). This would indicate that Slone had already been struck when Barnett and Lane exited their cars to free the shuttle car cable.

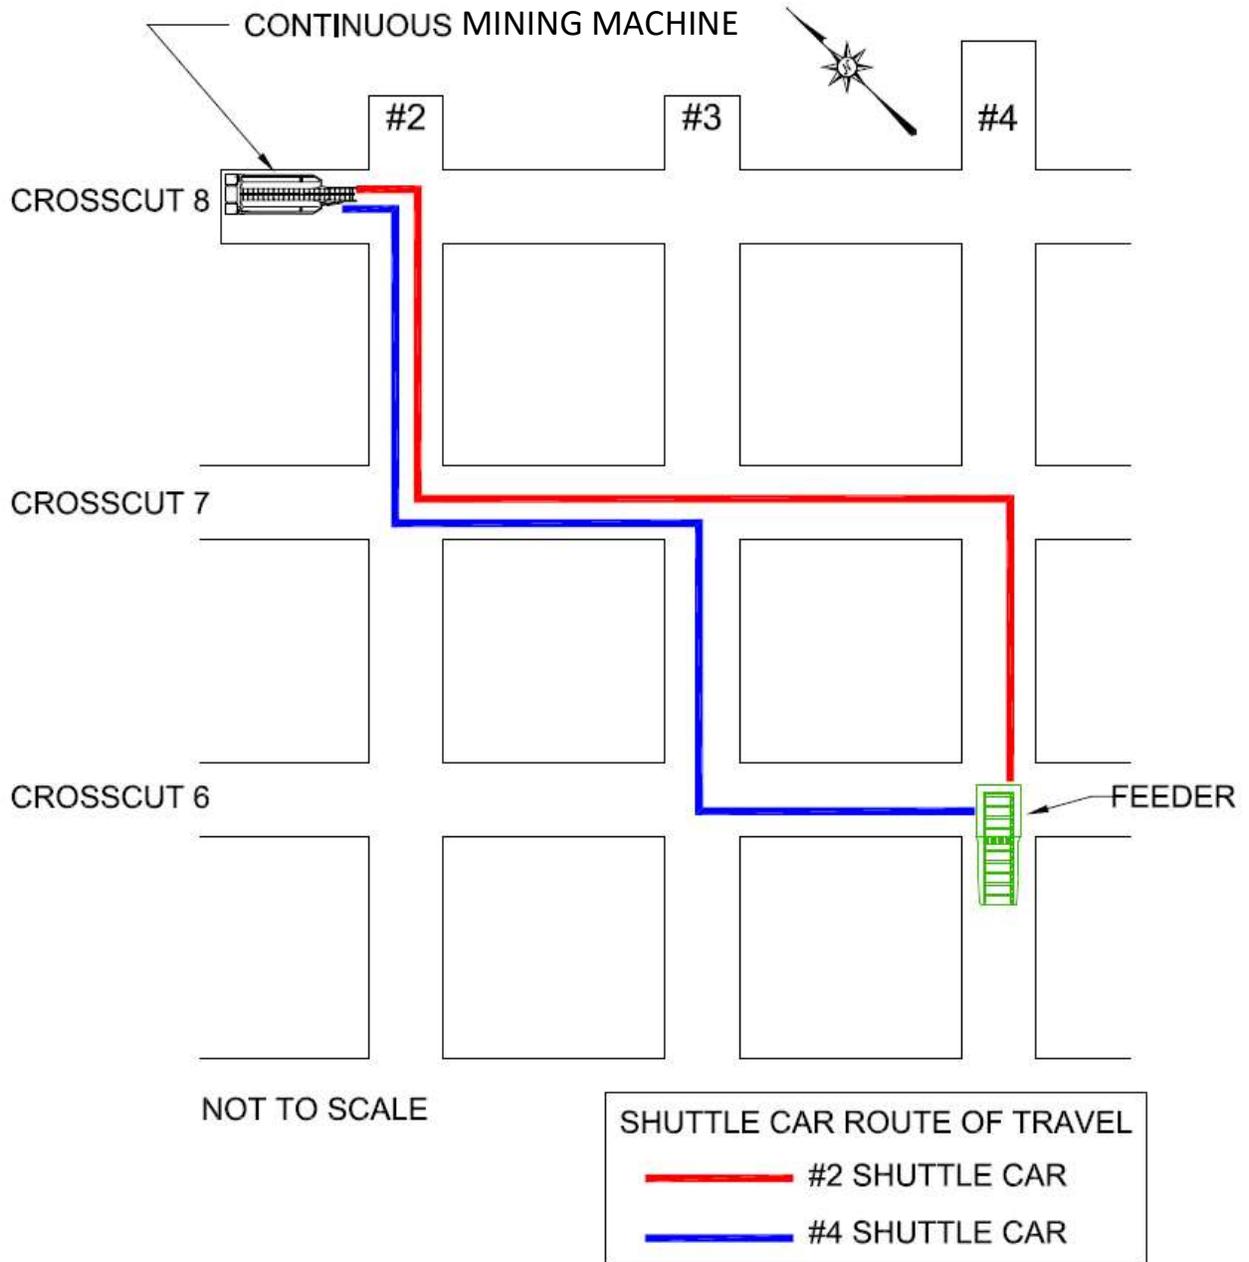
APPENDIX A  
Travel Routes of Shuttle Cars

After lunch, Richard Lane, Shuttle Car Operator, began operating the No. 4 shuttle car and James Barnett, Roof Bolter, began operating the No. 2 shuttle car. Lane drove his shuttle car to the continuous mining machine which was in the left crosscut off the No. 2 entry (see Appendix A).
