REPORT OF INVESTIGATION

Fatal Powered Haulage Accident
March 16, 2018

Oaktown Fuels Mine No. 1
Sunrise Coal LLC
Oaktown, Knox County, Indiana
I.D. 12-02394

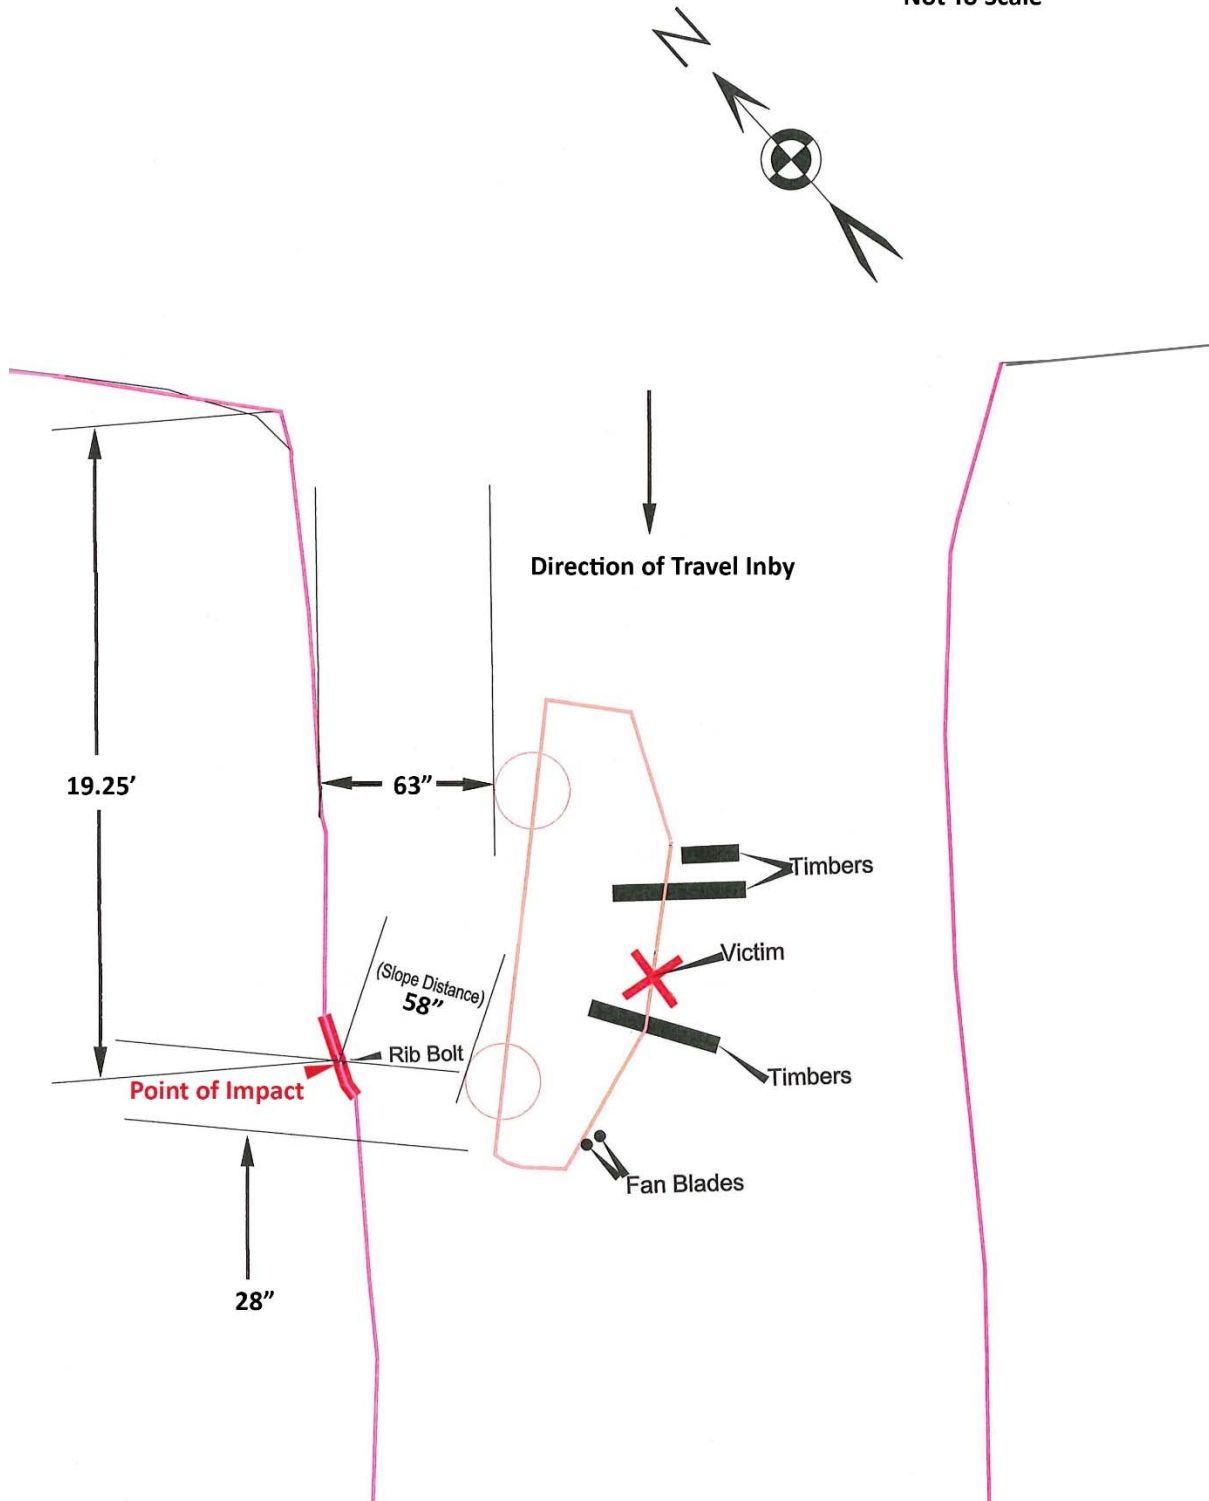
APPENDIX B
Accident Scene Drawing

The accident occurred on the M5 travelway at crosscuts 135 and 136 in entry No. 4. This is a main travelway and secondary escapeway for the mine. The entry was approximately 7 feet high and 18 feet wide. The mine floor was compacted with no abnormalities or deformities. When investigators arrived at the accident scene, they found the personnel carrier on its left side. It had been raised above the mine floor with two sets of 6" x 6" wood crib blocks under the canopy. Tire tracks showed the path the personnel carrier took to the point of impact. See Appendix B for a drawing of the accident scene.

Investigators observed hydraulic oil and diesel fuel on the mine floor that spilled from the tanks in the rear of the personnel carrier. The right coal rib that the personnel carrier struck had sheets of wire mesh bolted to the coal rib and was well rock dusted, except for the point of impact twenty-one inches above the mine floor. The impact left a hole in the wire mesh that was 2 feet wide and 1½ feet long. The right front bumper of the personnel carrier had been pushed into the right front tire which prevented investigators from being able to move the tire.
