REPORT OF INVESTIGATION

Fatal Powered Haulage Accident
June 4, 2018

Morgan Camp Mine
Carter Roag Coal Company
Mill Creek, Randolph County, West Virginia
ID No. 46-08656

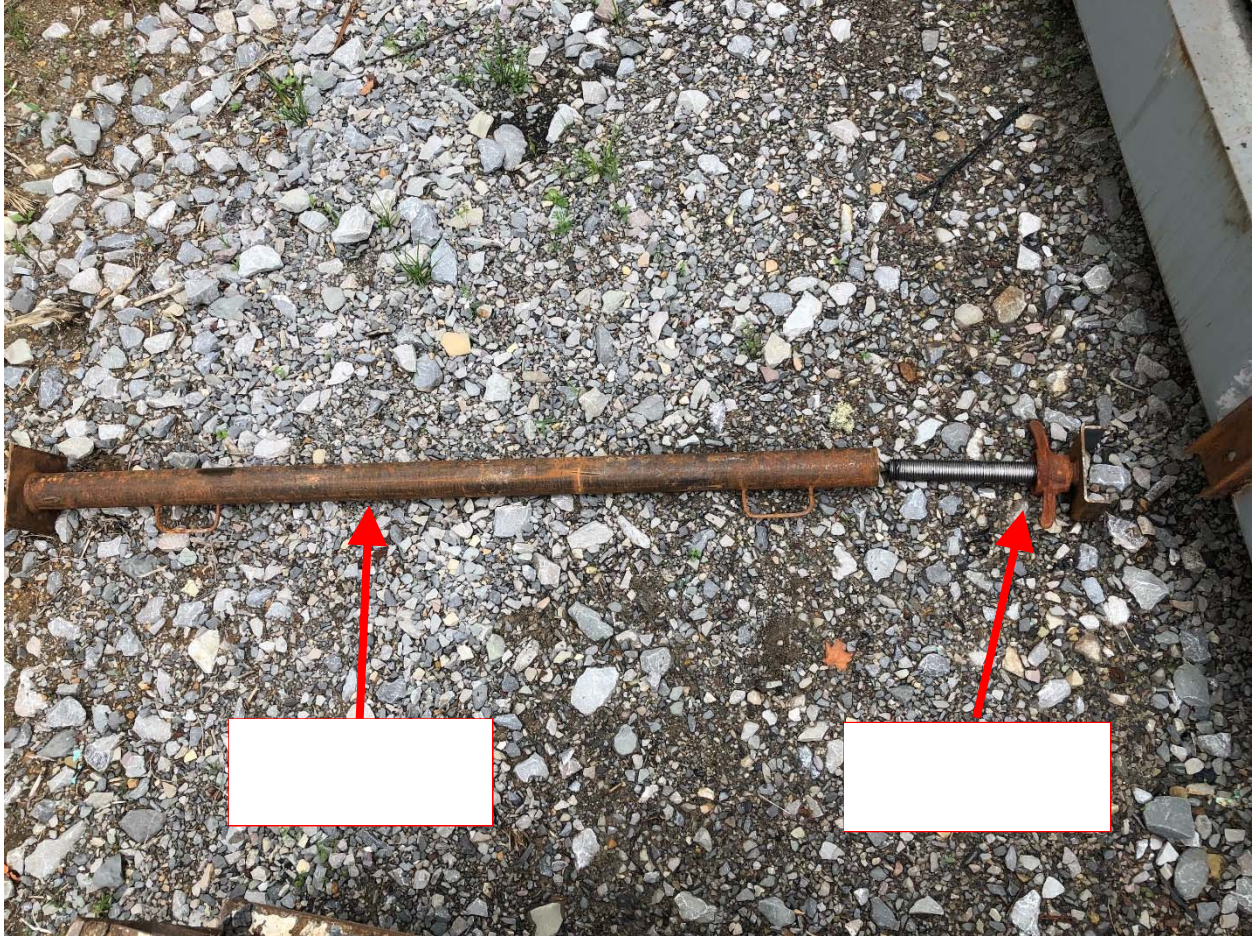
APPENDIX B
Photograph of a Roof-to-Floor Support

At approximately 11:40 p.m., the diesel personnel carrier contacted a roof-to-floor support (see Appendix B) lying in the South Mains haulage roadway at 3 block. The support base was propelled into the passenger compartment and struck Taylor in the head. Taylor was sitting in the right front passenger seat when he was struck. After striking Taylor, the support base struck Wright on the arm and then landed on the mine floor (see Appendix C). Wright was sitting in the driver's seat when he was struck.

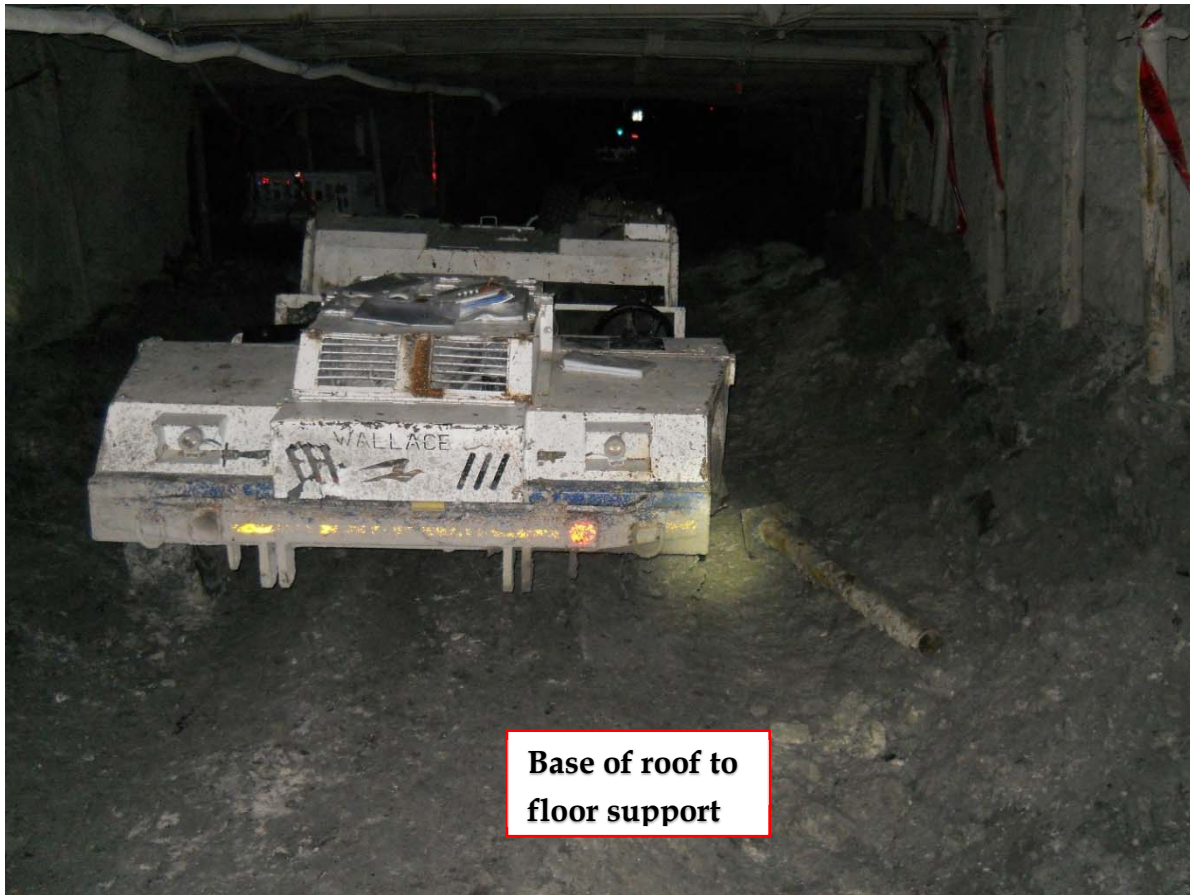
APPENDIX C

Accident Scene Photograph - Diesel Personnel Carrier and the Roof to Floor Support.

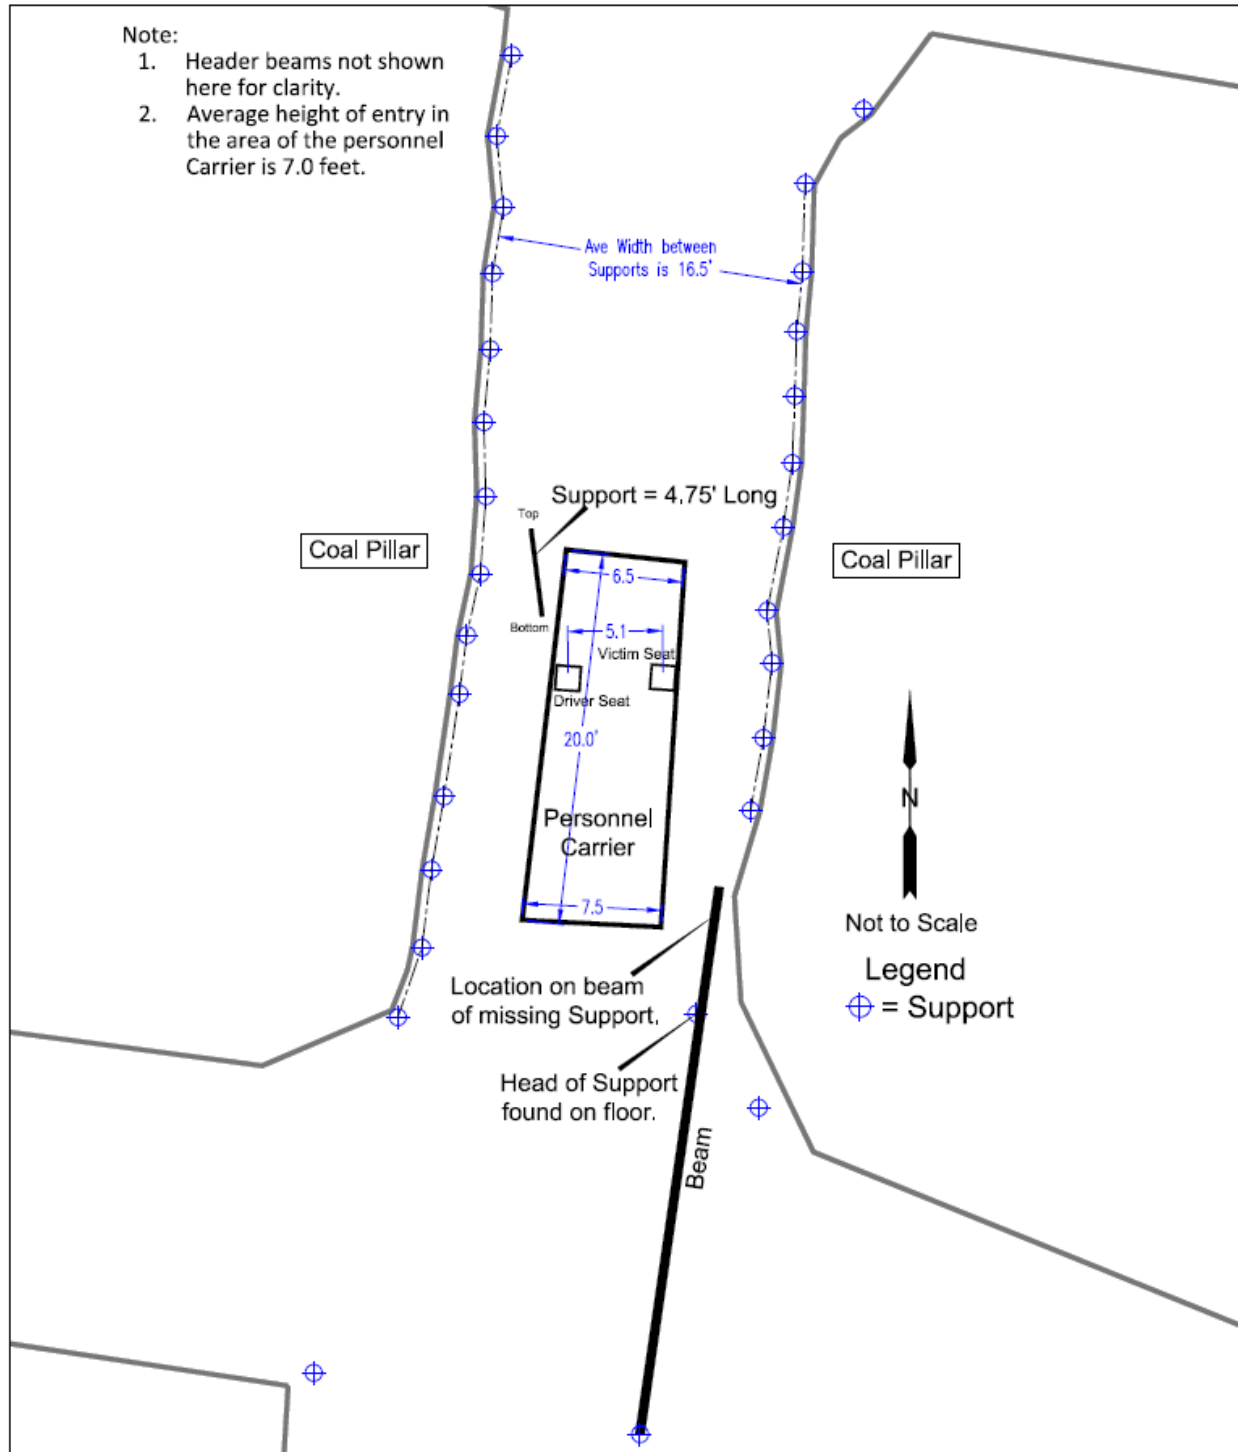
APPENDIX D

The accident investigation was conducted by Mine Safety and Health Administration (MSHA) personnel in conjunction with the West Virginia Office of Miners Health Safety and Training (WVOMHST) and mine management. The investigation team traveled underground and took pictures and measurements of the scene. The mine operator asked their surveyors to create a drawing of the accident scene (see Appendix D).

Drawing of the Accident Scene.

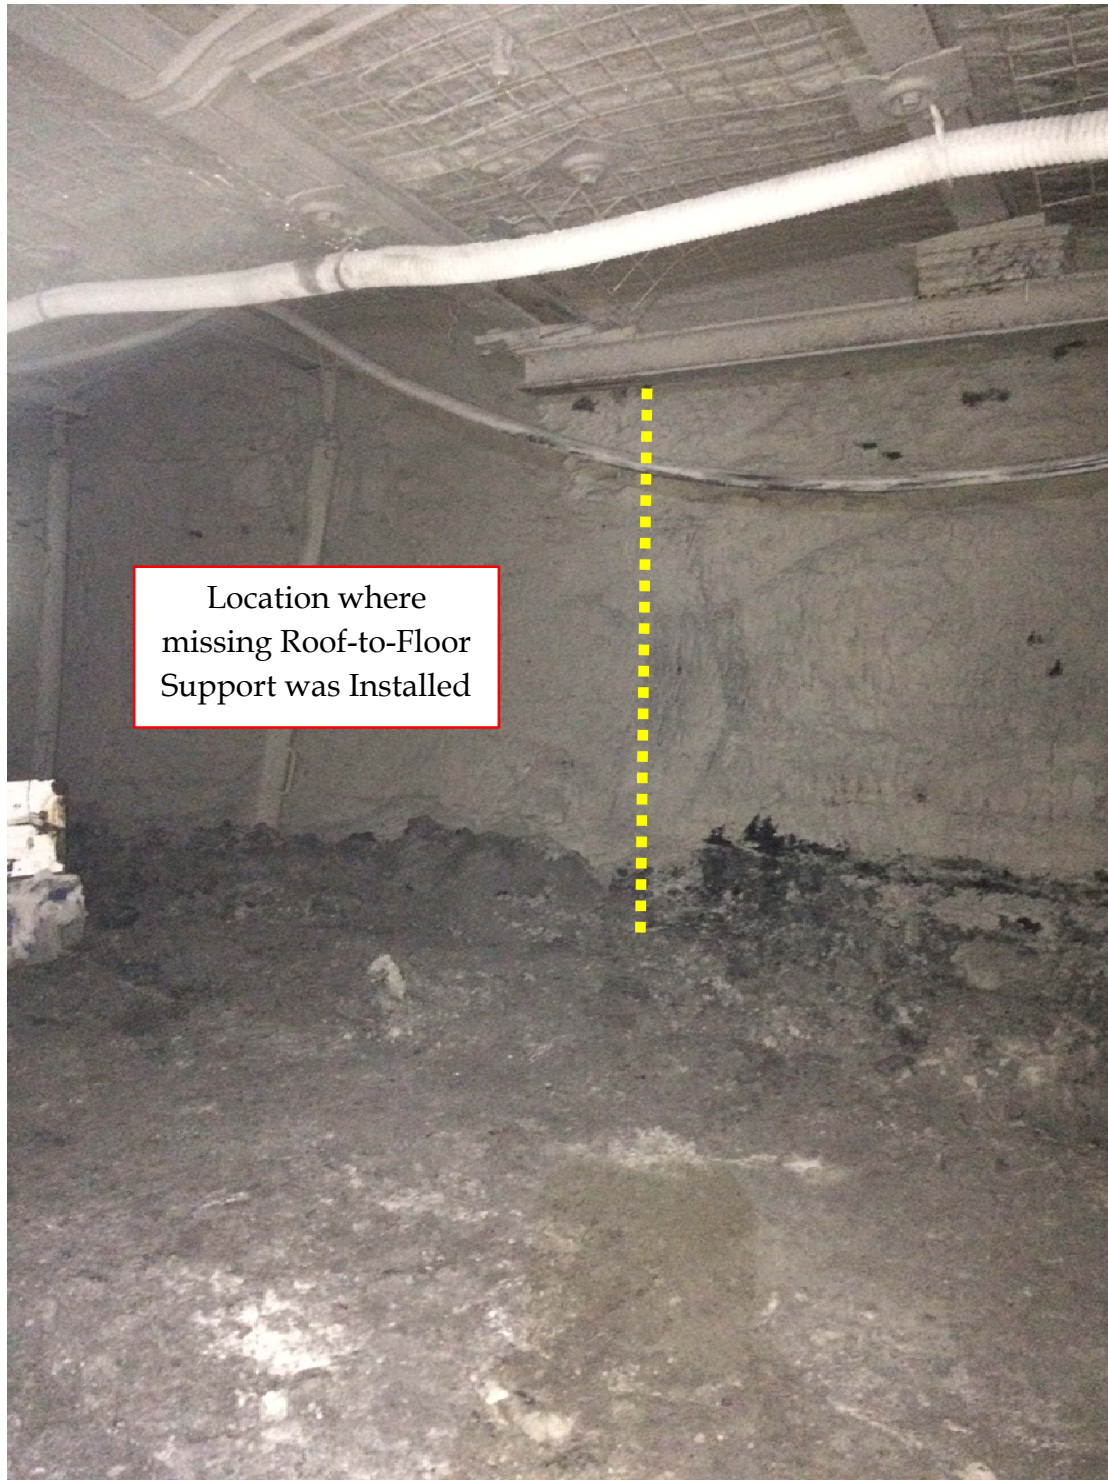
APPENDIX E

When investigators arrived at the accident scene, they found that the haulage roadway repair work had been completed. However, the roof-to-floor support installed under the outby end of a beam at 3 block was missing. The top of this support was found approximately 7 feet from where it had been installed and the base was located next to the personnel carrier. The roadway condition at the time of the accident and original location of the roof-to-floor support are shown in Appendix E. Investigators were not able to determine what caused the roof-to-floor support to fall into the roadway.

Photograph of Accident Scene
