REPORT OF INVESTIGATION

Fatal Powered Haulage Accident  
March 28, 2018

D-11 Panther Mine  
Blackjewel, L.L.C.  
Cumberland, Harlan County, Kentucky  
ID No. 15-18198

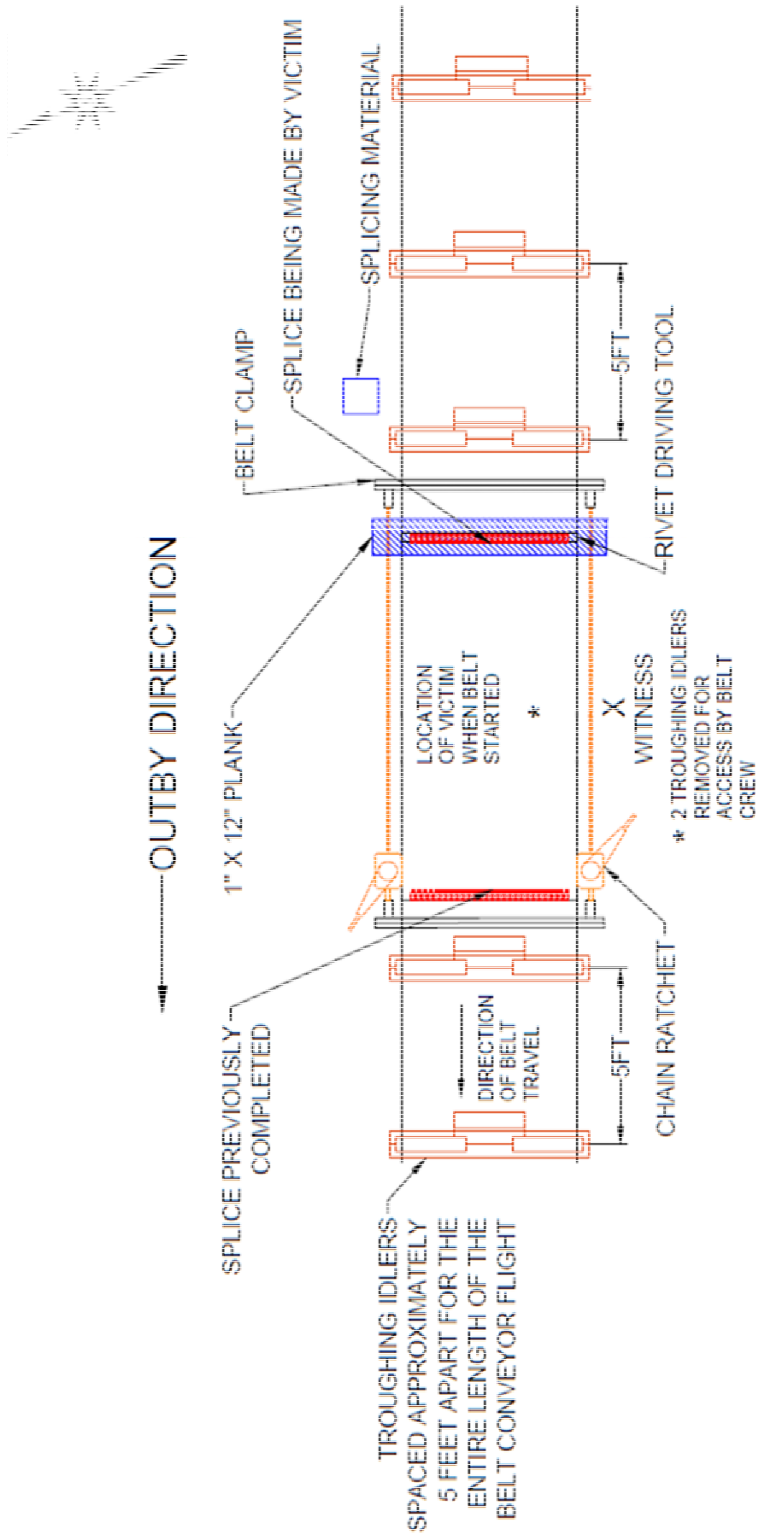
APPENDIX B  
Drawing of the Accident Scene

Still at crosscut 135, Saylor heard a noise, which he surmised was from a bad conveyor belt splice. The noise became louder and sounded more like the conveyor belt was broken and was contacting the troughing rollers. He saw reflective material on the conveyor belt and realized that something was wrong. He instinctively flipped the conveyor belt switch in the opposite direction, but the conveyor belt did not immediately stop. Saylor then pulled apart the conveyor belt switch wires he had just spliced. The portion of the conveyor belt where Grubbs was located coasted to a stop at crosscut 135. The belt had traveled a total of about 585 feet (see Appendix B) with Grubbs on it.

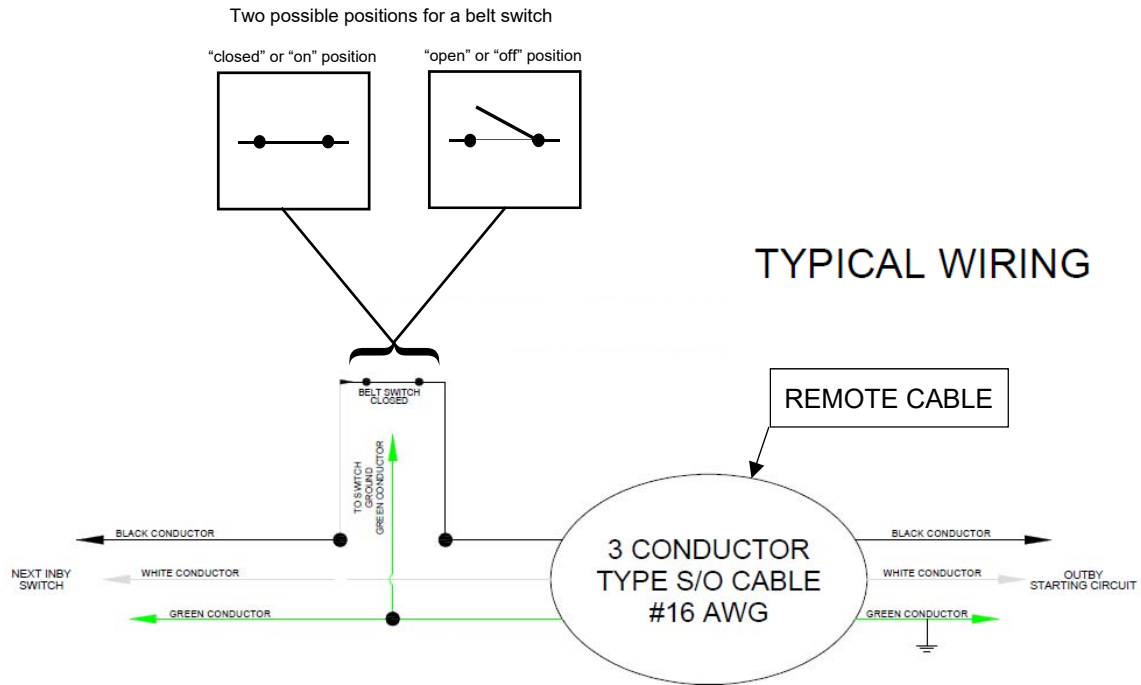
## APPENDIX D Belt Switch Wiring and Splice Diagrams

By using on/off switches, a miner could stop and then restart the No. 7 conveyor belt, located several hundred feet from the electrical controls at the belt drive. These on/off switches, or belt switches, installed approximately every 500 feet along the No. 7 conveyor belt, were in by the No. 7 conveyor belt drive. The belt switches were electrically connected or spliced into a cable (No. 16 AWG, type S/O) with black, white, and green insulated wires. This cable is called a remote cable.

The belt switches were spliced into the remote cable by separating either the white or black insulated wire. Each switch was connected so that it was between the two ends that were made when the black or white wire was separated. See the “TYPICAL WIRING” drawing in Appendix D. The Appendix shows that the wires of the switch, which are black and white, are not the same wires in the remote cable. The black and white wires of the switch are spliced into the black wire of the remote cable. The conveyor belt would run only when all belt switches were closed as shown. A belt switch was closed when it was in the “on” position. The electrical power to the belt drive would be deenergized when one of the belt switches was moved to the “off” position because this would open the switch. The green wire was used for grounding purposes only.

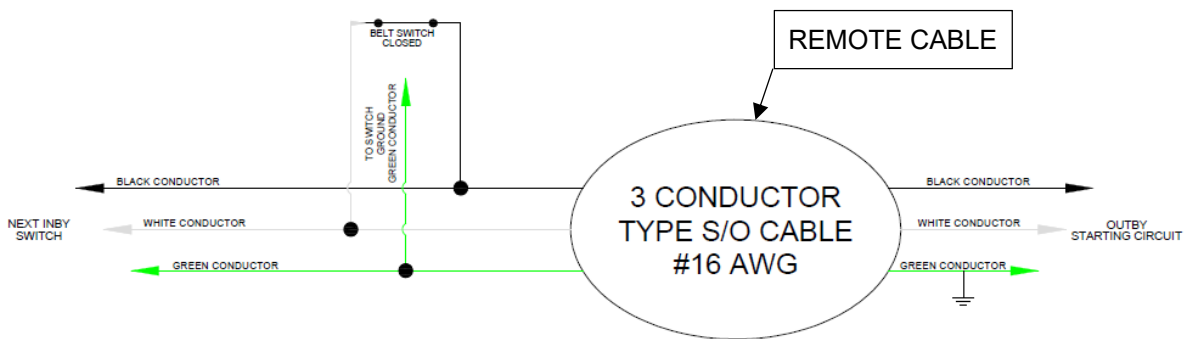
### WIRING AFTER SPLICE REPAIR AT TIME OF ACCIDENT

Saylor attempted to repair the damaged splice at crosscut 135 by connecting white wire to white wire and black wire to black wire. See the “WIRING AFTER SPLICE REPAIR AT TIME OF ACCIDENT” drawing in Appendix D. This placed the belt switch in parallel with the No. 7 conveyor belt switches. Since the switch was in the closed or “on” position, all of the in by belt switches were electrically bypassed and the No. 7 conveyor belt started.

2. Root Cause: The operator performed an improper repair of the remote cable and belt switch wires, which had been damaged during the on-shift examination. The repair caused the belt to start. The mine examiner had not been trained to repair the electrical circuit.

Corrective Action: The electrical circuit was repaired by a miner who was qualified to perform this repair. The mine operator retrained all miners that repairs and maintenance on any electrical circuit must be performed by a qualified electrician.
