REPORT OF INVESTIGATION

Fatal Powered Haulage Accident
March 28, 2018

D-11 Panther Mine
Blackjewel, L.L.C.
Cumberland, Harlan County, Kentucky
ID No. 15-18198

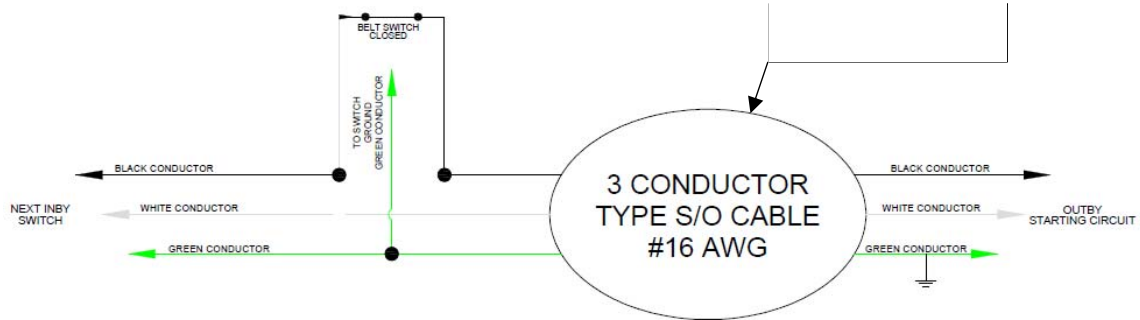
TYPICAL WIRING

By using on/off switches, a miner could stop and then restart the No. 7 conveyor belt, located several hundred feet from the electrical controls at the belt drive. These on/off switches, or belt switches, installed approximately every 500 feet along the No. 7 conveyor belt, were in by the No. 7 conveyor belt drive. The belt switches were electrically connected or spliced into a cable (No. 16 AWG, type S/O) with black, white, and green insulated wires. This cable is called a remote cable.

The belt switches were spliced into the remote cable by separating either the white or black insulated wire. Each switch was connected so that it was between the two ends that were made when the black or white wire was separated. See the “TYPICAL WIRING” drawing in Appendix D. The Appendix shows that the wires of the switch, which are black and white, are not the same wires in the remote cable. The black and white wires of the switch are spliced into the black wire of the remote cable. The conveyor belt would run only when all belt switches were closed as shown. A belt switch was closed when it was in the “on” position. The electrical power to the belt drive would be deenergized when one of the belt switches was moved to the “off” position because this would open the switch. The green wire was used for grounding purposes only.

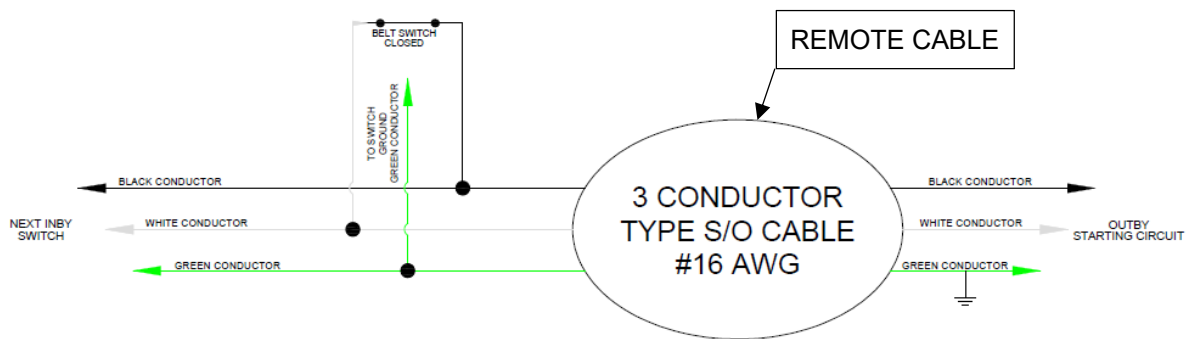
WIRING AFTER SPLICE REPAIR AT TIME OF ACCIDENT

Saylor attempted to repair the damaged splice at crosscut 135 by connecting white wire to white wire and black wire to black wire. See the “WIRING AFTER SPLICE REPAIR AT TIME OF ACCIDENT” drawing in Appendix D. This placed the belt switch in parallel with the No. 7 conveyor belt switches. Since the switch was in the closed or “on” position, all of the in by belt switches were electrically bypassed and the No. 7 conveyor belt started.

2. Root Cause: The operator performed an improper repair of the remote cable and belt switch wires, which had been damaged during the on-shift examination. The repair caused the belt to start. The mine examiner had not been trained to repair the electrical circuit.

Corrective Action: The electrical circuit was repaired by a miner who was qualified to perform this repair. The mine operator retrained all miners that repairs and maintenance on any electrical circuit must be performed by a qualified electrician.
