REPORT OF INVESTIGATION

Underground Coal Mine

Fatal Powered Haulage Accident
September 11, 2018

Kocjancic
Rosebud Mining Company
Brockway, Jefferson County, Pennsylvania
ID No. 36-09436

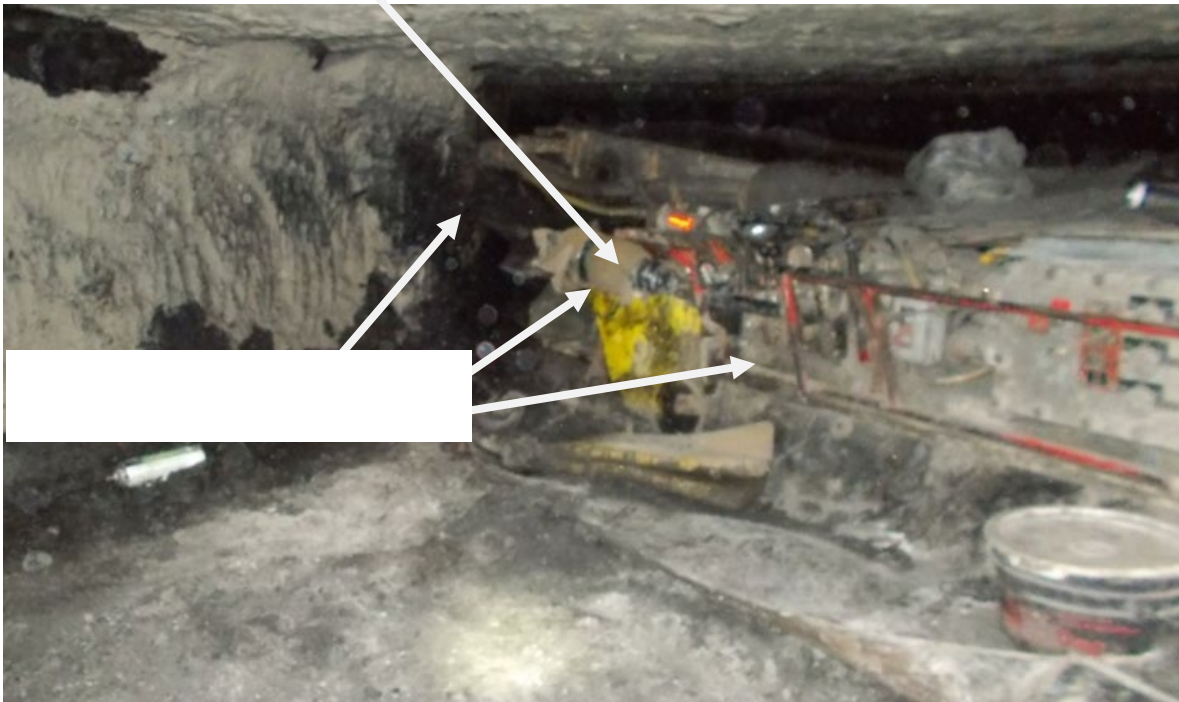
No. 1 mobile bridge carrier

The MBCs are operated manually, with the controls being on the side of the machine. Due to the low mining height, the operator typically crawls beside the machine as it moves forward and backward. The No. 1 MBC involved in the accident was equipped with a piece of conveyor belt material that was attached to the MBC so Rankin could ride on it as the unit moved across the mine floor. This piece of conveyor belt is commonly referred to as the "magic carpet." The magic carpet is typically used when there is no operator's deck attached to the machine. The deck is a solid platform for the machine operator to sit on and ride as the controls are operated. The deck provides lateral protection against crushing hazards because the metal deck frame extends beyond the MBC operator's body. The No 1 MBC was manufactured in 1988 with an operator's deck, but when it began to be used at the Kocjancic mine in 2013, it did not have an operator's deck. Investigators were not able to determine when the deck was removed or who removed it.

Corrective Action: The mine operator installed a substantially constructed equipment operator's deck for lateral protection against crushing injuries to the MBC operator. The construction of the deck is consistent with the original equipment manufacturer's design. Additionally, the mine operator installed "man-in-position" safety devices on the MBCs to deactivate the tram motors of the CMM and both MBCs when an MBC operator exits the operator's deck. The devices prevent restarting the CMM or any MBC until the operator returns to position. The mine operator also instituted preoperational examinations of the man-in-position safety device. The examination and results must be recorded and signed by a foreman, and defects affecting safety must be fixed before any MBC is used.

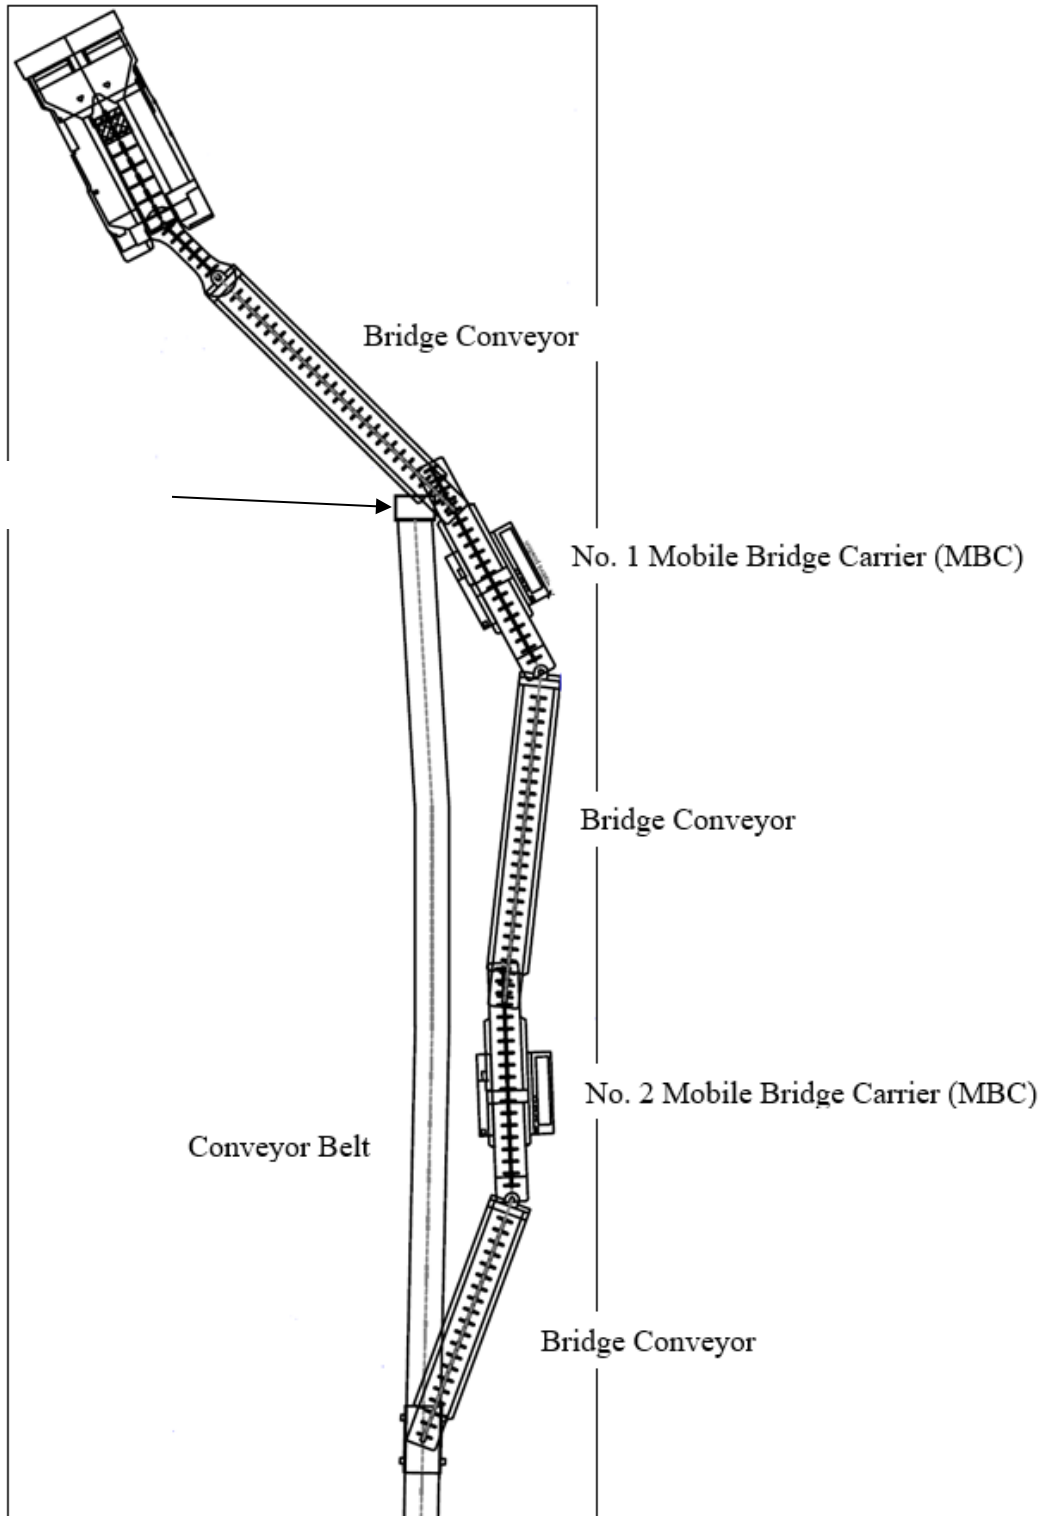
Appendix A
Continuous Haulage Mining System

The continuous haulage mining system involved in the accident is an "attached system," meaning that the MBCs and bridge conveyors are physically attached to the CMM, forming a train (see Appendix A). The train consists of one CMM, two MBCs, and three bridge conveyors. The MBCs are controlled by equipment operators who start and stop the bridge conveyors as needed.

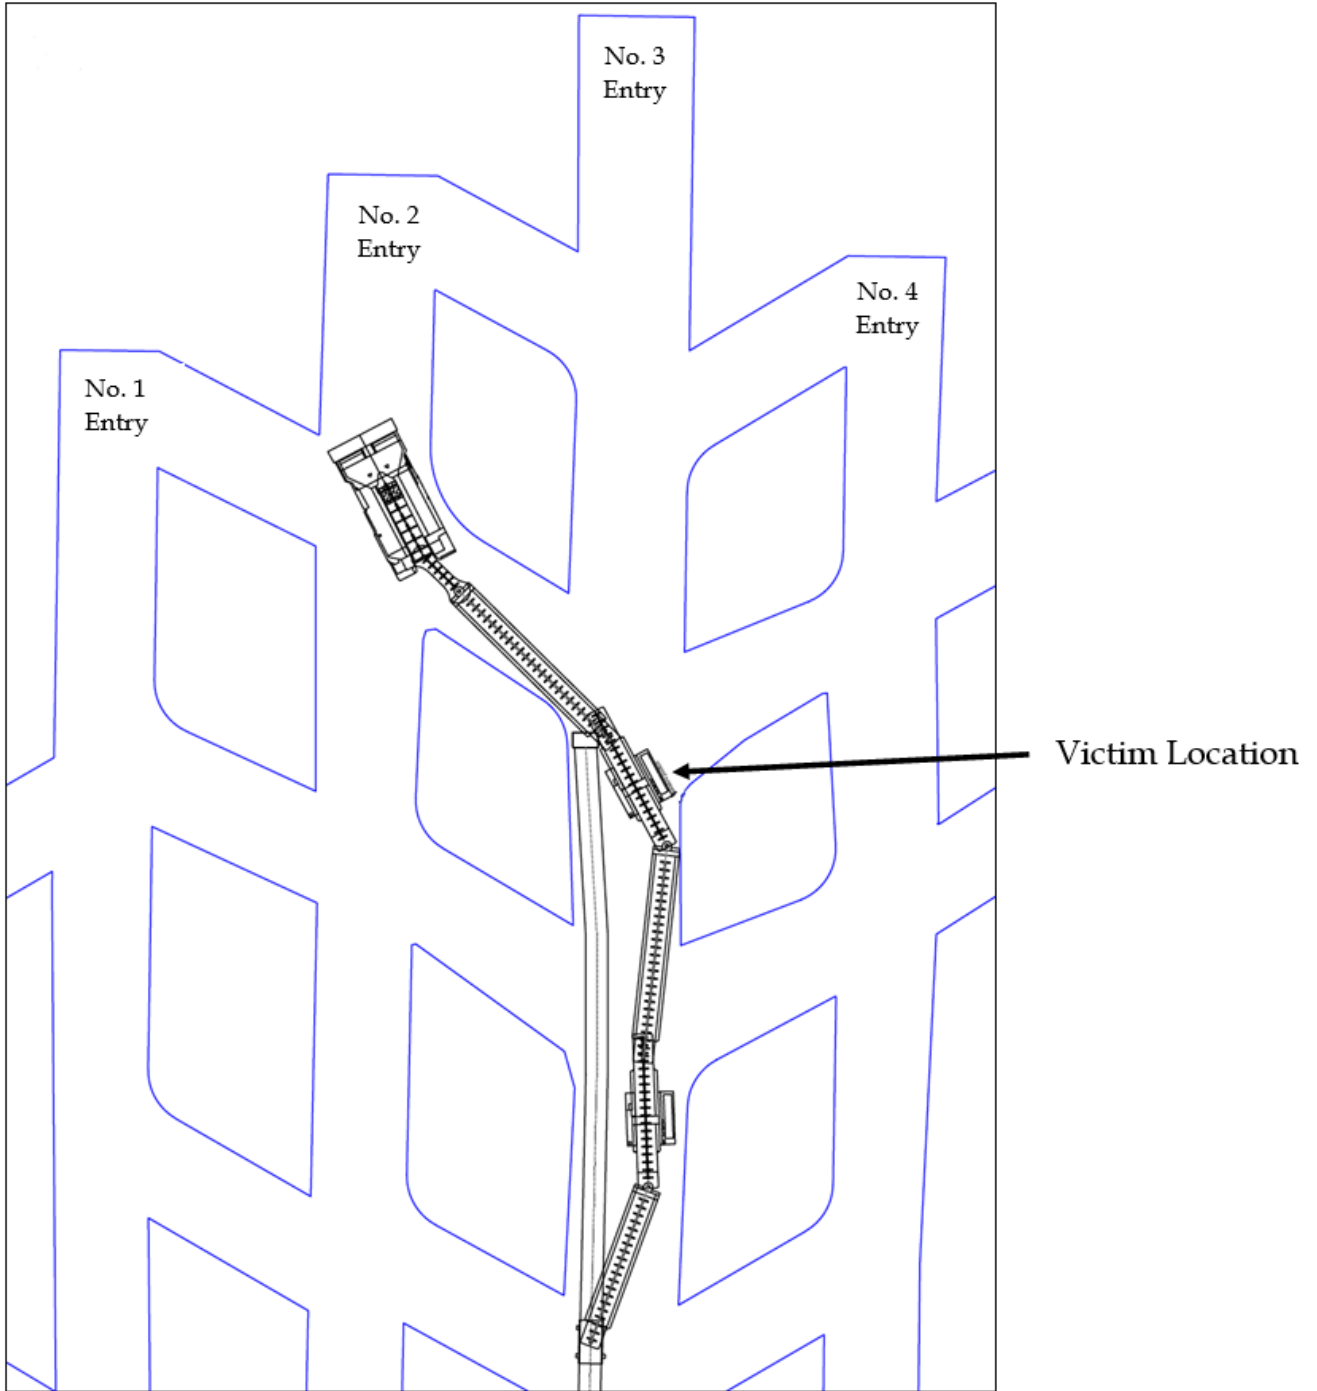
Appendix B
Victim Location
(Not to Scale)

The accident occurred in the No. 3 entry intersection of the C-8 Butt Rooms Section. The CMM backed up across the No. 2 entry intersection to allow the single-boom roof bolter to pass by into the No. 1 entry. This action placed the No. 1 MBC (victim's MBC) just outby the intersection of the No. 3 entry, alongside the stationary conveyor belt. The No. 1 MBC was idle indicating that the victim was not trammings it at the time of the accident. The CMM, while it was trammed backward, then forward, pinched the victim between the MBC and the coal rib (see Appendix B). The victim was moved along the rib line for approximately 8 feet until the MBC

reached the right outby corner of the intersection in No. 3 entry. The mined height at the victim's location is 46 inches. The mine floor was dry.
