UNITED STATES
DEPARTMENT OF LABOR
MINE SAFETY AND HEALTH ADMINISTRATION

REPORT OF INVESTIGATION

Fatal Fall of Highwall Accident
December 11, 2018

Little Spring Creek Mine
Cedar Lake Mining, Inc.
Walker County, Alabama
I.D. No. 01-03444

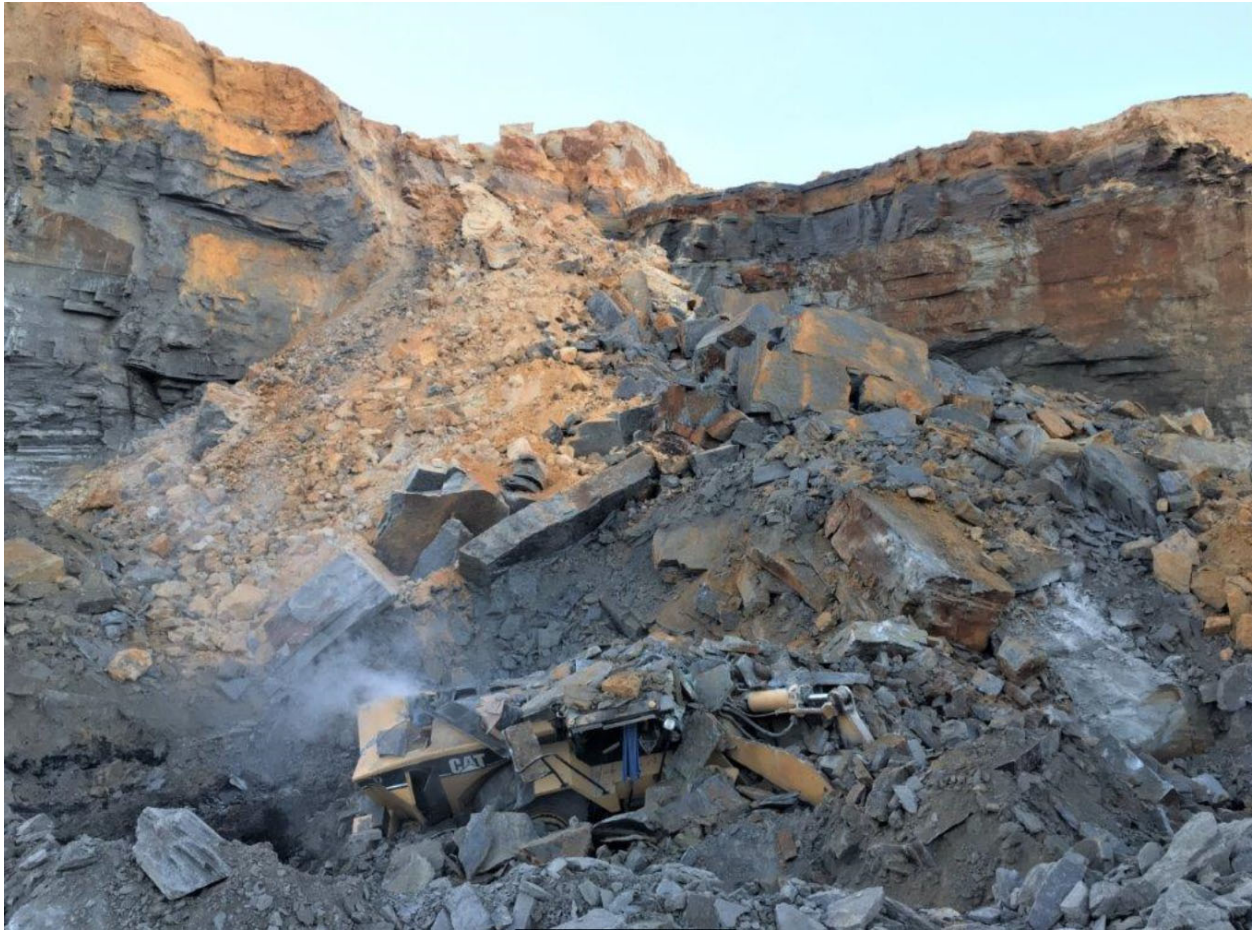
PHOTOGRAPH OF THE ACCIDENT SCENE

On Tuesday, December 11, 2018, at approximately 2:07 p.m., Micky Cook, a 38-year-old surface miner with 14 years of mining experience, was fatally injured when a large portion of a highwall (approximately 7,000 to 8,000 cubic yards) toppled, crushing the operator's cab of his front-end loader. Cook was operating the front-end loader to remove blasted material near the base of a 63-foot highwall.

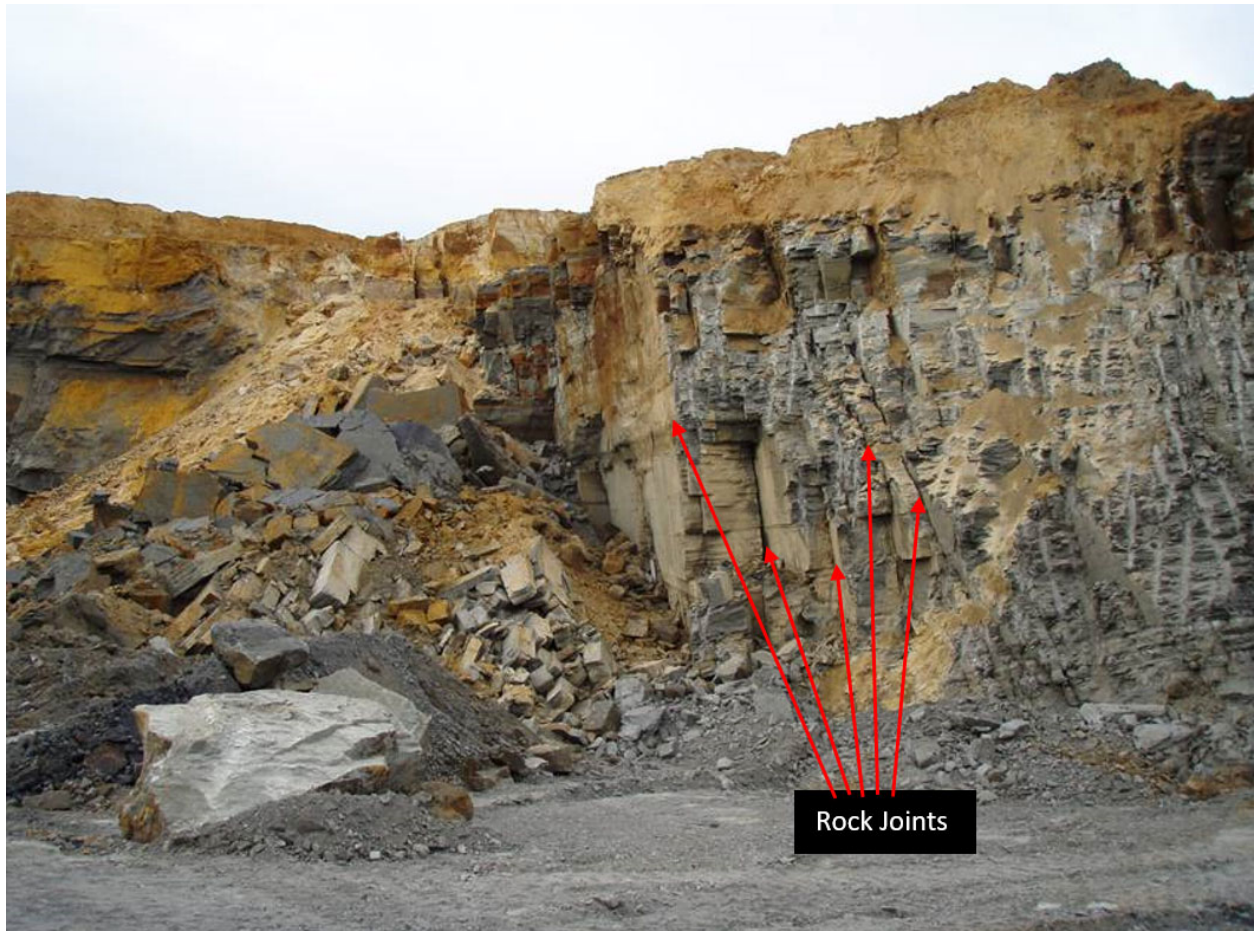
APPENDIX B
Multiple Discontinuities (Rock Joints)

Multiple discontinuities (rock joints) were observed in the exposed face of the highwall adjacent to the area that failed (see Appendix B). The bearing of one set of rock joints was N64°E. This is 48° off of the bearing of the highwall (N16°E). This joint set defined one leg of the triangular-shaped failure. The length of the failure area along this set of joints was approximately 90 feet. The spacing of this set of exposed highwall joints, immediately behind the area that failed, ranged from approximately 2 feet to 4.5 feet. The joints, and slabs of rock between the joints, were dipping 84.4° NW such that the rock was leaning toward the pit. Joint openings were up to 3 inches and staining of the exposed faces of the intact rock was present.

There were multiple noticeable discontinuities (rock joints) observed in the exposed face of the highwall adjacent to the area that failed and tension cracks in the soil roughly parallel to the highwall (see Appendix B). Along its entire 3,000 linear feet of highwall, the highwall was greater than 50 feet high and no safety benches were constructed. The GCP required a minimum 100-foot-wide bench be constructed for every 50 feet in highwall height. For over three months, the mine operator developed the highwall in a manner that violated the provisions of the GCP.

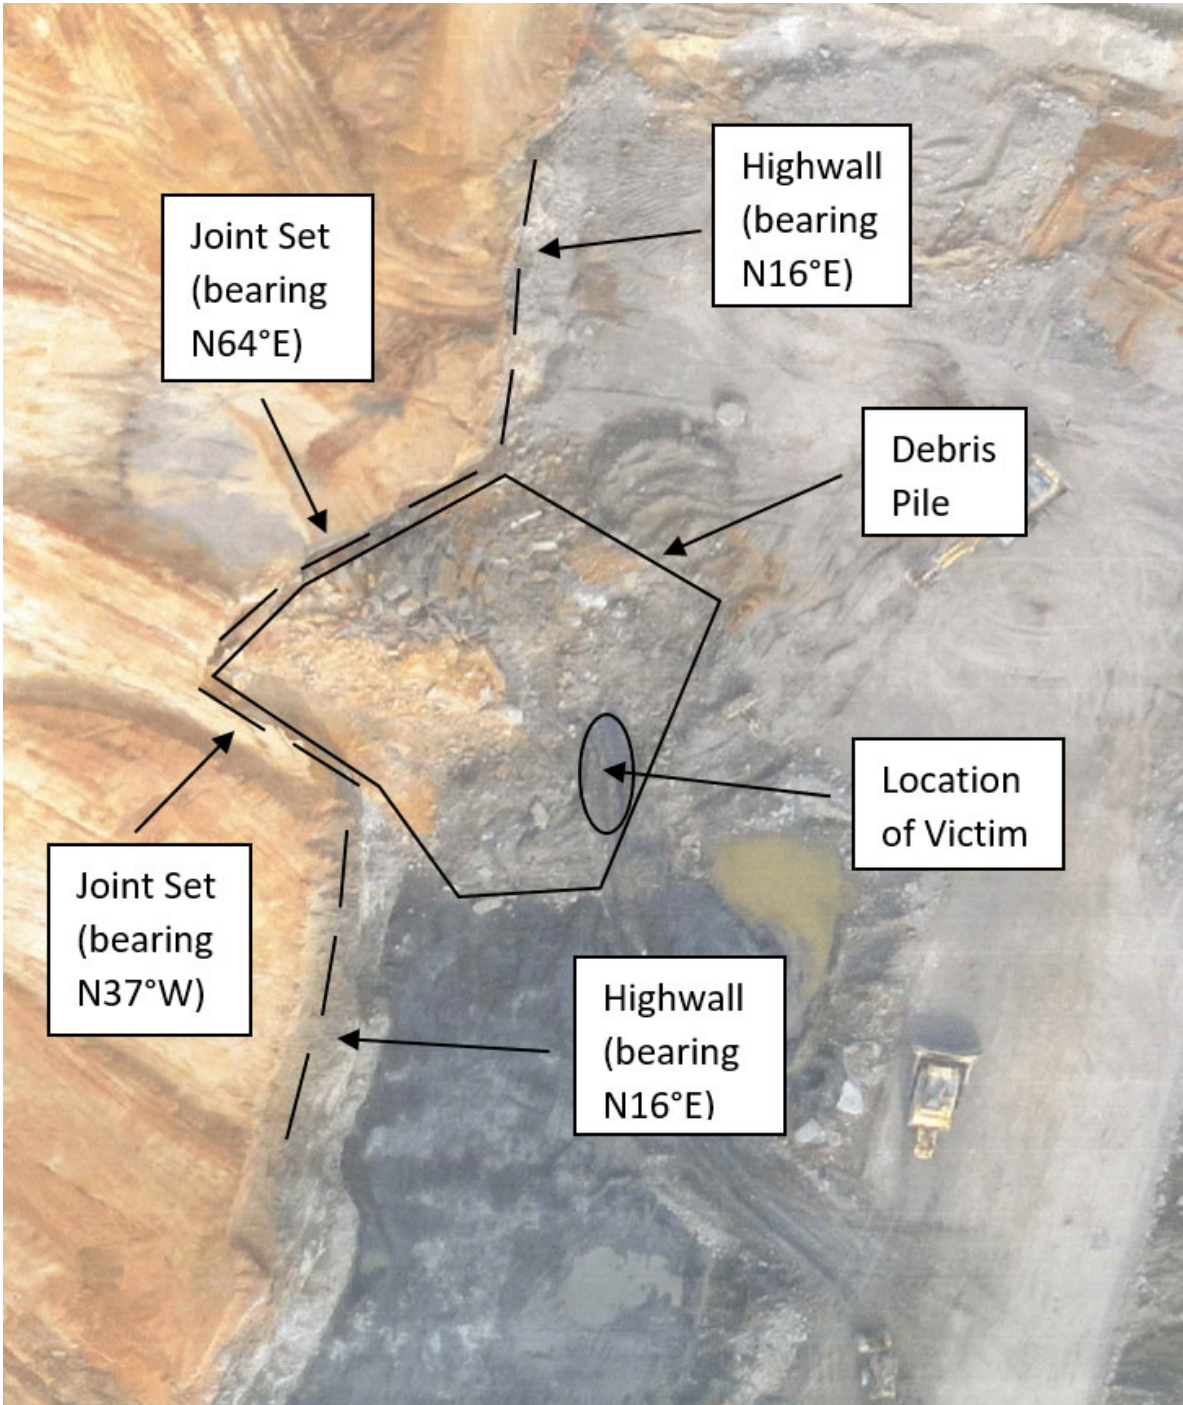
APPENDIX C
Aerial View of Accident Scene
(Not to Scale)

Investigators observed a second set of rock joints, with a bearing roughly perpendicular to the first set of joints (N37°W). This joint set defined the second leg of the failure triangle. The length of the failure area along this set of joints was approximately 60 feet. The dip of this set of rock joints was approximately 70° NE such that the rock was leaning away from the pit (see Appendix C).

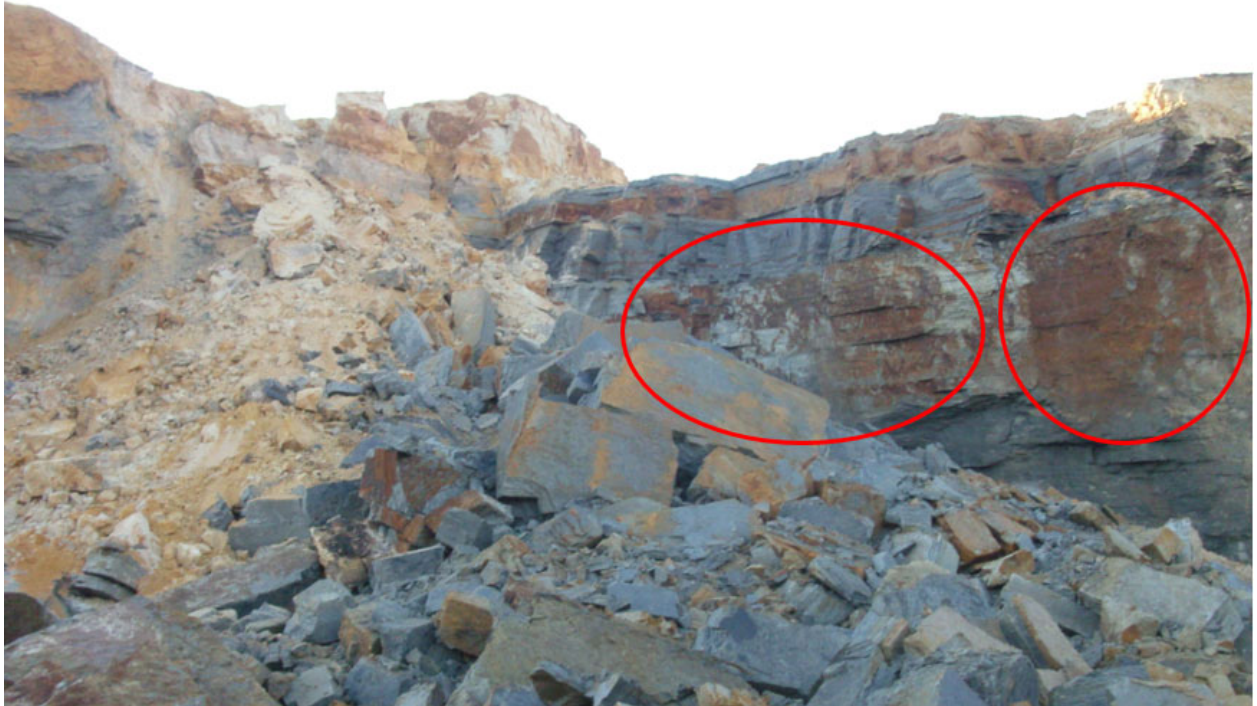
APPENDIX D
Staining of Rock Joints

Factors in the highwall failure were the location and orientation of the joint sets in the rock mass relative to the orientation of the highwall along with possible weather-related factors discussed below. The rock joints and rock slabs with a bearing of N64°E were leaning slightly toward the pit. The rock joints with a bearing of N37°W provided a release (break) for the rock mass that was leaning toward the pit. The staining on the face of the remaining rock indicated that the openings were preexisting and not due to blast fracturing (see Appendix D).
