REPORT OF INVESTIGATION

Slip or Fall of Person Accident
August 20, 2019

Scrubgrass Fuel Handling Facility
Scrubgrass Generating Company LP
Kennerdell, Venango County, Pennsylvania
ID No. 36-08567

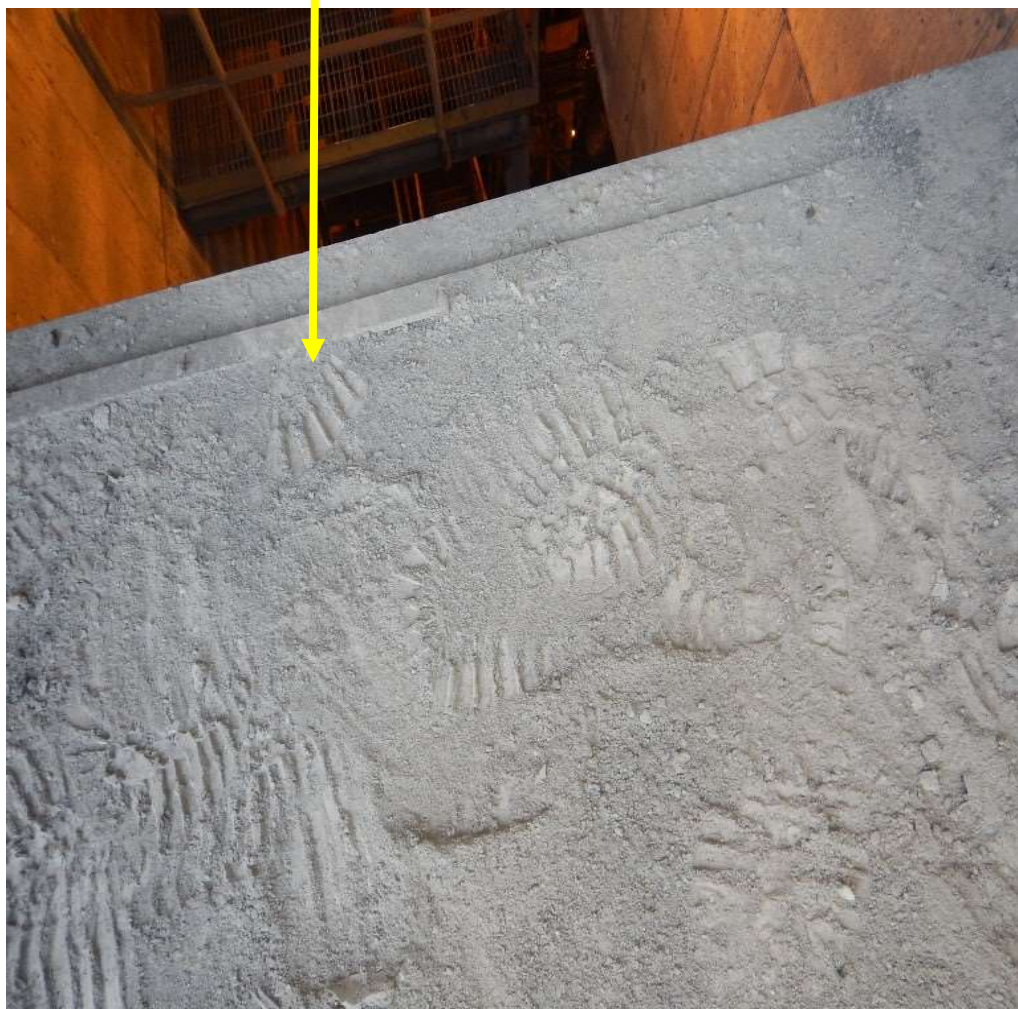
Appendix C
Accident Scene Photograph

Pictures taken show a left boot heel print, made by the victim, on the inside edge of the concrete shaft, along with a scrape mark matching the front of his boot tread (see Appendix C). Swartz stated that he never heard any noise from the victim. A raised concrete "lip," approximately 3 inches in height is present on the outside edge of the concrete shaft lining, 28 inches from the edge of the void. The purpose of the concrete lip is to act as a bumper to alert mobile equipment operators of the shaft opening and also to aid in keeping ground water from entering the shaft. Due to the close proximity of the waste bin to the shaft opening, and the safety gate not being closed, the lip created a safety hazard that may have contributed to the victim falling into the shaft.

Victim's left heel print on shaft edge, foot center over edge.
